# Failure analysis of natural gas pipes

Article in *Engineering Failure Analysis* · June 2010

Incident involving failures of 6 months old API 5L X42 (NPS8) and SDR 17, 125 mm medium density polyethylene pipe (MDPE) supplying natural gas to an industrial customer has caused serious 7 h supply disruption. Study was performed to identify the most probable cause of the pipes failures. The study conducted by reviewing the existing design and construction data, visual physical inspection, pipe material analysis, structural analysis using NASTRAN and Computational Fluid Dynamics analysis (CFD) using FLUENT. Investigations revealed that high pressure water jet from leaked water pipe had completely mixed with surrounding soil forming water soil slurry (high erosive properties) formed at a close vicinity of these pipes. Continuous impact of this slurry upon the API 5L X42 pipe surface had caused losses of the pipe coating materials. Corrosion quickly ensued and material loss was rapid because of the continuous erosion of oxidised material that occurred simultaneously. This phenomenon explains the rapid thinning of the steel pipe body which later led to its failure. Metallurgical study usin

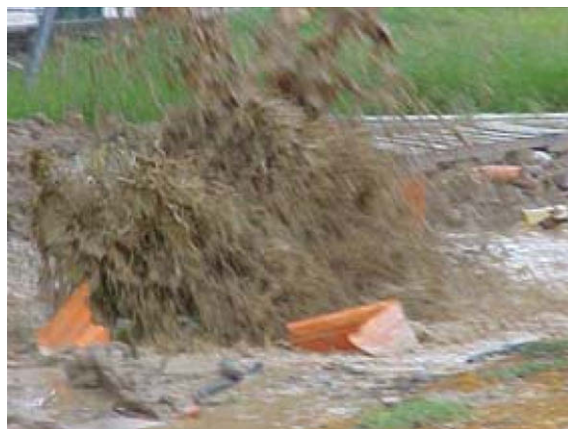
The location of the gas pipe leak was evident after the personnel from a gas utility company in northern part of Malaysia observed the bubbling of the gas through the watery soil (Fig. 1). Prompt action was taken where the leakages were immediately isolated through valves. A team was later sent to excavate the site at the incident area. This was carried out in order to locate the exact source of the leakage, to rectify and repair the damaged pipes and to make a proper record of the failure or damage for further investigation. Presented in this paper are findings, probable cause of failure and conclusions concerning the failure of the pipes.

Fig. 1. Surface water splashing due to gas pipe leakages.

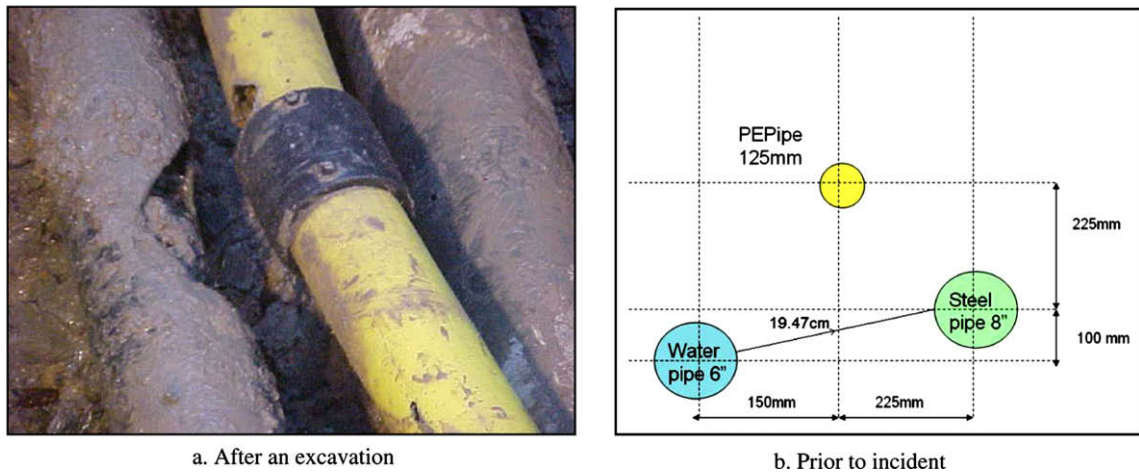
Upon the discovery of the incident location area, it was evident that three pipes adjacent to each other; a 8" (203.2 mm) steel NPS8 and a 125 mm MDPE natural gas pipes, and a 6" (152.4 mm) asbestos water pipe lying parallel to each other, with all three indicating signs of damage or leak. An electrical cable lying parallel to the pipes with no apparent sign of damage also presence in a close vicinity. The NPS8 and MDPE pipe was carrying natural gas at about 1800 kPa and 345 kPa pressure, respectively, prior to shut down. The asbestos pipe was transporting water with an estimated flowing pressure of 1000 kPa (10 bar).

The failed NPS8 gas pipe was made of carbon steel manufactured with specification of API 5L X42. It was buried 1.3 m below the ground about 195 mm laterally from the underground water pipe. The water pipe was buried at a similar depth. Slightly above it, at 1.2 m below the surface and at roughly the same distance between the steel pipe and the water pipe, is the MDPE gas pipe (Fig. 2). The thickness of the NPS8, MDPE and asbestos pipe were 5.6 mm, 11.4 mm and 10 mm respectively (see details in Table 1).

Fig. 2. Relative positions of API 5L X42, 6 in. asbestos and PE pipes.

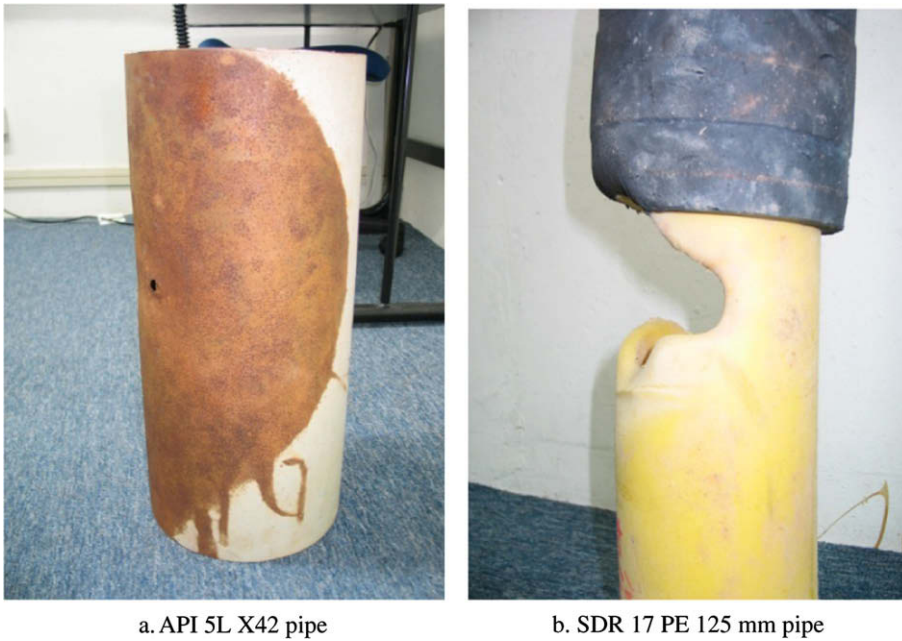
Visual inspections were carried out on both the photos and on the two physical pipe specimens provided (Fig. 3). When received, the exposed part of the steel pipe (with the coatings eroded) is already heavily oxidized (Figs. 3a and 4a). Only when the photo records were received, was the original condition of the exposed part, immediately after the incident, became evident. It was found that the coating materials has been completely stripped was in fact clean, smooth and shiny (Fig. 4b).

Fig. 3. Photos of two failed specimen.

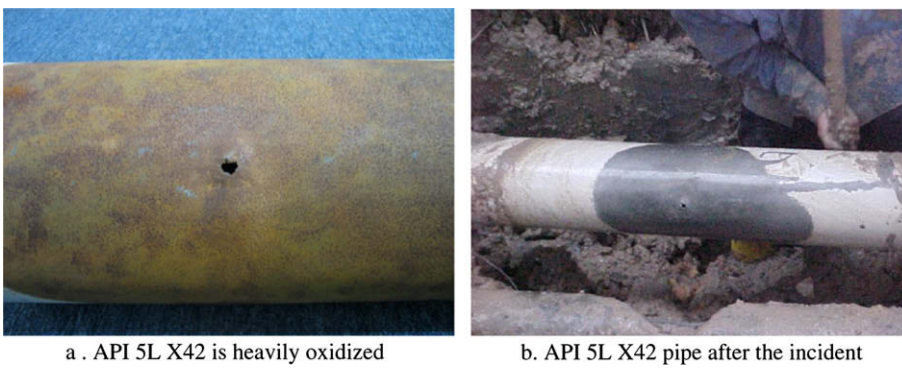
Fig. 4. Surface condition of failed steel pipe.

- iv. The simulation results seem to agree with the observed conditions of the pipe surface conditions as shown in Figs. 4b and 6a.

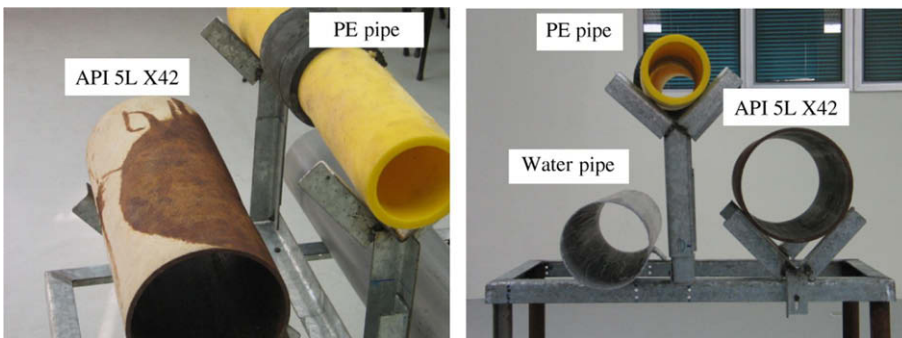
The pipes were later rearranged in the lab to reconstruct the positioning of each pipe relative to each other prior to the failures. This was conducted based on the original information supplied. The repositioning of the pipes was important to help us to build a better understanding on the direction of the leaks and how it might have impacted upon the adjacent pipes (Fig. 5).

Fig. 5. Reconstruction of relative original pipe positions.

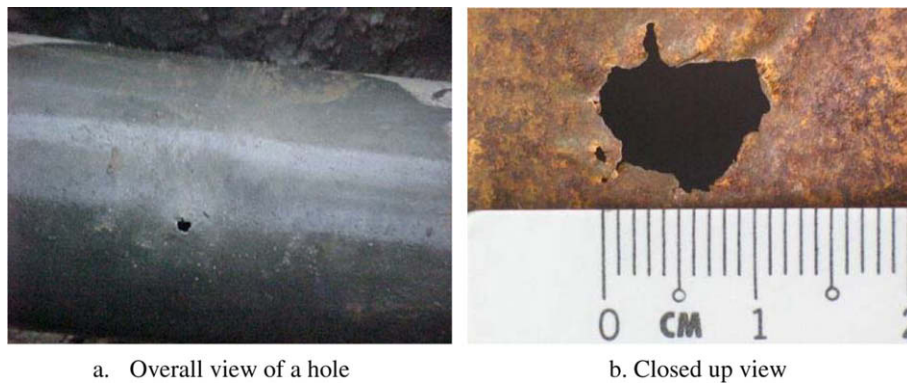
On the NPS8 carbon steel pipe section, a hole with an average diameter of 10 mm was discovered in the middle of the eroded part of the pipe (Fig. 6). The eroded part was found to be smooth and free from the rust. The size of the eroded section was around 50 cm by 30 cm (Fig. 4b). The absence of scratch marks or dents in the vicinity of the eroded part seem to support the statements of site engineers that no third party work was being observed at the location of incident.

**Fig. 6.** 10 mm diameter of hole on API 5L X42 pipe.

- i. The NPS8 gas pipe has a hole on the surface facing the water pipe measuring 11 mm × 9 mm shown in Fig. 6b.
- ii. The side of gas pipe facing the water pipe and where the hole is located has lost its coating completely and exhibited a clean and shiny surface as shown in Fig. 4b and Fig. 6a.
- iii. No significant scale or deposit was noted on the inside surface of the pipe indicating no internal corrosion.

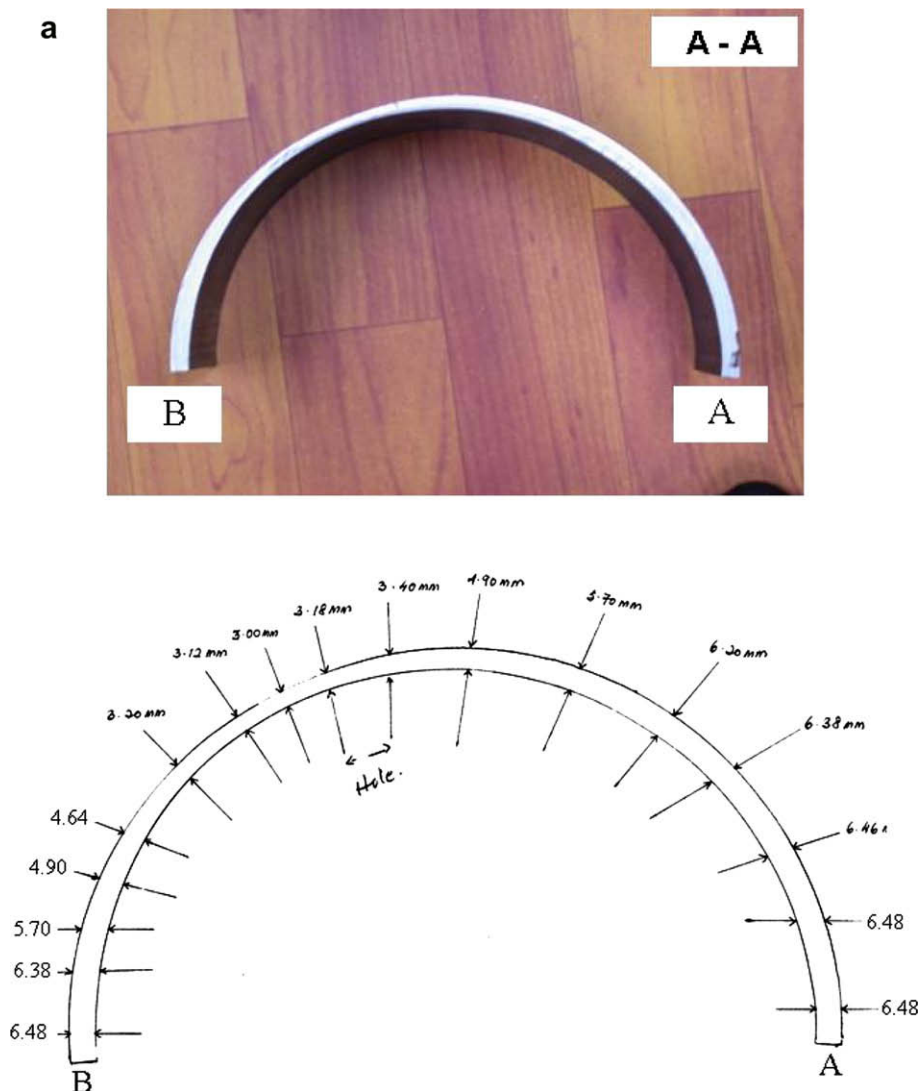
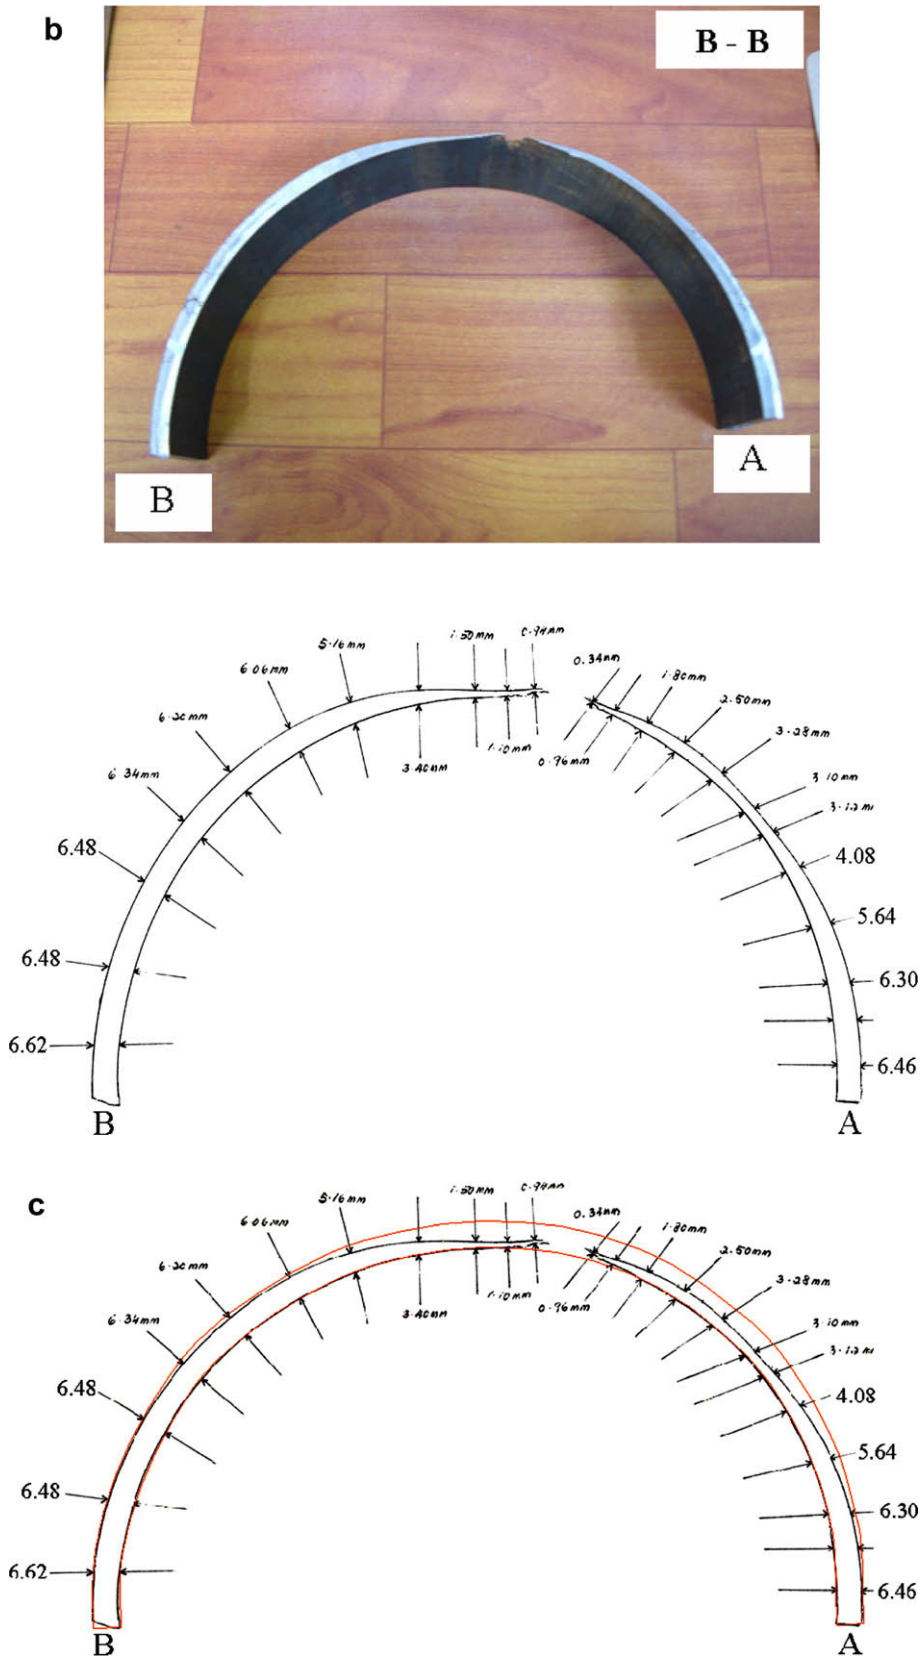
Dimensional mapping was conducted on the two half circles, where the hole is located, about 50 mm apart as shown in schematic diagram in Fig. 9. Results are illustrated in Fig. 10a–c for specimen A and specimen B, respectively. Results obtained clearly showed that the thickness of the metal decreased substantially closer against the jetting orifice position. In other words, metal loss has occurred on the area facing directly to the water pipe orifice jet resulting in a hole which increased in its dimensional size with severed metal losses. This indicates that the hole was caused by drastic erosion probably from the failed water pipe buried in the vicinity of the gas pipe.

**Fig. 10.** Dimensional mapping of API 5L X42 gas pipe. (a) Results of dimensional mapping for section A – A (50 mm away from hole). (b) Results of dimensional mapping for section B – B (half way through the hole). (c) Physical mapping at failure section B – B.

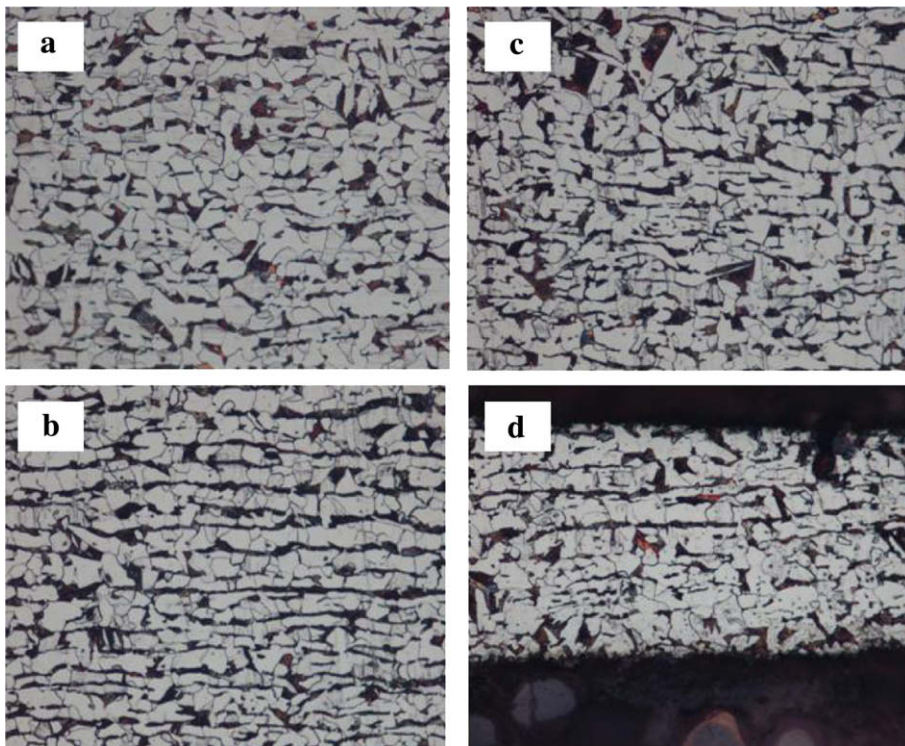
Examination of the microstructure at the failure region and base metal location clearly indicate close similarity between specimen 1 and specimen 2 that consists of the typical ferrite and pearlite structure observed in carbon steels. There is also no evidence of any micro fractures. The microstructures are shown in Fig. 11a–d for respective specimen 1 and specimen 2. These findings fully support earlier hypotheses that the pipe was failed due to the erosion of pipe surface instead of corrosion.

**Fig. 11.** Microstructures of the pipe taken from sample 1 (microstructure a) and sample 2 (microstructures b, c and d). There is no evidence of microstructure changes.

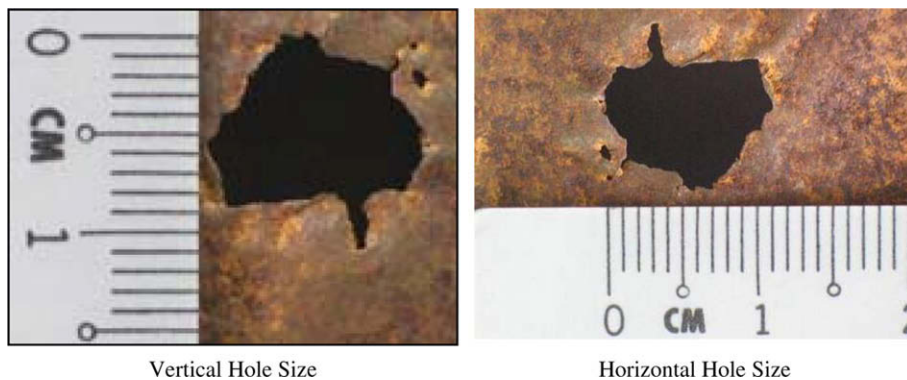
- ii. The photo in Figs. 2, 5, 13 and 14 seemed to support the hypothesis that the water jet direction was around  $20^\circ$  from the horizontal axis. The  $20^\circ$  of jet flow direction was determined through ideal geometrical approach by assuming the jet flow direction was normal to the surface of the outlet (normal impaction). Exact initialization and condition of the asbestos pipe failure cannot be determined due to unavailability of asbestos water pipe specimen.

Fig. 13. Leak size on the NPS 8.

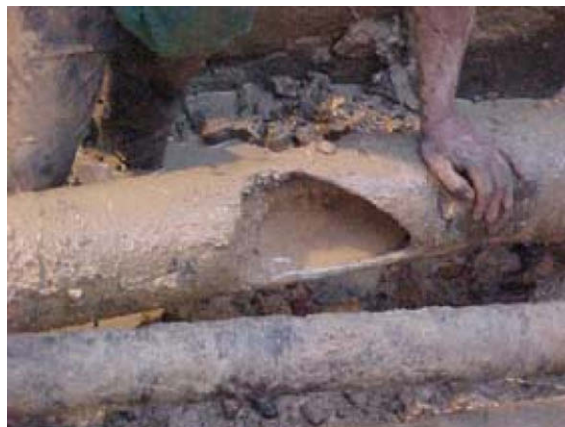
- i. As the water pipe made of asbestos material, its brittle characteristic would cause the pipe to fail instantly. There will be no significant physical outlook left on the failed edge region. However, it was noticed from the photo taken from the site showing the upper part of the asbestos pipe seems experienced more failure than the lower part.

Fig. 14. Damaged asbestos pipe (water pipe).

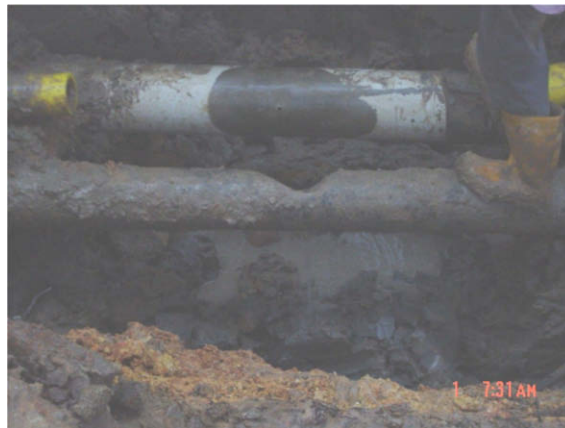
Ideas stating that the steel pipe has developed the first leak and caused the damage of the water pipe can easily be refuted. Photo evidence (Fig. 26) from the repositioning of the pipes showed that the steel pipe leak position is not directly facing the water pipe but rather towards the top. The opening of the water pipe is directly facing the eroded part of the steel pipe.

Fig. 26. Relative positions of the 8 in. water pipe to the NPS 8.
