Failure analysis of natural gas pipes

Z.A. Majid^{a,*}, R. Mohsin^a, Z. Yaacob^a, Z. Hassan^b

^a Gas Technology Centre, Universiti Teknologi Malaysia, 81310 Johor, Malaysia

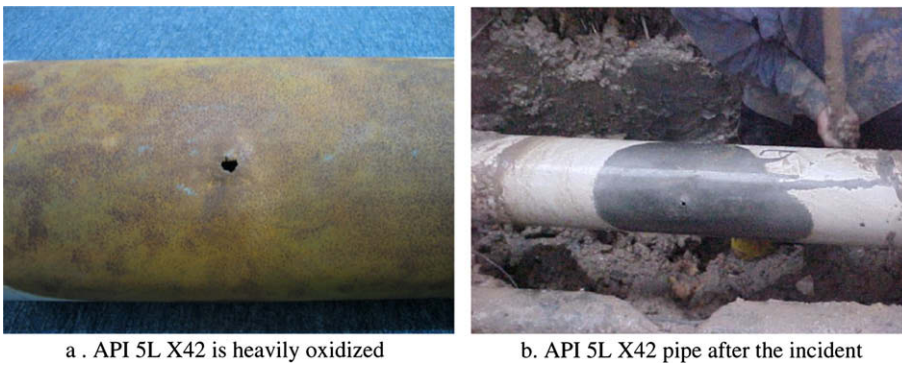
Visual inspections were carried out on both the photos and on the two physical pipe specimens provided (Fig. 3). When received, the exposed part of the steel pipe (with the coatings eroded) is already heavily oxidized (Figs. 3a and 4a). Only when the photo records were received, was the original condition of the exposed part, immediately after the incident, became evident. It was found that the coating materials has been completely stripped was in fact clean, smooth and shiny (Fig. 4b).

Fig. 4. Surface condition of failed steel pipe.

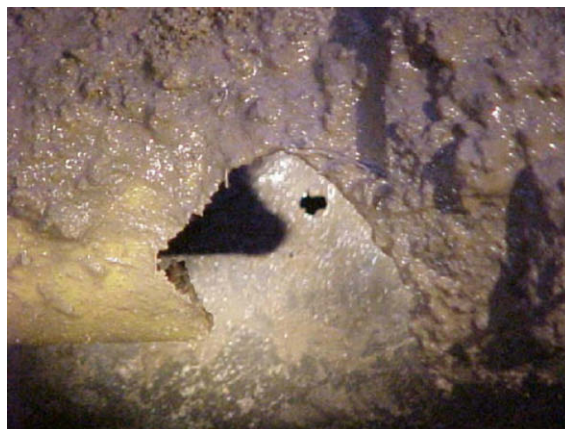
displaced causing the MDPE pipe to drop even further until it was low enough to be 'in the line of fire' from the high pressure gas jet (Fig. 7).

Fig. 7. In-situ PE pipe directly 'in the line of fire' of the API 5L X42 gas jet.

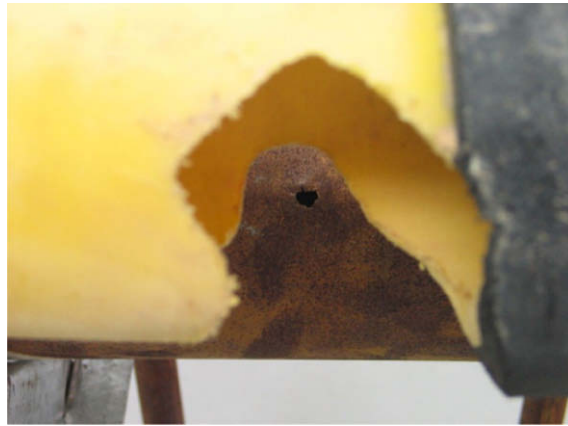
Fig. 8. Repositioned of API 5L X42 and PE pipe in lab (after excavation) truly match with Fig. 7.

Gas flow leak from MDPE pipe has not been considered. Eventually it was earlier concluded that the MDPE pipe failed due to high gas jet impingement from the steel pipe rupture. Due to the high gas jet pressure of NPS8 pipe, the MDPE was expected to experience immediate failure. The failure of the MDPE pipe should not affect other pipes. Jet flow produced by the MDPE pipe section is considered weak due to its large failure outlet (Figs. 3b and 8).

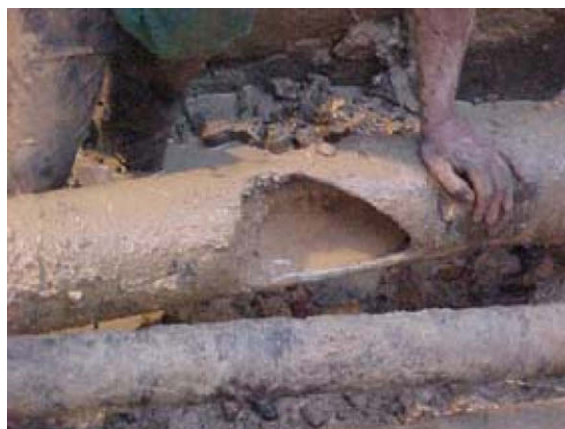
- i. As the water pipe made of asbestos material, its brittle characteristic would cause the pipe to fail instantly. There will be no significant physical outlook left on the failed edge region. However, it was noticed from the photo taken from the site showing the upper part of the asbestos pipe seems experienced more failure than the lower part.

Fig. 14. Damaged asbestos pipe (water pipe).

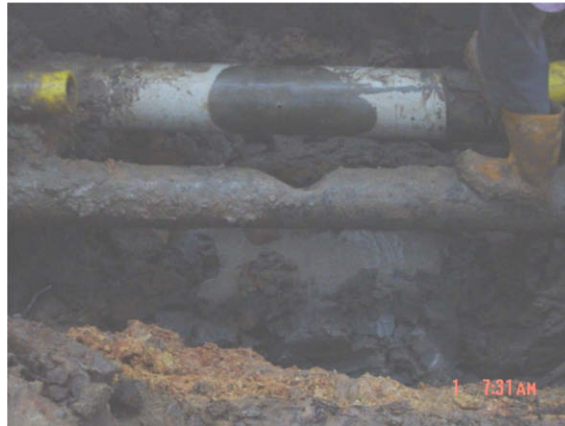
Ideas stating that the steel pipe has developed the first leak and caused the damage of the water pipe can easily be refuted. Photo evidence (Fig. 26) from the repositioning of the pipes showed that the steel pipe leak position is not directly facing the water pipe but rather towards the top. The opening of the water pipe is directly facing the eroded part of the steel pipe.

Fig. 26. Relative positions of the 8 in. water pipe to the NPS 8.
