Jurnal Teknologi

Performance of Micro Surfacing on Expressway

Nazaruddin Jamion^a, Mohd Rosli Hainin^{b*}, Haryati Yaacob^b

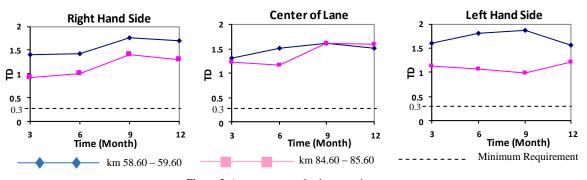
Figure 3 Average texture depth versus time

Table 4 presents the results of texture depth in 12 months. The relationship is shown in Figure 3. Texture depth of road surface is considered in good condition if more than 0.50 mm within 12 months, texture depth for micro surfacing is more than 0.50 mm [4]. The texture depth increased by 16.54 % after 12 months of operation. This happened because of the aggregate breakages and dislodgement. The dislodge aggregates left a surface void.

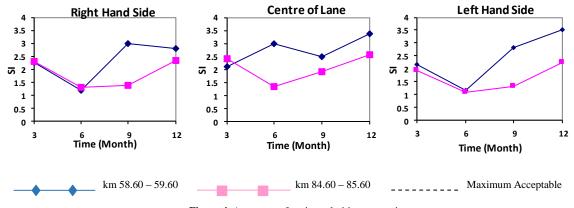
Figure 4 Average surface irregularities versus time

The results of surface irregularities are presented in Table 5 and the relationship is illustrated in Figure 4. Road surface irregularities are considered in good condition if less than 3.8 mm¹. Within 12 months, surface irregularities for micro surfacing are still less than 3.8 mm. The surface irregularities, increased by 27.73 % after 12 months of service. This occurred due to the bad jointing in the transverse joint.

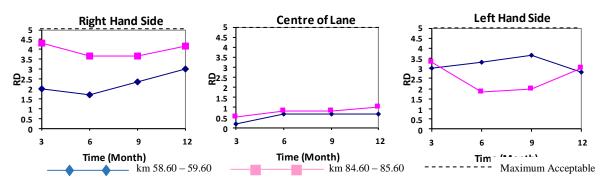
Figure 5 relationship between rut depth and time

Table 6 shows the results of rut depth in 12 months and Figure 5 illustrated the relationship. Road with rutting less than 5.0 mm is considered as in a good condition [1]. Within 12 months, rut

depth for micro surfacing is still below than 5.0 mm. The rut depth decreases 9.01 % after 12 months of operation. This is due to aggregate breakages and dislodgement. This is also because of bad jointing at the longitudinal and transverse joint.
