**EFFECT OF GEOLOGICAL STRUCTURE AND BLASTING PRACTICE IN FLY ROCK ACCIDENT AT JOHOR, MALAYSIA**

Blasting operation is common method in hard rock excavation at civil engineering and mining sites. Blasting results in the fragmentation along with environmental hazards such as fly rock, ground vibration, air-blast, dust and fumes. Most of the common accidents associated with blasting are fly rock. A fly rock accident had occurred on 15 July 2015 at a construction site at Johor, Malaysia. Due to this accident, nearby factory worker was killed while two other workers were injured after being hit by rock debris from an explosion at construction site, 200 m away from the factory. The main purpose of this study is to investigate the causes of fly rock accident based on geological structures and blasting practice such as blast design, pre inspection on geological structures, identifying danger zone due to blasting and communication and evacuation plan before blast. It can be concluded that fly rock could have been controlled in three ways: initial drilling of holes based on blast design, ensure limiting charge for holes having less burden or having geological discontinuity, and selecting p

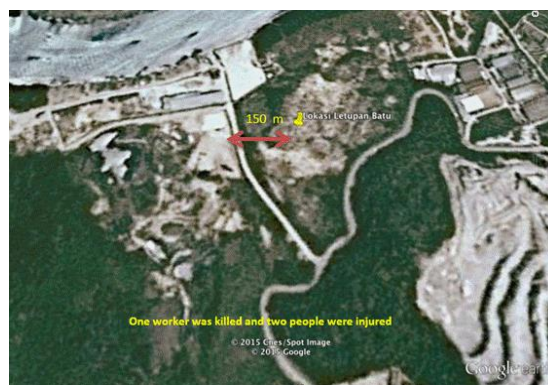
On July 2015, rock blasting contractor held a rock blasting work at a construction site in Johor. The rock blasting work was for levelling construction site in the area. However, on the day the blasting, an unprecedented catastrophe occurred in which a part of the rock mass approximately 2,000 m<sup>3</sup> from blasted granite flew away for a distance up to 200 m from the blasting face. From site survey, it was found that the size of the fly rock varied from 5 cm<sup>3</sup> to 0.3 m<sup>3</sup>. Figure 1 shows the location of the areas involved.

Figure 1 Location showing direction of fly rock

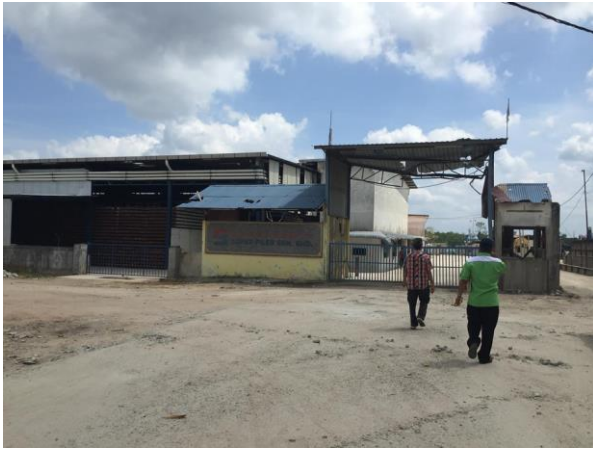
As a result of the explosion, unexpected fly rock covered surrounding area of the location. This unexpected accident killed a worker and injured two others. Workers involved were about 150 m to the west of the blasting location. Several vehicles were also destroyed and damaged. Some small fragments flew to a factory in southwest (about 50 m away). Figures 2 to 4 show the effect of the blasting.

**Figure 2** Location of the arrows shown in red and the effects of wild stone with orange arrows (150 m from the blast location)

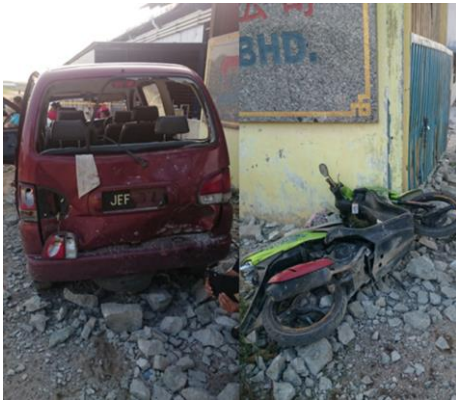
**Figure 3** The effect of damage – Vehicles damaged (150 m from the blasting site)

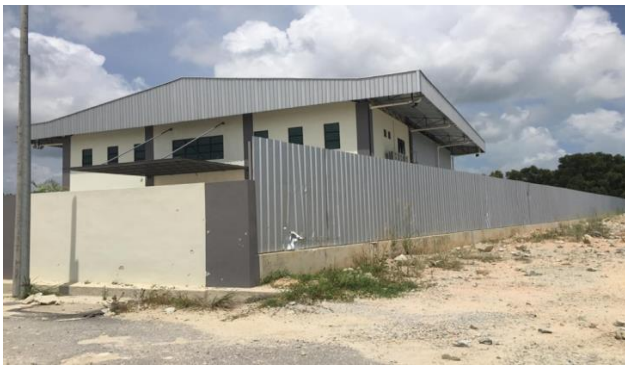
**Figure 4** A nearby factory

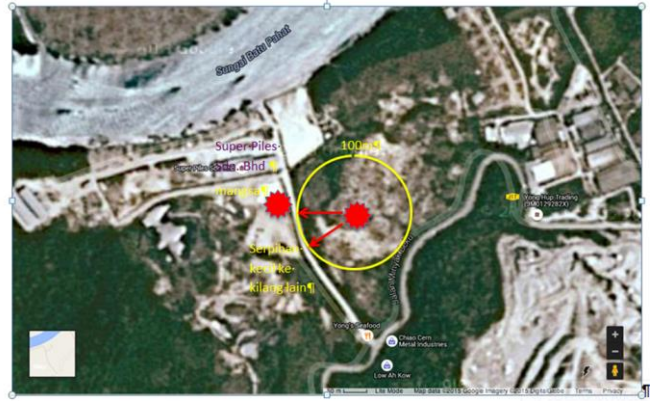
The area surrounding the blast site is shown in Figure 5. The blasting area marked with a red star and the radius of 100 m from the area where the blasting carried out are marked with a yellow circle line.

**Figure 5** Position of the blast location and 100 m radius area of the wild rock drift direction from the blast

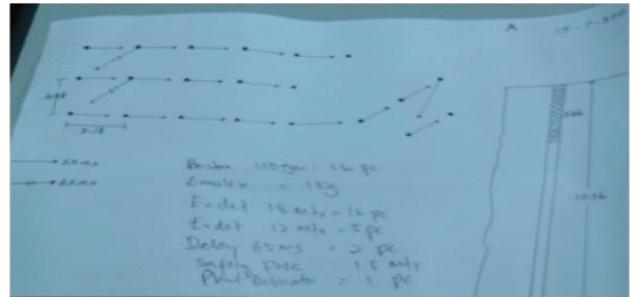
A company reported that, a total of 21 holes were drilled with burden x spacing as 4.9 m x 5.2 m and stemming of 3.7 m. The blast design and type of explosives used (provided by contractor) is shown in Figure 6, while the location of the blasting is shown in Figures 7 and 8.

**Figure 6** Design of blast reported by contractor

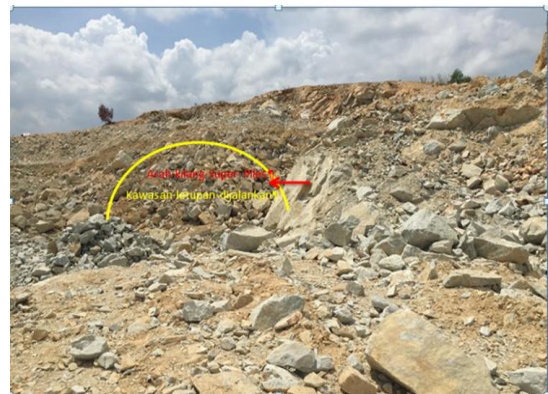
**Figure 7** The location of the blasting site (pictured on July 18, 2015)

The study was conducted at a geological structure of the rock mass affected to obtain presence information and orientation discontinuities that exist. The study was conducted after the incident, but the structure of rock left behind can still be used as a guide. Picture of rock face involved is shown in Figure 7. It should be noted that the quarry blasted and opened a site where serial blasts had been carried out. This means that the previous explosions had created the new discontinuities and cracks and fissures leave a larger aperture (up to 5-10 cm).

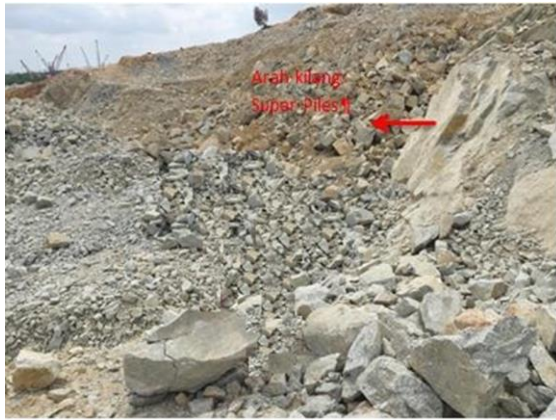
**Figure 8** Inspection carried out on site. Red arrow indicates the direction of joint dominance (to the west)

A total of 4 sets of fractures have been identified to exist at the blast site. This discontinuity occurred naturally and there are also new cracks as a result of the work of previous explosions. However, the joint set to the west is the most significant (dominant). As a result of the field measurement on traces of structures, a stereonet was drawn as shown in Figure 12.

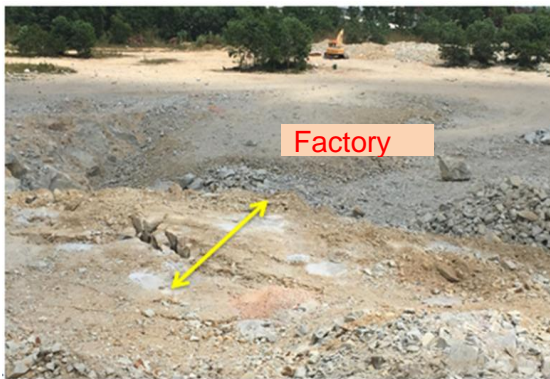
With observations on site and the information supplied by the contractor, the estimated volume of blasted rock mass is 3,000 m<sup>3</sup>, while the amount of explosive used was 1 tonne. Powder factor used in the blast was 0.33 kg/m<sup>3</sup>. It takes into account the 21 drill holes which identified the cause of the accident. Also identified from the inspection site, the source of this fly rock was from the line of drill holes in the front line. It was also observed the throw factor from second and third rows did not move far (Figures 9 to 11).

**Figure 9** Status of rows of holes 2 and 3 after blast (not moved far)

- i. Initial drilling of holes based on blast design
- ii. Inspecting holes on the day of blasting and limiting charge for holes having less burden or having geological discontinuity
- iii. Selecting proper sequence of initiation of holes. From Figures 9 and 10, it can observed that row 2 and 3 did not move. This could

have been due to cut off of holes due to less time to move front row.

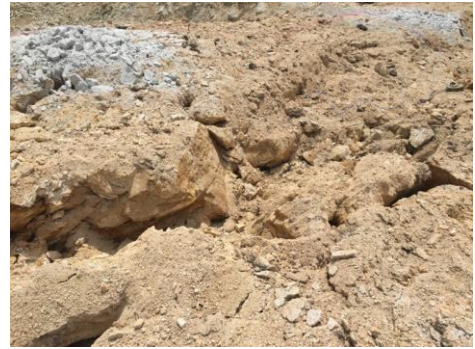
**Figure 10** The rock split in lines 2 and 3 and not moved far

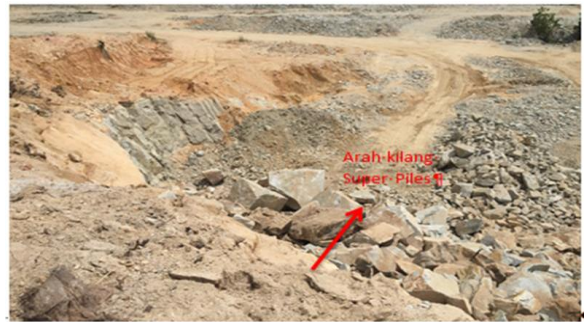
**Figure 11** Share of first hole that destroyed – believed to cause fly rock

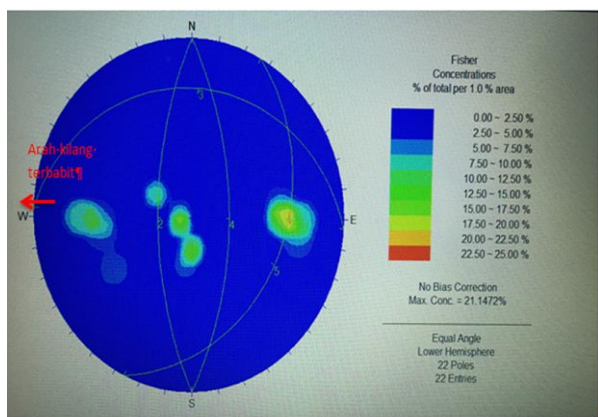
**Figure 12** Analysis of discontinuity indicating instability direction towards the factory

Local geology plays an important role. Orientation of joint, extended cracks and unfavourable orientation could posed danger. Explosive loading should be modified to suit the compensate changes in geology.
