Case Studies in Engineering Failure Analysis

Root cause analysis (RCA) of fractured ASTM A53 carbon steel pipe at oil & gas company

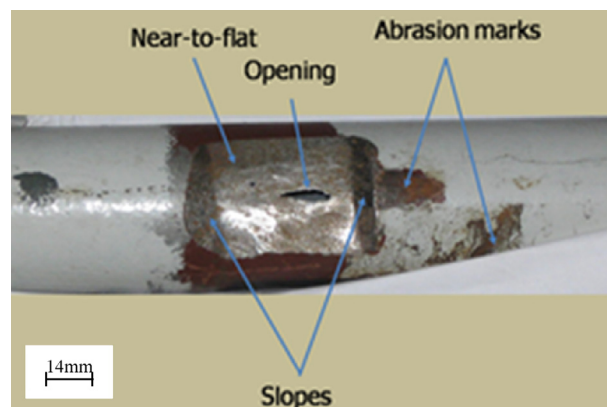
Visual inspections were carried out using photos and on the physical pipe specimen provided (Fig. 3). This pipe section was resting on the lower C-support. Failure areas marked on the failed specimen were cracked opening, abrasion marks, near-to-flat area and visible slopes on both ends.

Fig. 3. Portion of the pipe showing the failure area.

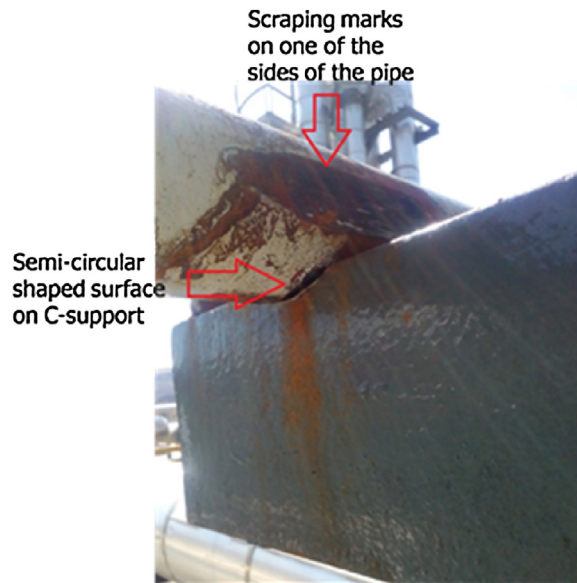
Fig. 4 shows actual location of the pipe portion that is resting on the C-support. The semi-circular shaped surface on this support is visible and indicates a material loss for both the pipe and the C-support.

In addition, minor corrosion and excessive scrapping marks on the sides of the pipe can also be seen. This situation further deteriorates the condition of the resting pipe.

Fig. 4. Actual pipe portion resting on C-support.

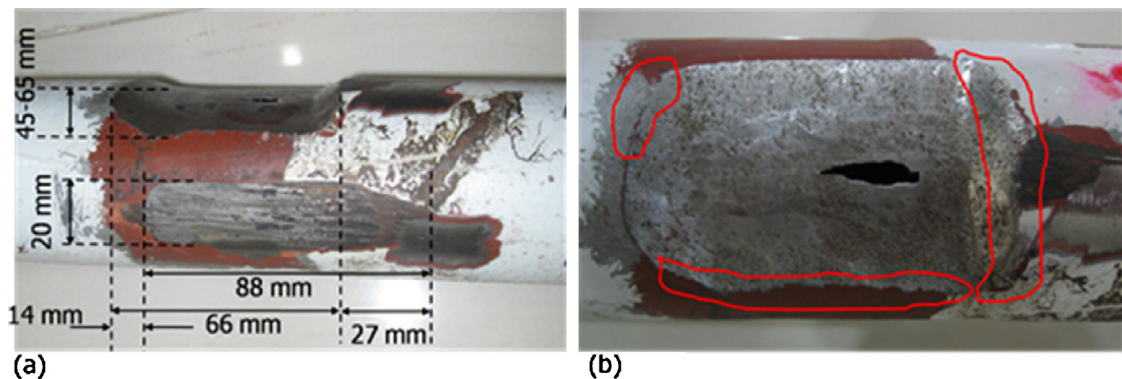
The carbon steel gas pipe was inspected externally and internally and photo-documented. Dimensional mapping was conducted and shown in Fig. 5a. The major failure area consists of approximately 45–50 mm in length of reduced section of pipe along with tapered edges on both sides of the cut. The depth of the reduced thickness portion varies from 3.1 mm to 4.3 mm on various locations, whereby, occurrence of the maximum thickness loss has led to the gas leakage from the opening. Moreover, it is also clear from Fig. 5a that the abrasion marks facing lower C-support and side support are not in line. Fig. 5b shows the presence of metal flakes around the boundary of the failure area. The direction of these flakes is towards outside with reference to the opening.

Fig. 5. (a) Approximate dimensions of the failure area resting on lower support and side abrasion region (Note: the smooth surface marks on right side are due to post failure lab work) and (b) metal flakes on boundary of the failure area.

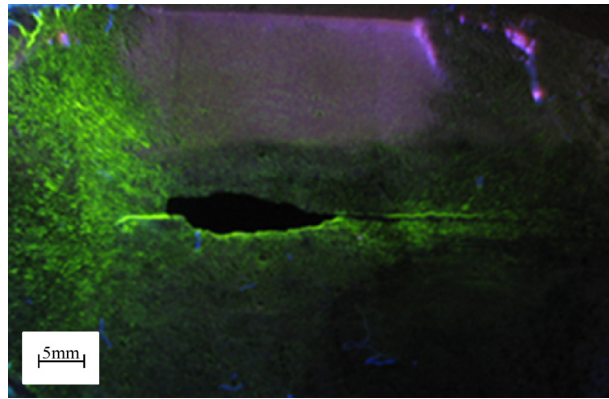
Fluorescent penetrant inspection (FPI) and magnetic particle testing (MPT) were performed on the fractured area of the pipe section. Fig. 6 shows the damaged pipe section under UV light during MPT. This proved that cracks have only initiated from the failed portion area due to the thickness loss and there are no further inherent defects.

Fig. 6. Fractured pipe area through UV light after magnetic particle testing (MT).

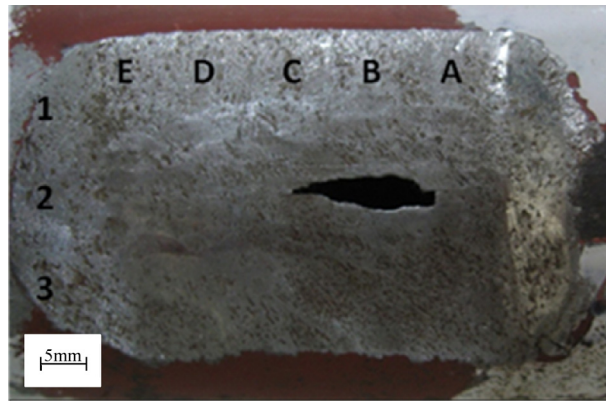
Ultrasonic thickness measurement (UTM) was performed for the fractured pipe section. The UTM results have shown marked variation in the thickness values at the vicinity of the fractured area. The thickness values vary from 1.48 mm to 2.91 mm. Marking plan and thickness variation are shown in Fig. 7 and Table 1 accordingly.

Hardness is affected by the levels of heat input and preheat used during welding. Table 2 shows hardness values (HRB) at selected locations of the failure region of the pipe. Apparently the unaffected portion has the highest hardness, 90 HRB, while it reduced to the minimum value of 64 HRB at failure location. Scatter of the measured hardness data is primarily attributed to the roughness of the eroded surface.

Fig. 7. Marking plan for UTM.

A	B	C	D	E
1	2.86	1.67	1.88	1.65	2.07
2	–	–	–	1.87	2.88
3	2.91	1.69	1.48	1.87	2.38

A	B	C	D	E
1	76	64	74	82	78
2	76	–	–	60	90
3	70	81	71	90	90

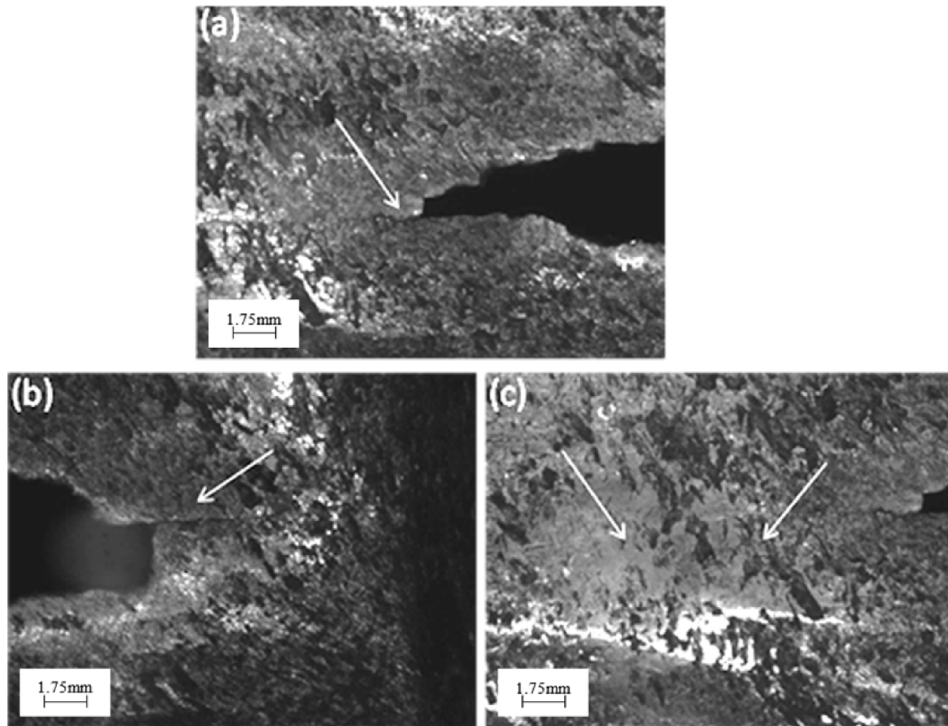
This task was carried out by examining the fractured area with stereo microscope. Fig. 8a and b shows that cracks nucleated from the edges of the opening due to post wall thinning nominal vibrations. Additionally, it can be seen that the surface texture of the failure area is a blend of shiny and uneven profile (Fig. 8c). Prepared specimen was also then examined with 200 \times magnification using Nikon optical metallographic microscope.

Fig. 8. Fracture surface analysis by stereo microscope.

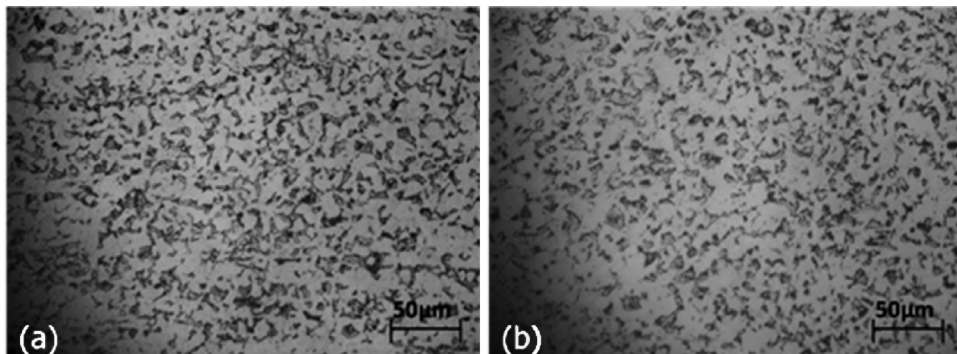
Examination of the microstructure at the failure region and the base metal location clearly indicate close similarity between both specimens that consist the typical ferrite and pearlite structure observed in carbon steels. There is also no evidence of micro fractures (Fig. 9a and b). These findings fully support the hypothesis that the pipe failed due to the increased turbulence caused by abrasive grindings and its adjacent regions and erosion-corrosion phenomenon was aggravated due to faulty workmanship erosion instead of corrosion.

Fig. 9. Optical micrograph of (a) fractured area and (b) base metal at 200 \times .

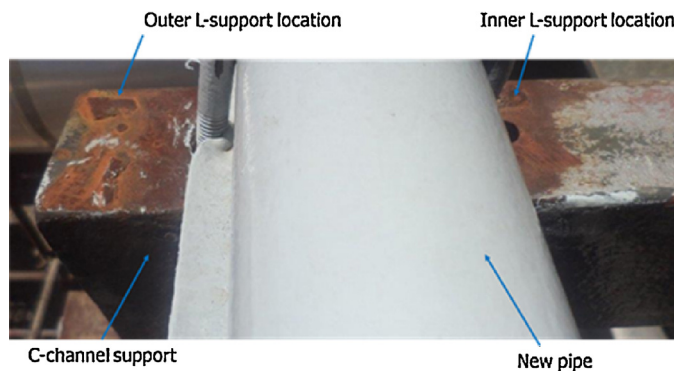
- i. In addition to pipe contact with the C-support, Figs. 10 and 11 show that the pipe was also in contact with inner L-support. This leads to a hypothesis that there may be significant amount of axial movement during the service. However, this theory was nullified by our earlier observed scrapping marks (Fig. 5a) on the pipe which indicates that the abrasion marks on lower and side facings on the pipe are not inline. This shows that any linear movement along the length of the piping during the service could not be the cause of failure. The reason is both motions should have been taken simultaneously.

Fig. 10. Actual location of the L-supports on C-support.

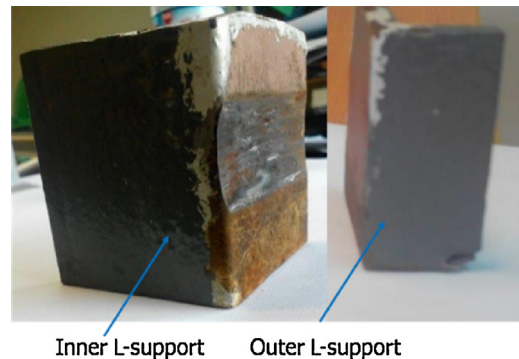
- ii. Based on the inspection results, it was observed that the failed surface does not indicate any metallurgical failure, and hence could be a foremost basis of failure. The surface texture on the main failure area shows grinding marks (Fig. 11). This leads to a conclusion that the main failure area on the piping could be due to manual grinding.

Fig. 11. Inner and outer L-supports.

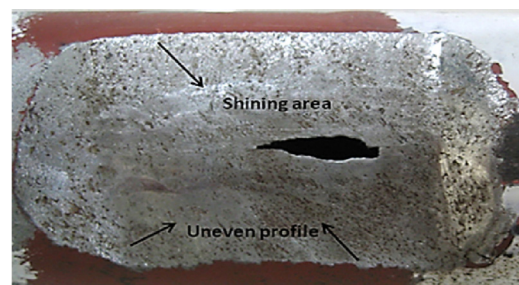
Fig. 12. Shining and uneven profile of failure area.

Shining and uneven profile of failure area can be seen in Fig. 12. It is also observed that pipe surface adjacent to the failure region was also excessively grinded, as shown in Fig. 13.

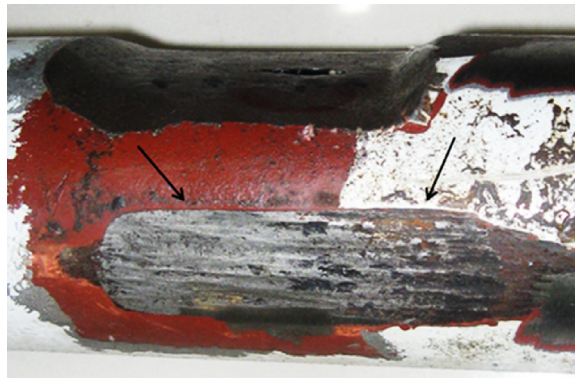
Fig. 13. Grinding marks on side surface of pipe.

- iv. The geometry and location of the excessive grinding at the failure and its adjacent regions of the pipe, base area of the C-channel and L-shaped side supports, clearly indicate that these grindings might have been performed to accommodate the pre-installed piping spool to avoid the alteration in pipe position to sit properly on support.

Based on the above, it is recommended that during installation/fabrication of piping system, proper procedures may be implemented, followed by visual inspection through qualified inspector(s) including pre-service and in-service inspection.
