SLOPE ANALYSIS AND REMEDIAL WORK ON LANDSLIDE AT
TAMAN SETIAWANGSA KUALA LUMPUR

A project report submitted in partial fulfilment of the
requirements for the award degree of
Master of Engineering (Geotechnics)

Faculty of Civil Engineering
Universiti Teknologi Malaysia

DECEMBER 2016

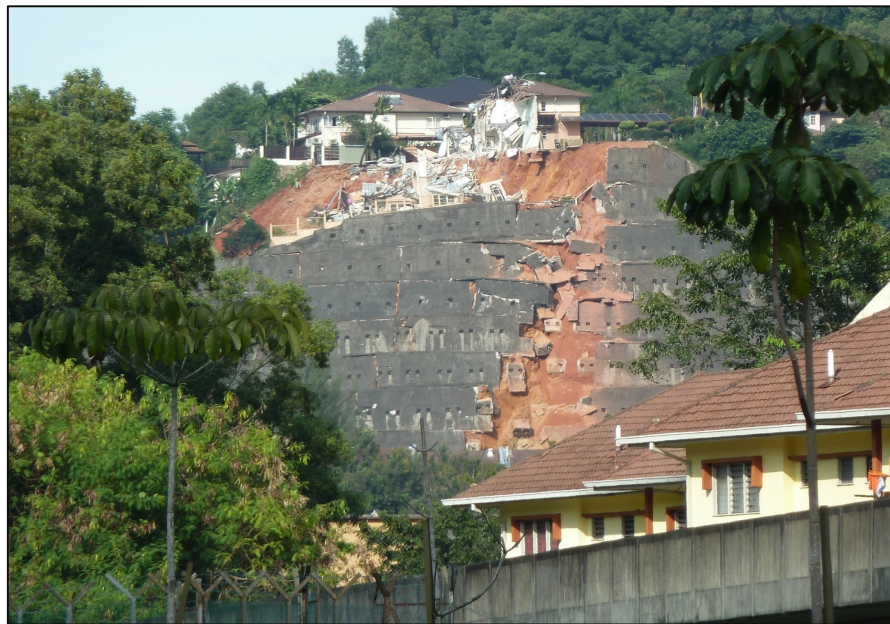
Figures 1.1 and 1.2 show the front view of the slope failure and the location of the site. This failure caused a residential house located at the top edge of the slope to partly collapse. The failure also caused one carriageway of the dual carriageway at the bottom of the slope to be closed. The slope contain of 11 berm of cut and steep slope strengthened by permanent ground anchors constructed in the period 1989 - 1991. Each berm has as average height of 5.0m with the horizontal spacing of the anchors was approximately 1.5m.

Figure 1.1 Front view of the slope failure
