STABILITY ANALYSIS FOR SLOPE REHABILITATION WORKS AT
KM424.80 SOUTH BOUND, NORTH SOUTH EXPRESSWAY

A project report submitted in partial fulfilment of the
requirements for the award of the degree of
Master of Engineering (Geotechnics)

School of Civil Engineering
Faculty of Engineering
Universiti Teknologi Malaysia

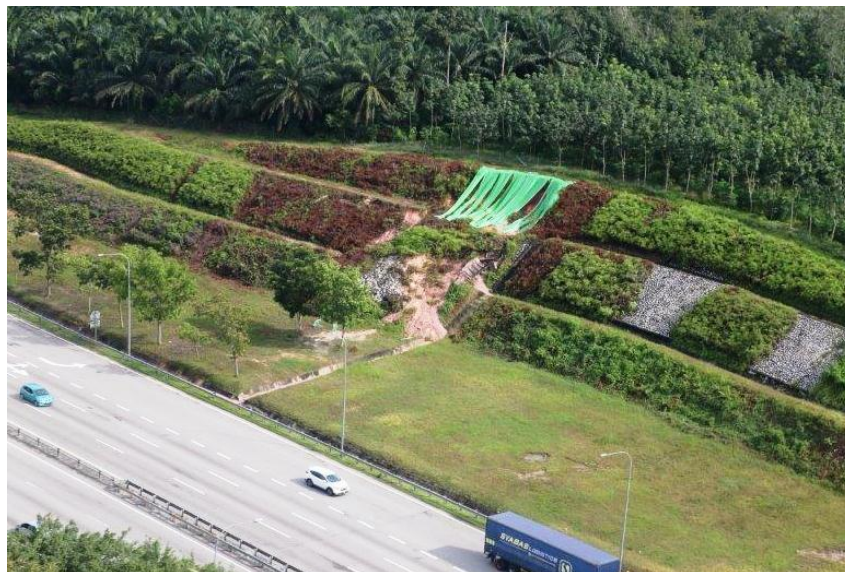
- i. A localised slope failure in between slope surface no. 1 and 3 which is approximately 40m length and 30m height
- ii. Displacement of berm drain at berm no. 1 and 2
- iii. Damaged to the existing stone pitching wall and cascaded drain of the slope due to soil movement
- iv. Barren area due to erosion at a few locations

Figure 1.1 Overall view of failed slope at KM424.80 South Bound
