Development of Proving Ground Field Test for Establishment of Vehicle Accelerated Corrosion Test Procedure in Malaysia

L. Anuar^{1,2}, A. Amrin^{1*}, R. Mohamad¹, S. A. Aziz¹ and M. Toozandehjani¹

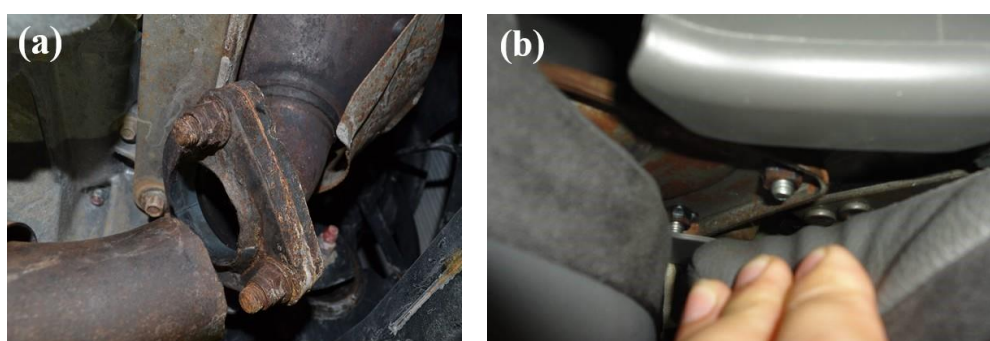
The cosmetic corrosion rating (CCR) and corrosion rate measurement were analysed and discussed in this section in order to select the potential corrosion driving cycles. The Field Test 1 underwent 3 times of salt trough, mud trough and gravel roads exposures in each driving cycle. The CCR for Field Test 1 is presented in Table 3. It can be seen that the area of underbody, underhood and exterior surfaces complied with test requirements outlined in Table 2. Further exposures during Test 1 revealed that the underbody has started to experience CCR 1 (perforation) at Year 7.

The exhaust flange was unexpectedly experienced a component failure where a weld detachment occurred as shown in Figure 5(a). The weld detachment failure was considered as loss of function and failed to meet vehicle and component functional use. While, for interior surfaces, at year 10, the seat frame experienced moderate corrosion (CCR 6) as shown in Figure 5(b). Figure 6 shows example of exterior/secondary surfaces that were evaluated during the test. The exterior/secondary surfaces were observed to comply with the requirement of minimum rating 6. However, some obvious corrosion areas was found like bleed of rust on fuel filler lid as shown in Figure 6(c).

Figure 5. (a) Exhaust flange failure and; (b) rusty seat frame.

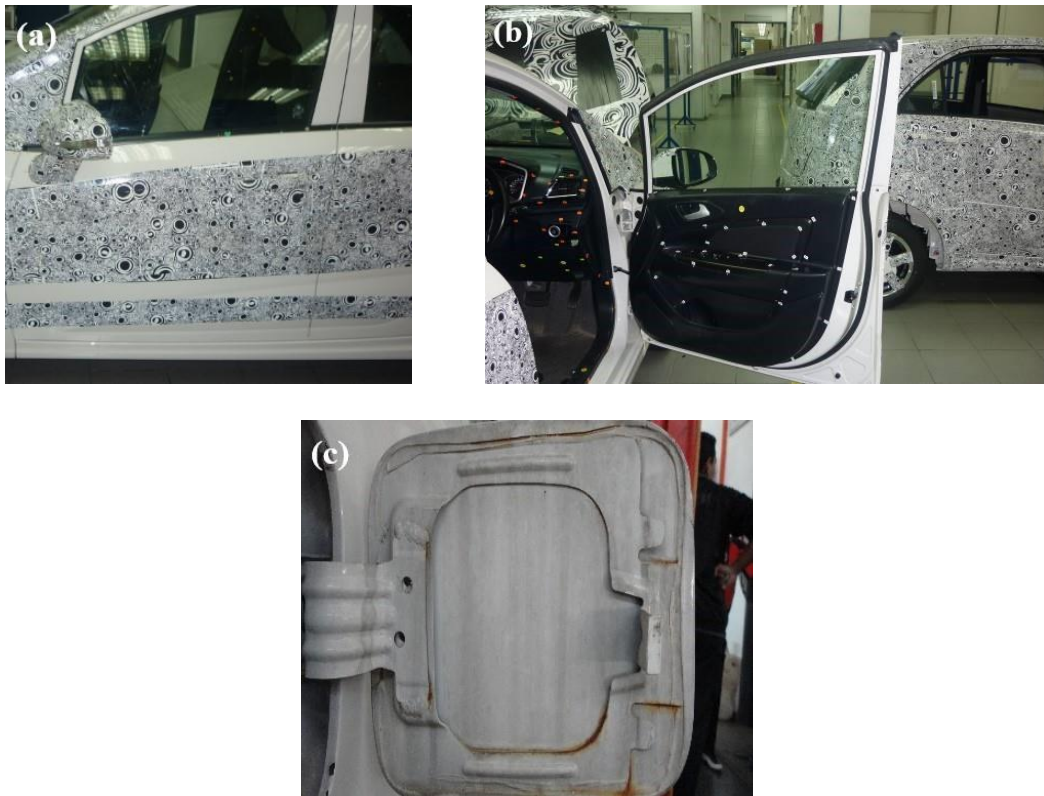
Figure 6. (a) exterior of vehicle, (b) secondary surfaces at door panel and; (c) bleed of rust at fuel filler lid.
