SFRA Test Method Application for Turbo Generator Rotor Winding

Zakky Mubarak, and Eko Supriyanto

PT. Indonesia Power, Jakarta, Indonesia, Faculty of Engineering, Universiti Teknologi Malaysia, Malaysia

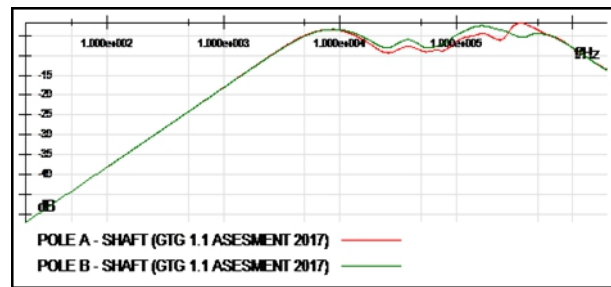
Figure 3. First abnormal condition of SFRA test result in 2017.

In 2017, the rotor generator was tested and Remaining Life Assessment was conducted. Based on the results in Figure 3, the graphs in do not coincide. Analysis of the Pole A to Shaft and Pole B to Shaft test result shows the deformation and abnormal symptoms in the winding rotor generator. This deformation may indicates short interturn. After inspection and dismantling the rotor generator, short interturn was found during visual check [6]. It is caused by migration insulation interturn end winding and broken insulation between coil layers.

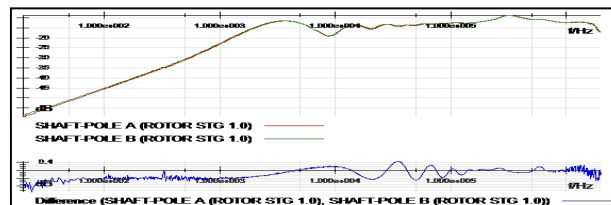
Figure 4. Health winding rotor generator steam turbine STG 1.0 in 2017.

As a comparison, a healthy steam turbine rotor generator at the same area was tested with identical time, tools and conditions. The graphs, in Figure 4, coincide, which means there is no defect between the rotor coil and ground.

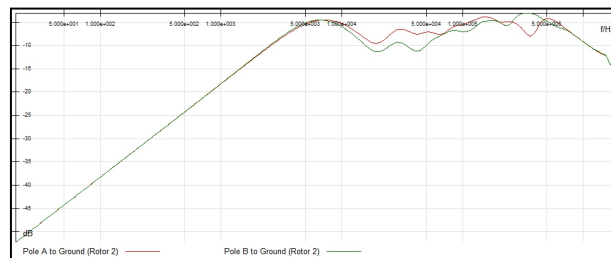
Figure 5. Result of Gas Turbine SFRA Test in 2019 (actual was found short interturn after disassembly).

After 2 years of operation, a maintenance outage was planned for the Gas Turbine Rotor in 2019, for test and repair. The SFRA test result is shown in Figure 5.

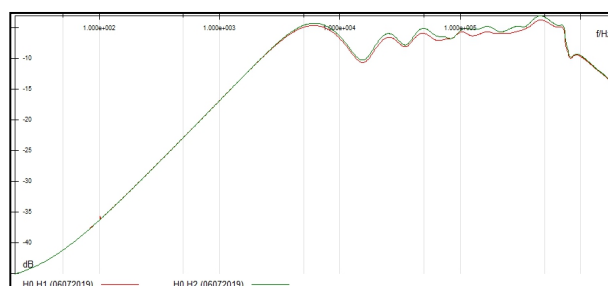
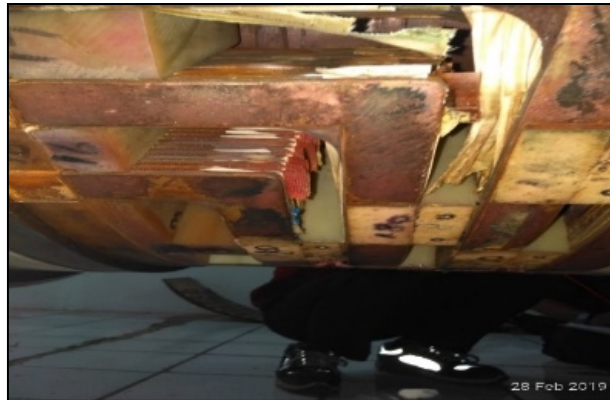
Figure 6. Migration insulation interturn elbow end winding area.

Figure 6 shows one of the defects found in the generator rotor is a migration of the insulation interturn between the coils which causes a short interturn. The migration occurs at the end winding, especially in the elbow section under the insulation retaining ring.

After dismantling and checking in the Gas Turbine rotor generator. After rotor disassembled and found interturn insulation damage at several layer. Rotor Generator fix to repair with Total Re insulation is performed by replacing interturn isolation between coil layers, insulation slot liner, filler slot wedges, block end winding. With this repair, the generator has returned to health condition. With this health condition a short interturn simulation and several other abnormal conditions can be performed. Figure 17 shows the short interturn simulation graph between 1 layer at coil number 7A. Short interturn simulation graph 3 layers at coil number 4-5A is shown in Figure 18.

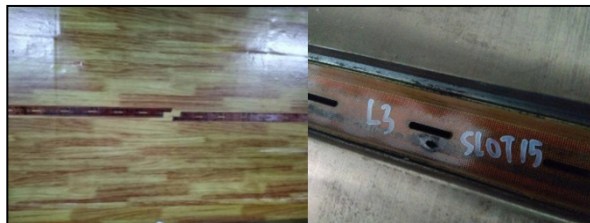
Figure 7. Degradation insulation interturn slot coil.

The second type of insulation damage occurs in the coil slot area. Interturn insulation is cut off and perforated due to overheating that occurs while the generator rotor operates. Overheating causes degradation of the insulation interturn layer. This damage can also be detected visually, that is, if the cooling hole in the coil is plugged with an insulation layer, it is possible that the insulation is broken. Figure 7 shows one of the insulation damages in insulation layers coil.

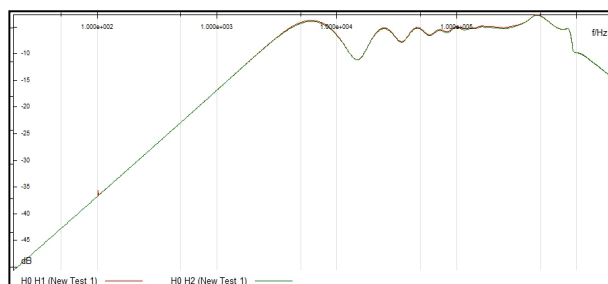
Figure 8. SFRA test result steam power plant in 2016 (normal / health condition).

In different case and type unit of rotor generator, abnormal condition of rotor generator such as elongation coil (irreversible expansion caused by heat coil when generator operation) is possible to happen in rotor winding. Elongation indication can be done by trending every two years. At the steam power plant, there is a trend on the test in the last 2 years, as shown in Figure 8. It can show the normal condition of rotor generator. Based on the results of the visual check and operating data, the generator rotor is in normal condition. So that the test results show that there are no lines that intersect.

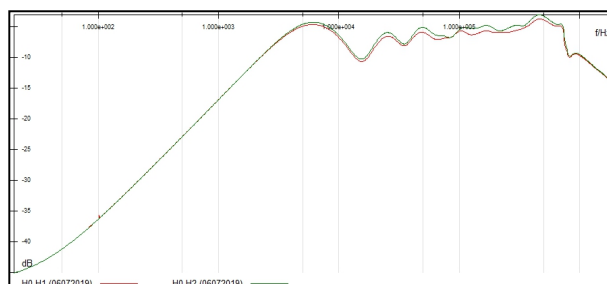
Figure 9. SFRA test result steam power plant after two years operation in 2019 (abnormal condition).

It was different two years later, after visualizing and comparing the test results, it was found that there were lines that did not intersect. The results of the graph are shown in Figure 9. The graph shows that the trending does not coincide.

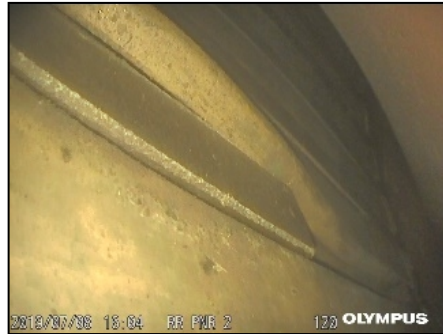
Figure 10. Visual check coil elongation in 2019.

The results of the visual check are shown in Figure 10. Changes in the dimensions of the coil affect the RLC value of the generator rotor winding. The coil damage that occurs in the coil material is an extension of the coil dimensions that does not return to its original shape due to heat from the operation of the generator rotor. This damage can be observed by doing a visual check on the area under the retaining ring.

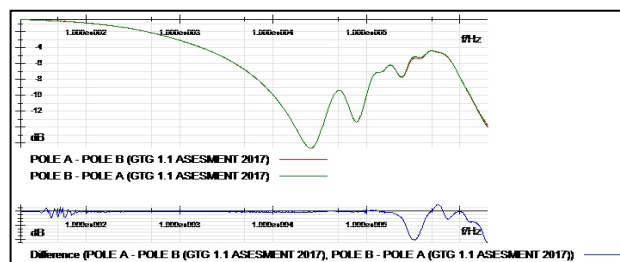
Figure 11. Major Inspection Gas Turbine in 2017

The results shown in Figure 11 are from the test on the Turbine Gas Generator rotor at 2017. Using one of the circuit methods, namely by connecting the probe between Pole A to Pole B, no abnormal results were obtained. In this condition the rotor already indicates a short interturn.

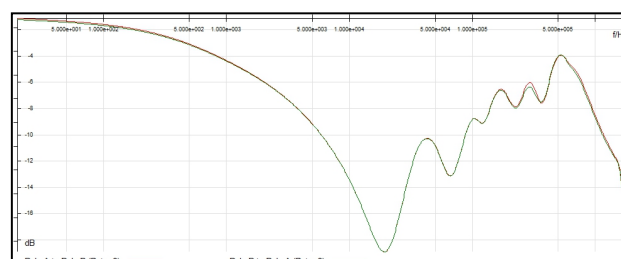
Figure 12. Combustion Inspection Plus Gas Turbine in 2019

Figure 12 shows the result after two years of operation. The data was collected using the same circuit method (pole A against pole B), which also found no damage. In reality, it has been found that there is a short interturn due to migration of the insulation layer on the end winding and degradation of the insulation slot coil layer.

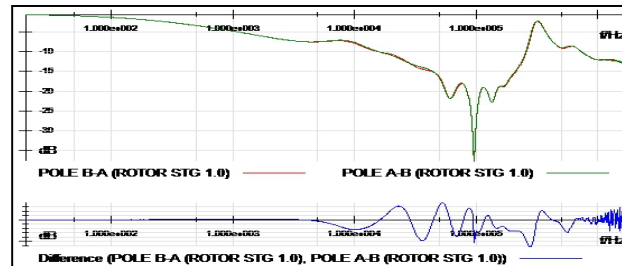
Figure 13. Mean Inspection Steam Turbine in 2019 as a comparison (Health Winding Condition).

Figure 13 shows the test results comparison, tests were carried out at the same time in 2017 on different rotor generator units. The test was carried out on the Steam Turbine Rotor Generator unit. In this case there were no abnormal symptoms either. The generator rotor is in good health. From the results of the data collection method Pole A to B and Pole B to A, they unable to provide information about the damage to the short insulation interturn. This is because the defect between winding rotor generator is already happened, which there should be an indication of damage from the chart.

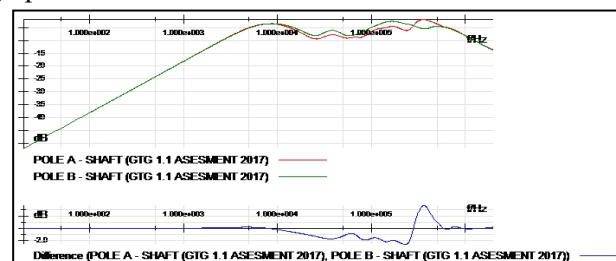
Figure 14. Major Inspection Gas Turbine in 2017.

The second method to find a short interturn is by connecting the probe circuit between the pole and the shaft. In Figure 14, it is found that there is a graph that does not coincide. This graph shows an abnormal condition in the interturn coil. The results below were carried out in 2017 with an indication of rotor vibration during operation.

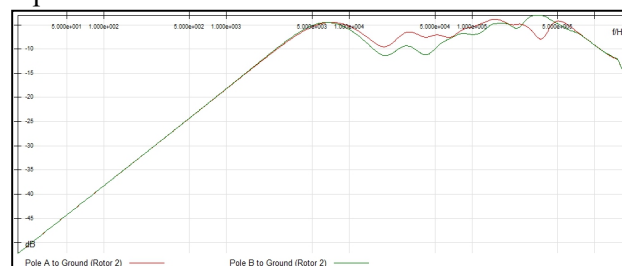
Figure 15. Combustion Inspection Plus Gas Turbine in 2019.

Figure 15 shows after two years of operating with a vibrating rotor condition, when it was operated with excitation values, the graph was not coincided. This indicates the presence of asymmetry due to changes in resistive and capacitance values.

Based on the data above the graph in GTG 1.1 does not coincide. So that shows the deformation from the results of the analysis of the Pole A to Shaft and Pole B to Shaft test can show abnormal symptoms on the winding rotor generator. This deformation can also give an indication of short interturn. So, from the 2 mode tests, the test that can be analyzed is the second mode.

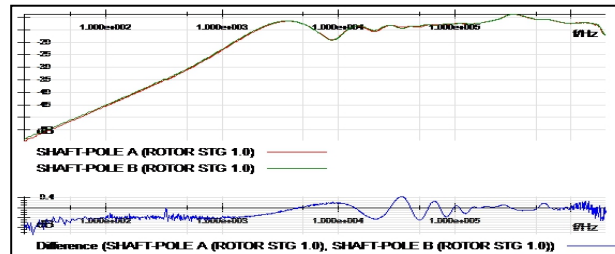
Figure 16. Mean Inspection Steam Turbine at 2019 as a comparison (Health Winding Condition).

As a comparison that this test method can be accurate, the test is carried out on the generator rotor under normal operating conditions. The graph in Figure 16 shows the absence of normal conditions in the generator by showing a coinciding graph.
