A case study on the structural assessment of fire damaged building

To cite this article: M H Osman *et al* 2017 *IOP Conf. Ser.: Mater. Sci. Eng.* **271** 012100

M H Osman¹, N N Sarbini², I S Ibrahim¹, C K Ma², M Ismail² and M F Mohd³

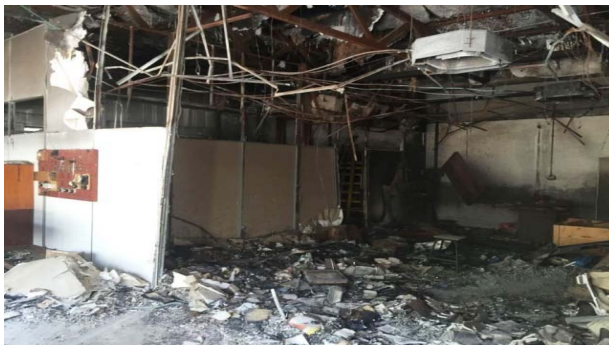
This paper discussed on the case study of a fire damaged building. The building is made up from reinforced concrete for the beam, column and wall, while have steel trusses as a main structural element. In general, the condition inside the office was affected by the fire (figure 1). There were a lot of things that were affected such as partitions, windows, electrical circuit, electrical sockets and insulations. All the things mentioned were found broken and damaged due to the fire. Effect of fire to the structural components can be seen from the shaded colour of walls, columns and beams, at all over the surfaces. On the other hand, the trusses components were also affected by showing rusted steel appearance all over the surfaces. The structural assessment was aimed to investigate the effect of fire to the elements inside the building, to investigate the condition of the main structural element due to the fire (steel trusses) and to recommend overall condition of the building.

Figure 1. Interior view of the building damaged by fire shows most of the elements inside the building were affected.

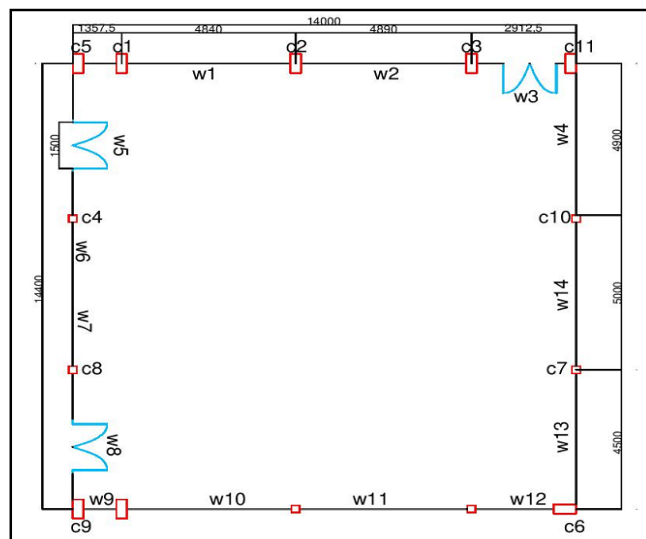
Visual inspection has been conducted for all elements inside building (figure 3). Through visual inspection, it was found that there were many damages to the roof due to the fire. There were a few damages found at the metal sheets which made it not fit for roofing system. The same observation were found for the foil insulations. It was found that all of the foil insulations were damaged and was not suitable for use.

Figure 3. Plan view of a fire damaged building shows ten columns (c1 to c10) and fourteen walls (w1 to w14). Other elements that were not visible inside the plan view are two beams spanning from c5 to c9 and from c11 to c6; and six steel trusses spanning in between the beams.

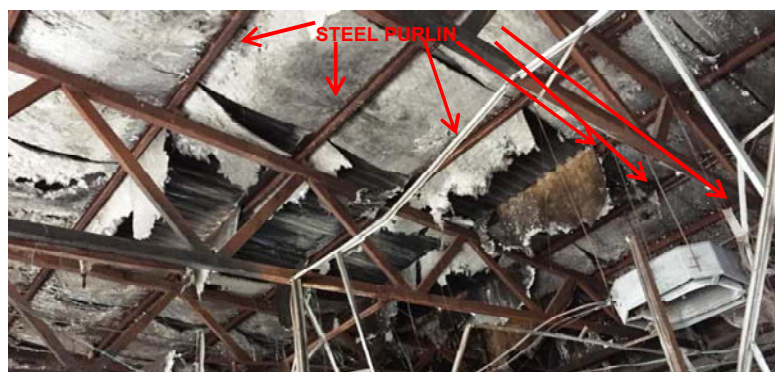
The condition of steel purlins was found most affected. These conditions were expected due to the material properties of steel purlin of which have a strength that is lower compared to the steel truss. Therefore, the effect of fire will create so much impact to the steel purlin compared to the steel trusses. General overview on the steel purlins that were corroded on-site was shown in figure 4. Most of the steel purlins were corroded along their lengths. The most affected steel purlin was found for a purlin located above the area of fire initiated. The steel purlin was heavily buckled and twisted along their length.

Figure 4. Observation on steel purlins that were affected by fire.

The coupon tensile test was carried out on the steel purlins [9]. The test is conducted for the steel purlin due the observation during visual inspection which found that steel purlins were the most affected element on-site. This is due to the appearance of the element that was heavily buckled and twisted compared to the steel trusses. A total of 6 samples that consisted of: 3 samples from the most affected area and 3 samples from less affected area. The average tensile capacity is 341 N/mm² for least affected samples, which is 15% less than the design requirements of 400 N/mm². Meanwhile, the average tensile capacity is 324 N/mm² for the most affected samples, which is 19% less than the design requirements of 400 N/mm². Therefore, the test results show that the steel purlin was severely affected with its yield capacity reduced at maximum of 19% from the actual capacity.

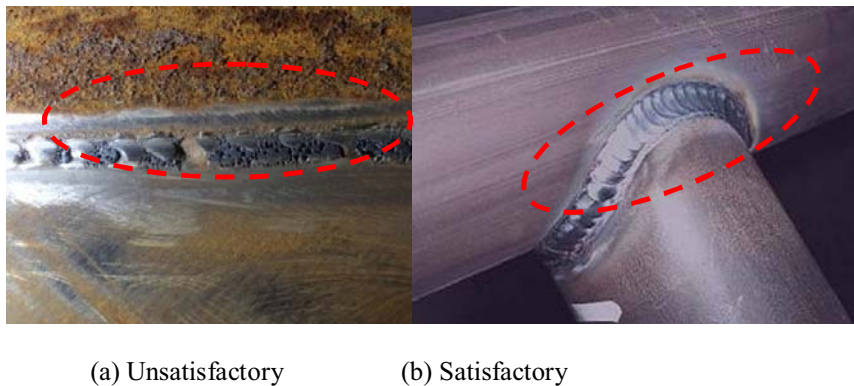
extent of the depth of the corrosion. After the process, it was found that the condition of the welding at most of the connections were not satisfactory. An example of the less satisfactory condition that was found on-site is shown in figure 5(a) is considered as poor quality.

Figure 5. Appearance of welding quality at connection.

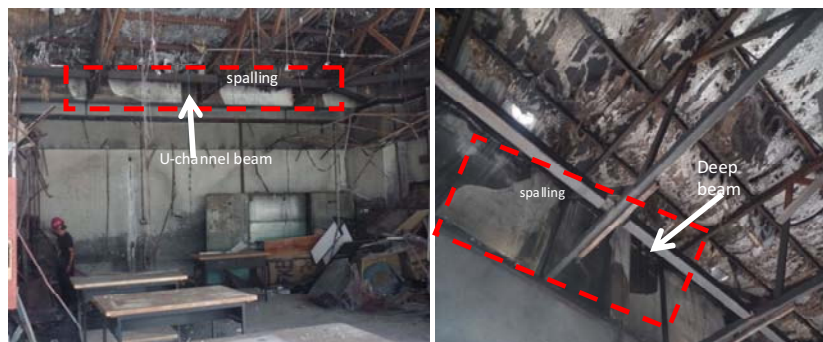
On the other hand, the visual inspection shows that there are many spalling of the plaster on the surface of the beam. However, the concrete surface beneath the plaster layer is not affected. The concrete was found not affected due to the appearance and condition that still intact and shows the original grey in their colour (figure 6). The observation is also shown by column and wall elements.

In general, it can be summarized that reinforced concrete elements inside the building were just externally affected by the fire. Although comparison of the elements colour and texture to table 1 shows that the elements were experiencing about 600 to 800 °C temperature, nevertheless, only plastering of the RC elements were affected. In this case, only RC beams were found affected showing by spalling of the plastering. This proved on the capacity of RC elements in resisting fire as per mentioned by previous works [1-3]. Meanwhile, the steel purlins and trusses needs to be investigated in detail due to the confirmation on its behaviour after fire.

Figure 6. Physical appearance of the beams

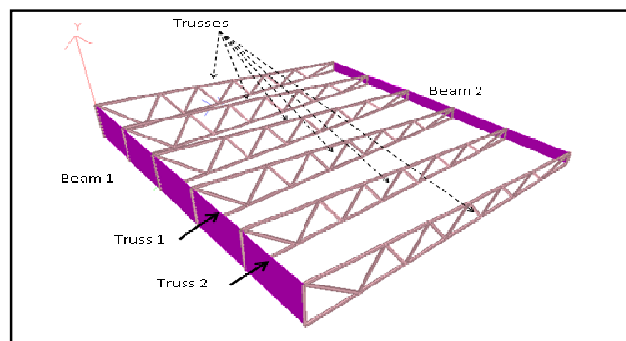
The objective of load test is to ascertain current capacity of trusses on-site (figure 7). Previously, RC elements have been found externally affected; however, the truss is made up from steel material. Therefore, further test is needed for the truss elements. Two trusses are selected based on its condition as the most (Truss 1) and least (Truss 2) affected truss. Full load test was carried out to determine the truss behaviour due to the loading and unloading process at service load. Loading was applied in 1 kN increment; and up to maximum service load of 14 kN at point D and E (at the middle of the truss span). The results for load-deflection relationship for two LVDTs location is shown in figure 8(a).

The full load test and sustained load test results shows that the trusses are still stable and capable in resisting service load for further used.

Figure 7. Steel trusses on-site

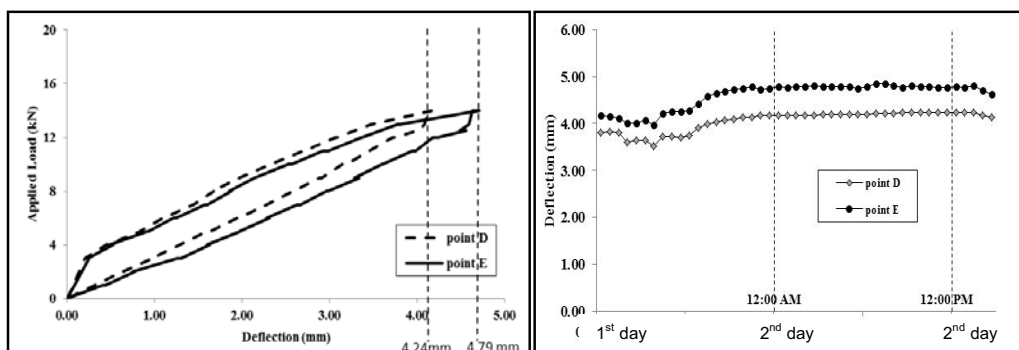
In general, the deflection relationship have the same curve pattern at LVDTs position (point D and E) indicating that the loading system and test setup are closely symmetrical and aligned. The same pattern was observed for both trusses, during the loading and unloading process. The recorded deflection at LVDT 1 (point D) and LVDT 2 (point E) was 4.24 mm and 4.79 mm for Truss 1, respectively. Meanwhile, Truss 2 recorded deflection of 4.06 mm and 4.49 mm at LVDT 1 (point D) and LVDT 2 (point E), respectively.

Meanwhile, the sustained load test (for service load at 14 kN) was carried out for 24 hours and at the same time, deflection was recorded at every 30 minutes. Truss 1, the most affected truss was selected to undergo this sustained load test. The deflection relationship at points D and E is shown in figure 8(b). The deflection of the truss at LVDT 1 (point D) ranged between 3.51 mm and 4.24 mm, while LVDT 2 (point E) ranged between 3.96 mm and 4.85 mm. The graph pattern indicates a bit increasing trend as the load remained sustained on the slabs; at early 8 hours. However, the deflection became constant after 8 hours from the start of the sustained load.

Figure 8. Deflection relationship during the test
