# Bridge Pillar Defect Detection using Close Range Thermography Imagery

**Abstract**—Currently, radiometric thermography image has been explored adequately as alternative advance Non-Destructive Testing (NDT) especially for early detection analysis in various applications. Systematic image calibration, higher spatial resolution and high degree order image processing, thermography imagery potential to be used in concrete structure defect detection. Therefore, this study is carried out to examine the defect on bridge pillar surface concrete using drone-based thermography sensor (7–13  $\mu\text{m}$ ). Close range remote sensing NDT based on drone platform and imagery segmentation analysis have been applied to interpret the crack line on two pillars at North-South Expressway Central Link (ELITE) Highway. As a result, thermography imagery segmentation and support by multispectral radiometric imagery (RGB) successfully to delineate the micro crack line on the bridge pillar concrete using K-means clustering method. Overall, this study successfully shows the higher order optional platform using drone and thermography sensor that potentially to be applied in forensic concrete structure de

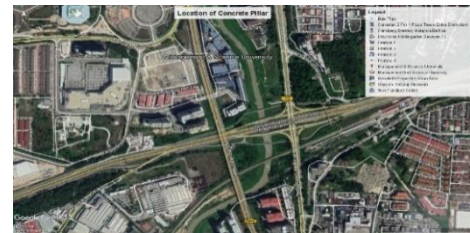
(a)

The research areas that explored are located at part of North-South Expressway Central Link (ELITE) Highways' bridge pillar, which is also known as Asian Highway 2 (AH2), situated near to Management and Science University (MSU) Shah Alam, Selangor, Malaysia (03°04'41.3"N,101°33'06"E) as shown in Fig. 1. This study focused on the crack detection of two pillars or piers of the highway bridge. The data acquisition that has been collected then processed and analyzed using the specific software to detect crack on bridge surface.

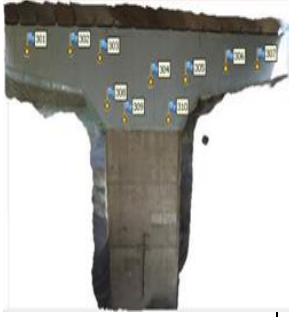
Pillar No	Location of target	Network of target
34A

TABLE II. LOCATION OF CONTROL TARGETS

In this study, the location of markers on two pillars was set to the upper area as the focus point for thermography analysis and shown in Table II. Each marker's position was determined using the tacheometry technique using an arbitrary coordinate system consisting of a single baseline. The geometric control point coordinates of each pillar are shown in Table III and Table IV, respectively. The information from the GCPs was then used to create the thermography orthomosaic, as explained in the following section.

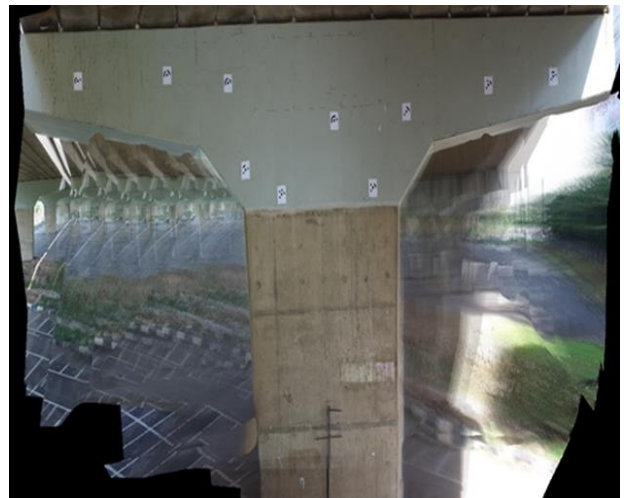
Fig. 3. Dense Point Cloud.

After constructing the tie point cloud, a dense point cloud was generated. The distinction between a tie and a dense point cloud is that the former is used to determine the exterior orientation parameter by resecting the tie point. Meanwhile, the latter is used to transform each pixel in the image into three-dimensional space. From the dense point cloud, a variety of photogrammetric products such as a 3D model and orthomosaic can be generated. The thermographic orthomosaic in this work was created using the Pix4D mapper (academic version).

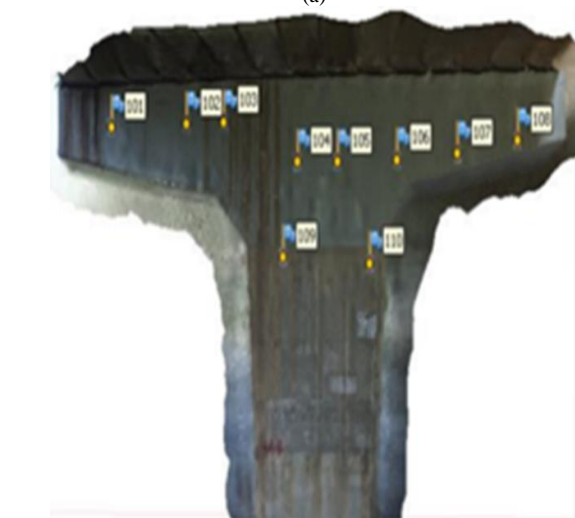
Fig. 5. RGB Image Stitching. (a) 34A (b) 34B.

The process began with aligning the color images in Pix4D in order to create a tie point cloud and estimate the exterior orientation parameter for each image. The GCPs are then used to reorient the image via bundle adjustment and to scale the pillar's 3D point cloud for metric measurement. Following that, a dense 3D point cloud was generated and the coordinates of pillar features such as edges and contrast spots were extracted in order to align the thermography imagery. Due to high resolution of color image, the common features on overlapped images were seamlessly matched for tie point construction.
