## **SIMPLE AND FAST DAMAGE IDENTIFICATION ON 6061 ALUMINIUM BASED ON MODE SHAPE CURVATURE**

This paper presents a simple and fast approach for the identification of damage to isotropic steel structures. The main contribution of this work is a simplified approach using cubic polynomial regression, unlike previously developed damage identification models that use two specimens. This was achieved by differentiating the mode shape displacement from the mode shape curvature using a central finite difference equation to determine the damaged curve, and subsequently, computing the undamaged curve using a Cubic Polynomial Regression (CPR) model. To validate the accuracy of the model, five specimens with different types of damage (single and double notch) at various depths were simulated. The performance of the model was evaluated against the experimental modal test results. It was found that the presented model was capable of detecting the type of damage (whether single or double notch) in a 6061 Aluminium beam structure. However, when compared to the experimental results, the average difference could reach up to 17% due to external factors. In particular, the performance of the presente

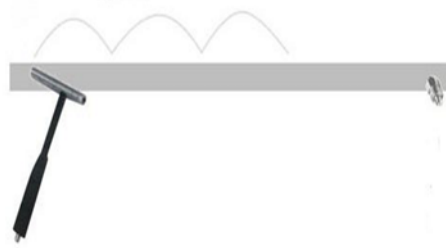
**Fig. 2. The roving hammer test.**

point, where the mode shape is adequately excited when the structure is impacted by the hammer. This method, as shown in Fig. 2, is known as the 'roving hammer' test.

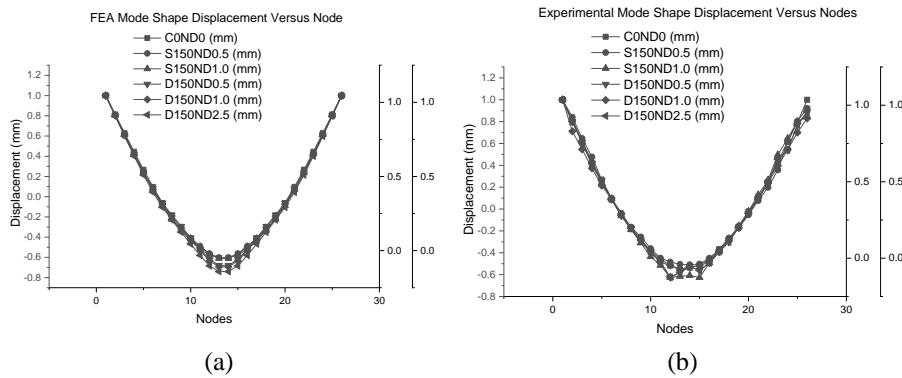
**Fig. 4. Graph of mode shape displacement versus node for all specimens (a) FEA simulation (b) Experimental result.**

The FEA simulation defined the damage size of the crack depth for a single-notched and double-notched beam that was 150 mm in length. The results of the simulation analysis were generated by ABAQUS, as shown in Figs. 4(a) and (b). The graphs of the simulation data for all the specimens, as shown in these figures, had a smooth shape for the mode shape displacement. Only the fundamental bending mode shapes were considered for the data processing.

The distance between the nodes was 25 mm for all the specimens, and the values of the displacement among the specimens are ranged from -0.00251245 mm to 1 mm. From the graph, it was apparent that the length of the mode shape displacement for the double notch with a depth of 2.5 mm (D150ND2.5) was slightly longer and distorted when compared to the control sample (C0ND0). What stood out in this chart was that the growth of the damage or notch in the beam could cause the mode shape displacement tended to elongate further as the integrity of the structure tends to be deteriorated.

Turning now to the experimental evidence in Fig. 4(b), a comparison of the two results revealed that the experimental result showed an excessiveness in the peak from Node 12 until Node 15. A few factors could have affected the precision or accuracy of the results, such as the elastic support and force when hammering. According to Hanly [12], other environmental factors such as temperature, acoustic noise, humidity, corrosive substances, and shocks and vibrations may affect the results obtained.
