## Evaluation of Mangroves Effectiveness in Strengthening Coastal Bund Using Geophysical Method (Non-Destructive Testing) at Tanjong Laboh, Batu Pahat, Johor

DOI: <https://doi.org/10.30880/ijie.2023.15.06.018>

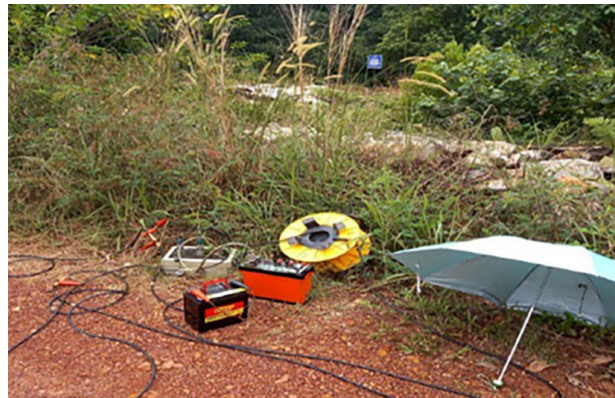
Resistivity traverse was performed during January 2022 using electrical resistivity equipment set that consists of ABEM SAS 1000, multiconductor cables, stainless steel electrodes, electrodes connector and current sources. Two resistivity lines were carried out at study area and 41 electrodes were pegged 2.5 m apart on the ground along 0.5 km of the line survey. The Wenner-Schlumberger design configuration was utilized due to it has greatest signal strength and gives a dense near-surface cover of resistivity data. The equipment set up at study area as shown in Fig. 3. This method also has the ability to detect vertical resolution of horizontal structures and provides clear image of groundwater and saltwater intrusion [9].

**Fig. 3 - The equipment set-up of ABEM SAS 1000**

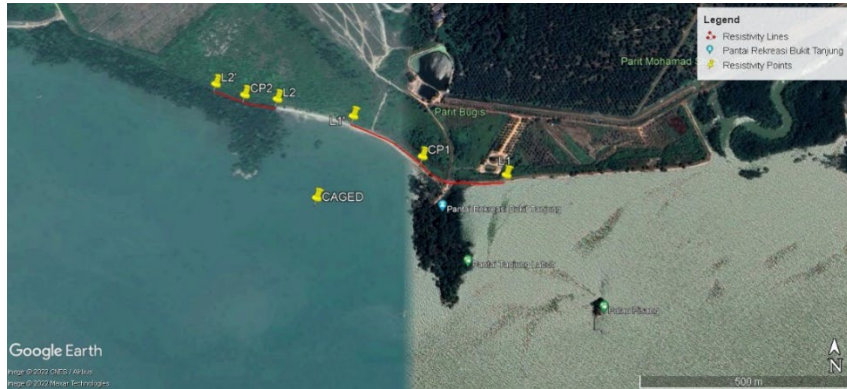
Fig. 4 shows the location of the electrical resistivity line from L1 to L1' where this line was located on an engineered bund and rock outcrop exposed without mangrove ecosystem. Meanwhile, the resistivity line from L2 to L2' was in the area with mangrove forest. There are four short cables of C1, C2, P1 and P2, that were used to connect the equipment terminal to the ground surface. The coordinates and reduced levels of resistivity line were tabulated in Table 1. In order to determine the subsurface resistivity, a certain amount of electric current (10 - 100 mA) was inserted into the ground through a pair of stainless-steel electrodes. The grounding of electrodes was properly installed to prevent penetration issues such as faulty datum point or inaccurate current transmission. Several electrodes also need to be wet by water during the data acquisition process to ensure proper penetration and propagation of current underground due to hot and dry weather.

Fig. 4 - The location of resistivity line of L1 to L1’ and L2 to L2’

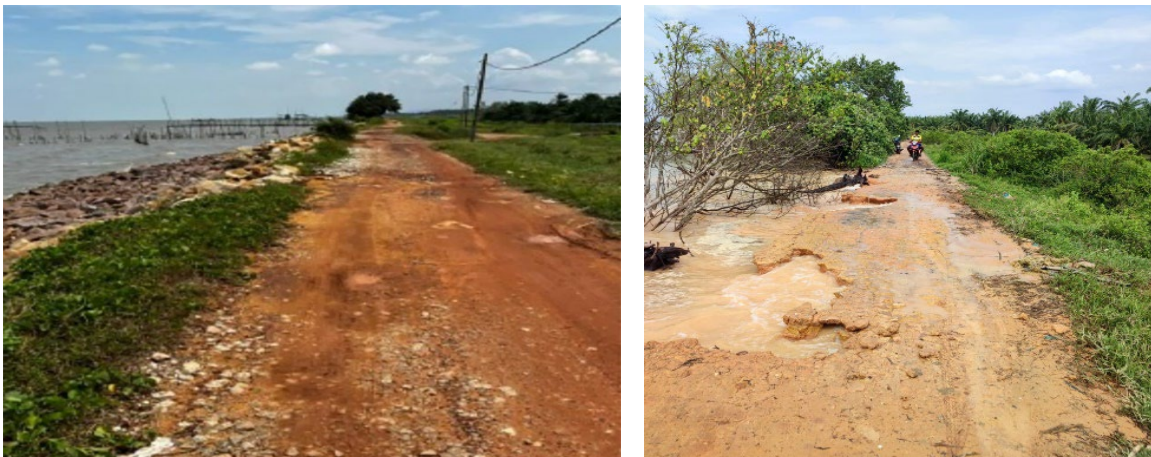
**Fig. 7 - Coastal bund without mangrove ecosystem before and after high tides phenomenon**

The coastal bund condition for area with revetment and without mangroves was observed and the picture taken on 1 November 2021 shows no sign of erosion. However, on 6 December 2021, there was a high tides phenomenon and the same coastal bund area experienced erosion and cracking due to tides force and overflowing of water across the bund. The difference in coastal bund condition without mangrove ecosystems before and after high tides are shown in Fig. 7.

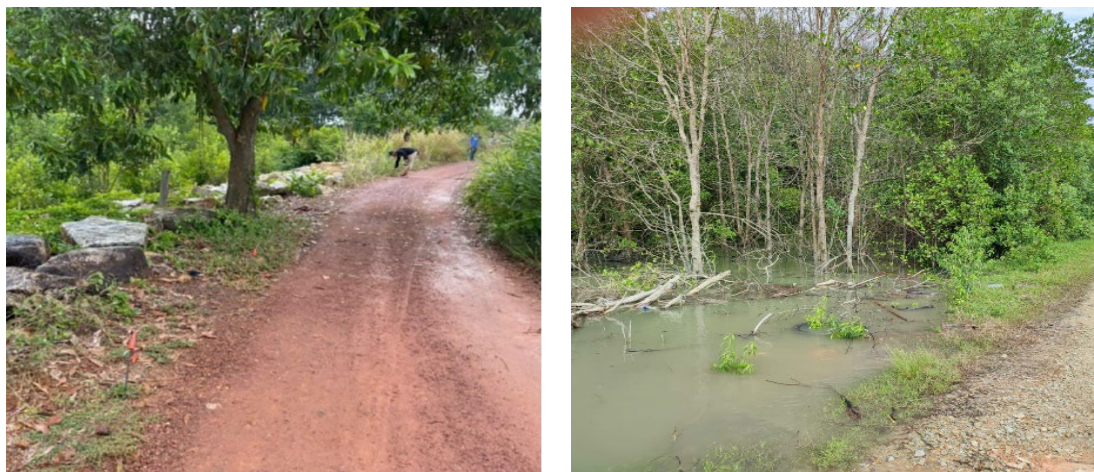
**Fig. 8 - Coastal bund with mangrove ecosystem before and after high tides phenomenon**

Moreover, for comparison purposes, the coastal bund condition for areas with mangrove forest was also observed. The picture taken on 1 November 2021 of the coastal bund covered with mangroves indicates no erosion occurred. However, the coastal bund condition remains the same even after the high tides' phenomenon on 6 December 2021 with no sign of erosion and there is no overflowing of water across the bund. The difference between the coastal bund condition with mangrove ecosystems before and after high tides are shown in Fig. 8. This shows the effectiveness of mangroves in strengthening the coastal bund where the dense roots of mangroves that bind together the soil can minimize the impacts against destructive natural forces of wind and wave action [13].
