Iraqi Geological Journal

Lake Water Quality Assessment Based on Multispectral Unmanned Aerial Vehicle Images and In-Situ Testing

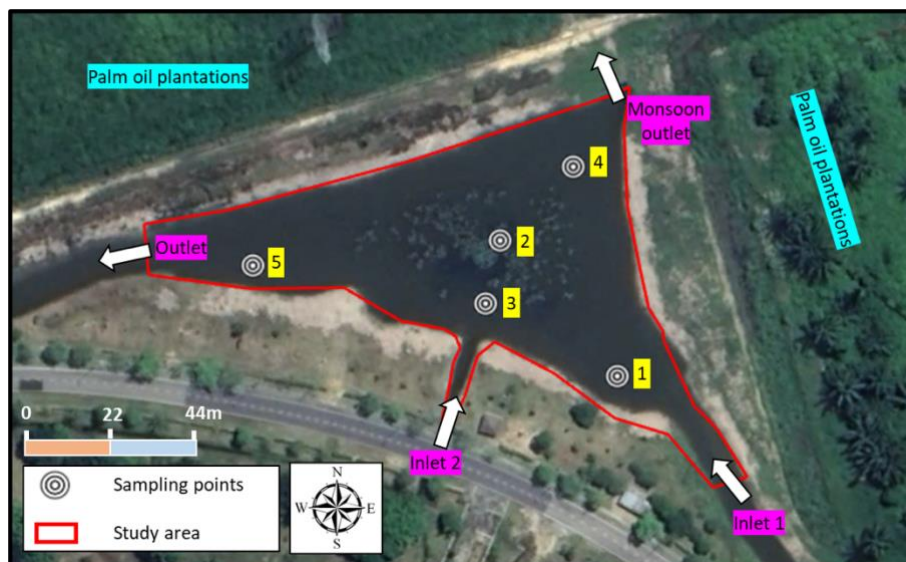
Fig. 2. Study area and sampling locations

For the purpose of water quality assessment, in-situ water quality testing was conducted at 5 different locations for the targeted water quality parameters (turbidity, temperature, DO, and pH). The in-situ testing approach provides immediate results, allowing for real-time assessment of water quality without needing laboratory analysis. This approach can be valuable in various scenarios, such as environmental monitoring, emergency response, field research, or routine water quality assessments. Fig. 2 shows the sampling locations at which point 1 is located at the inlet number 1, point 2 at the middle point of the lake, point 3 at the inlet number 2, point 4 at the furthest points toward the north direction (close to the monsoon outlet), and point 5 at the main lake outlet. Horiba U-52G Multiparameter Meter was used to perform the in-situ water quality testing. This meter has the capability to measure the needed parameters with a resolution of ± 0.1 for pH, ± 0.3 °C for temperature, ± 1 NTU for turbidity, and ± 0.2 mg/l for DO.

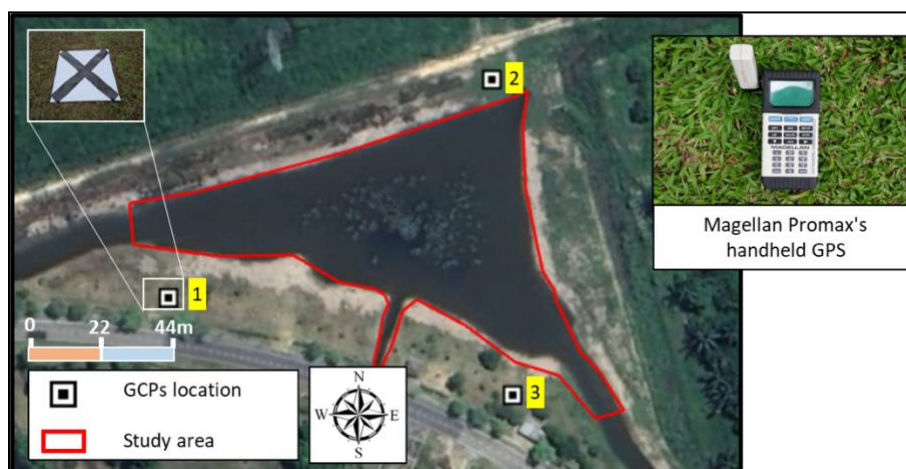
Fig. 3. Ground control points locations

Ahead of the data collection using UAV, ground control points (GCPs) were identified and located in the study area. GCPs are essential and one of the most important factors that must be identified to be used in georeferencing and image processing stages. In this study, marked or premarket targets were located at 3 different locations as shown in Fig. 3. The coordinates of these locations were defined through Magellan Promax's handheld GPS device (Fig. 3). After defining the GCPs, the data collection using UAV was established. An aerial mapping camera was mounted to a UAV and aerial images were captured for the entire study lake. Two different aerial images were collected, including (i) RGB image, and (ii) NIR image. Basically, RGB stands for Red, Green, and Blue, which are the primary colours used to create colours in the image. In an RGB image, each pixel is represented by three colour channels: red, green, and blue. The intensity values of these channels determine the colour of the pixel. On the other hand, an NIR image refers to an image captured in the near-infrared (NIR) portion of the electromagnetic spectrum. The NIR region lies just beyond visible red light and is characterized by wavelengths ranging from approximately 700 to 1400 nanometres. Later, the two collected images (RGB and NIR) were used to develop the lake's water quality maps.
