# EFFECT OF CLAY SHALE SHEAR STRENGTH DEGRADATION ON BORED PILE FRICTION IN CLAY SHALE

This research aims at investigating and modeling the axial bearing capacity degradation of a bored pile on clay shale due to the bored pile installation processes. Clay shale sample models were prepared to simulate the wetting and drying cycles through weathering process between 0 to 6 hours. All samples were tested in which every 1 hour of the weathering process representing 1 cycle of wetting and drying. The direct shear laboratory tests were performed to obtain the peak and residual shear strength parameters of the interface between the bored pile and clay shale. The peak and residual shear strength parameters were obtained after 6 hours of the weathering process. The residual shear strength parameters were measured by applying with and without stress release. This investigation showed that the shear strength degradation at peak, residual without stress release, and residual with stress release respectively reached 87-62%, 28-20%, and 25-14% after 1 to 6 hours of weathering process. This result is very useful for predicting the bored pile skin friction in clay shale soils.

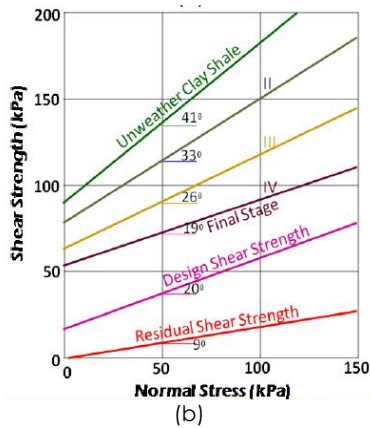
**Figure 2** Results of (a) clay shale shear strength degradation from peak and residual with unsoaked and soaked samples [10] and (b) degradation of clay shale shear strength due to weathering effect [11]

[12] when compared to the soaked and remoulded peak stress as shown in Figure 2(a) [13]. The weathering effects have been studied [14] as shown in Figure 2(b).

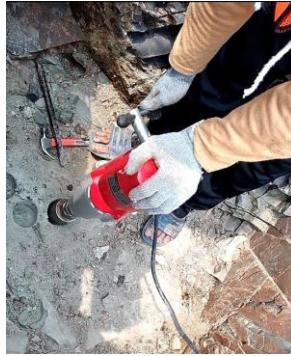
Figure 4 Taking samples using a core drill

In this study, the friction resistance of a bored pile in clay shale was modeled in a laboratory using direct shear test. The excavation-weathered clay shale was also simulated using cycles of wetting and drying. Disturbed and undisturbed samples were gathered from the Semarang-Bawen Highway at STA 438. The undisturbed samples were collected using a core drill to generate accurate shear strength parameters. The core drill bit had the same diameter as the direct shear split box pit, which was 60.5 mm. The samples were obtained using a core drill shown in Figure 4 and were properly sealed in black plastic (which was not exposed to sunlight and water) as well as put in a pipe to prevent from collision.

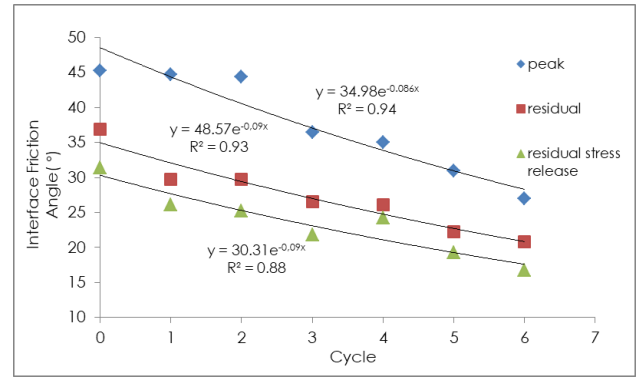
**Figure 12** Degradation pile and clay shale interface friction angle at peak, residual, and stress release vs. cycle

In each cycle, the interface shear strength parameters of the bored pile and clay shales, such as adhesion ( $a_c$ ) as well as friction angle of clay shale and bored pile ( $\delta$ ) can be calculated (see Figures 8, 9, and 10). The regression results of each parameter then were plotted in Figures 11 and 12. These figures show that the adhesion ( $a_c$ ) and interface friction angle between the concrete and clay shale ( $\delta$ ) from the peak stress was greater than those of residual stress and residual stress release conditions. At the same time, the shear strength at the residual stress condition were almost the same as those at residual stress release.

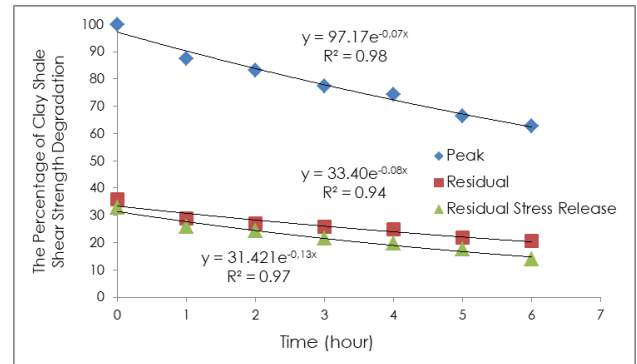
**Figure 13** Clay shale shear degradation at peak, residual, and stress release condition vs. time (hour)

To quantify the shear strength degradation, the ratio of shear stress ( $\tau$ ) and normal stress ( $\sigma_n$ ) were calculated. Therefore, the shear strength degradation was not affected by depth and normal stresses. To determine the clay shale shear strength degradation without normal stress dependence, the stress ratio in each peak, residual without stress release, and residual with stress release condition were calculated. The shear strength degradations for each stress condition are shown in Figure 13.

This investigation showed that the shear strength degradation at peak, residual without stress release, and residual with stress release respectively reached 87-62%, 28-20%, and 25-14% after 1 to 6 hours of weathering process. This result can be used for predicting the bored pile skin friction in clay shale soils.
