FAILURE OF ROOF STRUCTURE DUE TO WIND LOAD

A project report submitted in partial fulfilment of the
requirements for the award of the degree of
Master of Civil engineering (Civil – Structure)

Faculty of Civil Engineering
Universiti Teknologi Malaysia

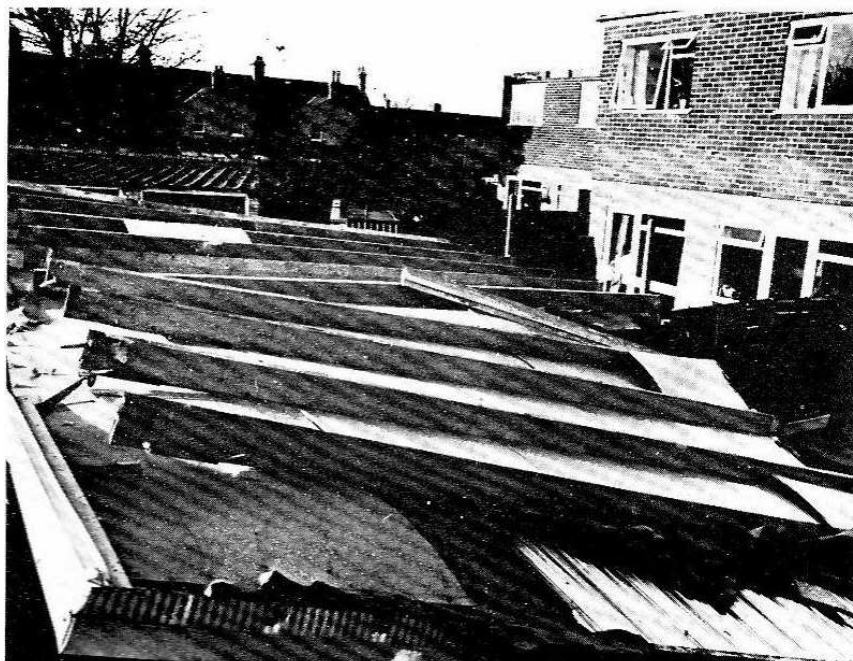
Figure 1.1: Some of the common example of roof failure

Uplifting of the roof structures or roof sheeting during rainstorm has been causing damages to the buildings. Generally, failure occurred at the two points, either at the roof frame's sheeting or at the frame to roof beam connections. There are 2 types of structure are to be analyzed; the different of these two building will be the buildings dimension and geographical locations.
