Simulation of the Tanjung Kupang Air Crash

Abstract: The air crash at Tanjung Kupang, Johor on the 4th December 1977 was the first air accident for the Malaysia Airlines (MAS) and the worst for Malaysia. A Boeing 737-200 with 100 passengers and crews was hijacked before it crashed. Evidences from the accident pointed to an interference of hijackers to the aircraft flight operation. Simulating the accident helped investigators to understand the probable cause of the accident. The Trajectory Reconstruction Method was used to obtain necessary data for the accident simulation. Result from the simulation indicated that the ill-fated aircraft experienced three steep pitch-down movements before it stalled and crashed.
Keyword: Air accident simulation, Trajectory Reconstruction Method.

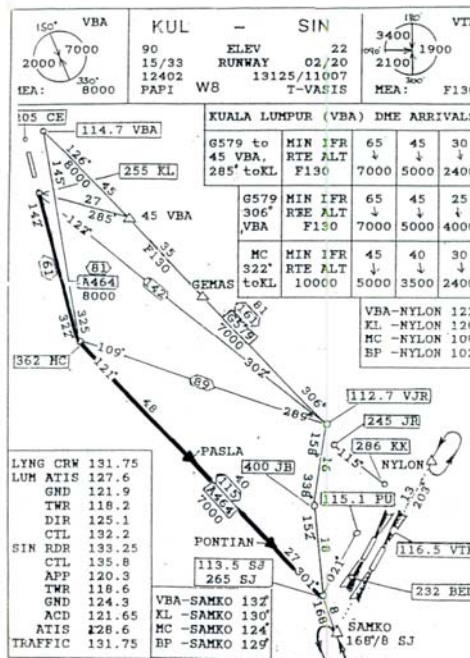
Fig. 1: Flight Route to the Singapore International Airport [1]

Flight MH653 was permitted to fly to Singapore at cruising altitude of 21,000 feet, following the flight route shown in Figure 1.

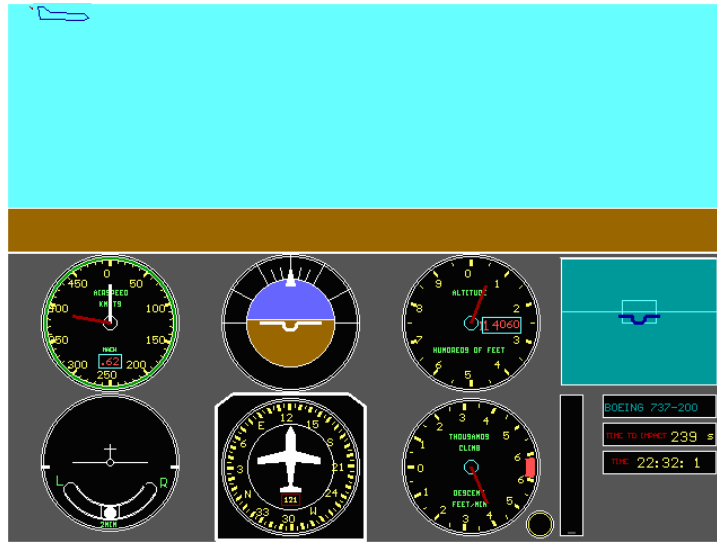
Fig. 5: Cockpit instrument visualization

The author and his team developed two computer programs. The first computer program generated the required data for visualization of the cockpit instruments and the aircraft orientation with respect to the horizon. It allows air crash investigators to be inside the cockpit of the ill-fated aircraft and understand what had happened.

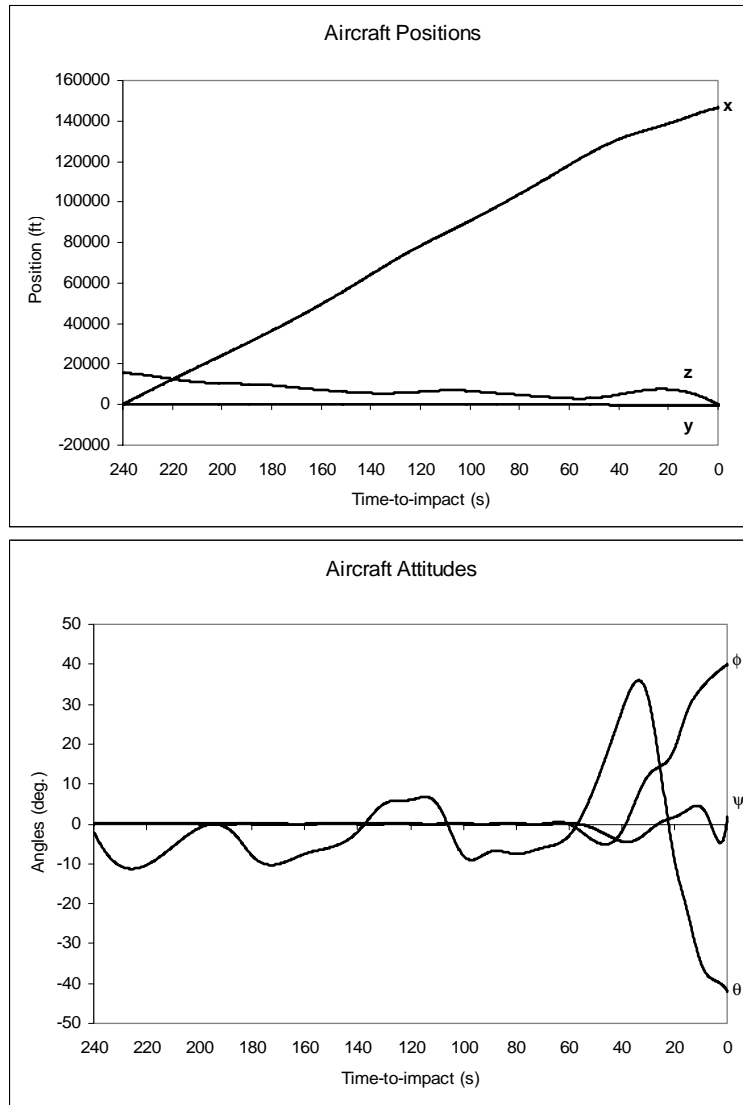
Fig. 7: Positions and attitudes of the 9M-MBD

Data gathered from the Trajectory Reconstruction Method analysis are shown in Figure 7. At 240 seconds from impact, the aircraft was at an altitude of 15,640 feet above sea level and descending. It started to pitch-down until its pitch angle reaching -11.3 degrees before pitching-up again 14.8 seconds later. The abnormal pitch-down caused the aircraft to lost 2090 feet; a rate of descent of 8,475 ft/min.

The aircraft began to level 45 seconds later for a few seconds before experiencing the second pitch-down motion. Its pitch angle reached -10.3 degree before the aircraft started to pitch-up. It continued to pitch-up until the pitch angle reached 6.8 degrees, 125 seconds before impact. This caused the aircraft to climb above its glide slope. The aircraft entered its third pitch-down motion at 114 seconds from impact, reaching pitch angle of -9.0 degrees, 17 seconds later. Then, the aircraft pitch up again before leveling 47 seconds later.

The situation in the cockpit had obviously been critical 60 seconds before the impact. The aircraft not only pitched-up, but it also experienced roll and yaw. It banked slightly to the right before banking uncontrolled to the left. It also yawed to the right before yawing back to the left.

Unable to maintain the aircraft directional and lateral control while the aircraft was losing altitude rapidly, the pilot excessively pitched-up the aircraft from 0 degree to 36 degree in 23 seconds, reaching up to altitude of 6,470 ft. As the aircraft stalled 34 seconds from impact, it dived at an increasing rate of descent in a steep nose down attitude; further aggravated by high rate of roll and yaw. On impact, the aircraft struck the ground at pitch angle of -42 degree, roll angle of 40 degree and yaw angle of 2 degree.

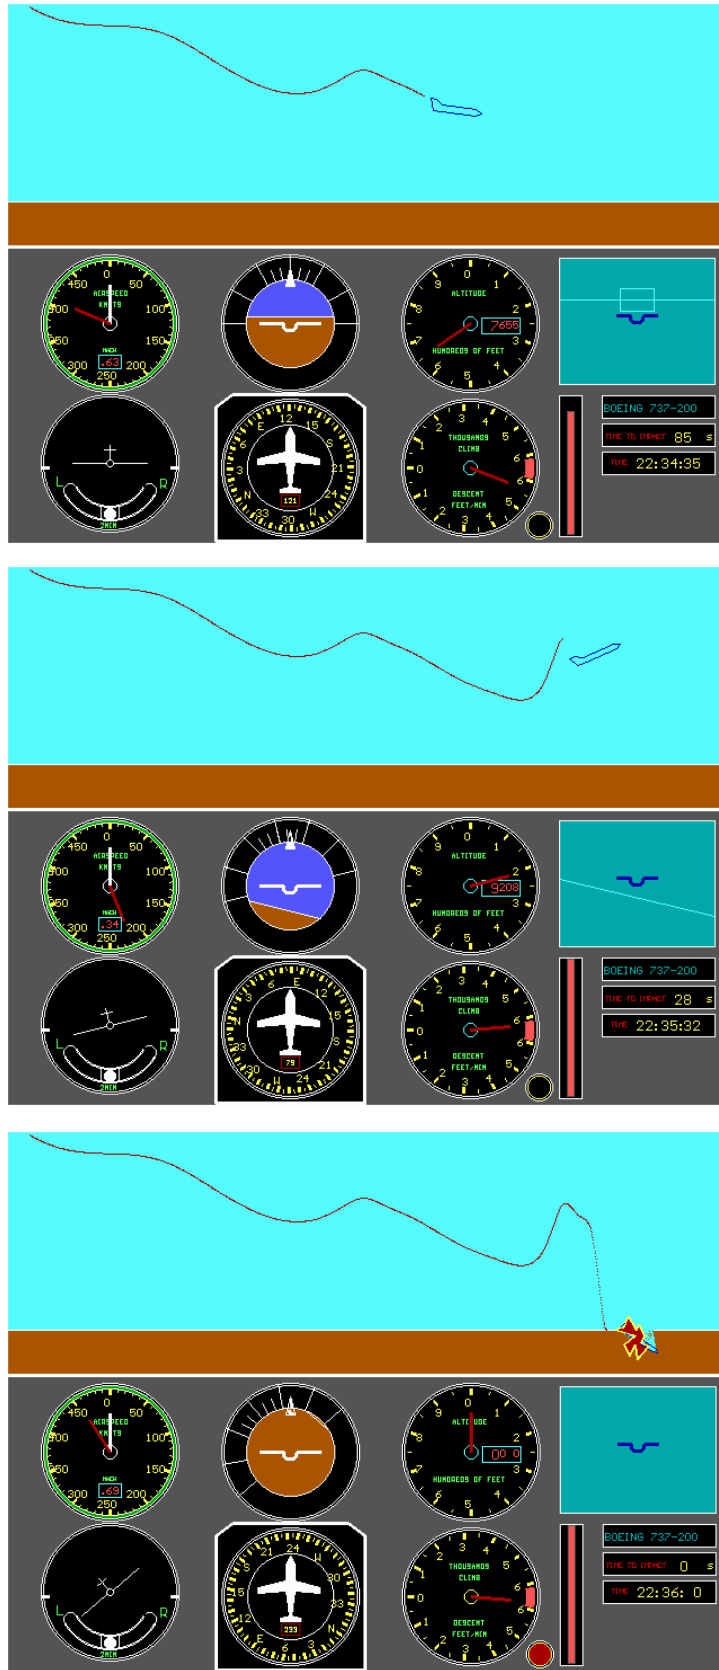
Fig. 8: Cockpit views of the 9M-MBD

Visualization of the air crash data provides a clear picture of what had happened to flight MH653. Figure 8 shows the cockpit views while the Figure 9 represents the aircraft in three-dimension.
