Influence of Cutting Conditions on Surface and Sub-Surface Quality of High Speed Dry End Milling Ti-6Al-4V

H. Safari, S. Sharif*, S. Izman

Faculty of Mechanical Engineering, Universiti Teknologi Malaysia, 81310 UTM Johor Bahru, Johor, Malaysia

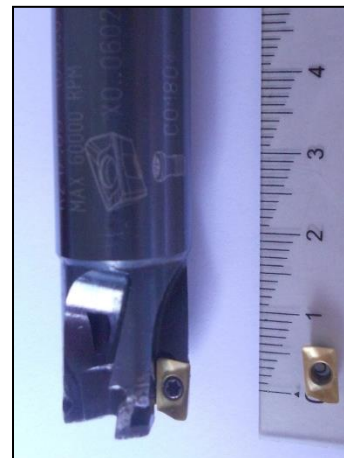
Figure 2 Tool holder and insert used for HSEM

A TiAlN/TiN PVD coated carbide milling insert known as Nano Turbo from SECO with designation XOMX060204R-M05 F40M was used and mounted onto a tool holder type R217.69-1616.0-06-4A. Table 1 provides the specifications of the cutting tool insert and the holder. Figure 2 displays the images of tool holder and inserts used throughout the investigation. To avoid the influence of the tool run-out on surface quality analysis all the experiments were completed using single cutting insert.
