**FINITE ELEMENT ANALYSIS ON THE DEFECTED REINFORCED  
CONCRETE COLUMN**

A project report submitted in partial fulfilment  
of the requirements for the award of the degree of  
Master of Engineering (Civil-Structure)

Faculty of Civil Engineering  
Universiti Teknologi Malaysia

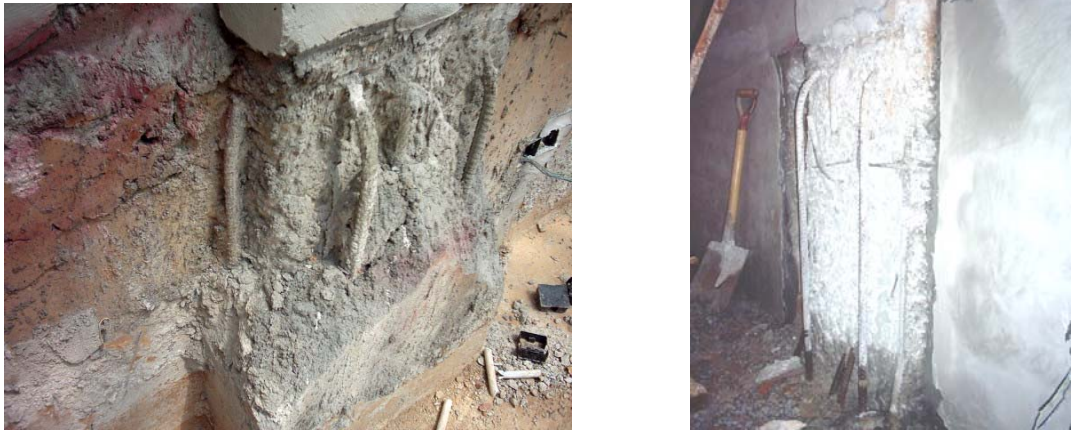
**Figure 1.1 :** The damage to the column

This study is conducted in reference to a real construction project<sup>1</sup> where non-conformance of architectural and structural drawing has occurred. The site problem was initiated when a stump was cast higher than finished floor level, due to the misinterpretation of the drawings during levelling survey work. This resulted in the protrusion of the stump from acoustic wall surface. Hence, the stump was hacked to provide a flat surface for the installation of the acoustic wall (see Figure 1.1).

The strength of the defected column is assumed to have reduced due to hacking. Because the column is an important structural member of the building, a study to determine its capacity is proposed.
