EFFECT OF CUTTING SPEED ON BIO-CORROSION OF AISI 316L STAINLESS STEEL

Keywords: metallic implant, face milling, cutting speed, surface roughness, surface characteristic, corrosion behavior.

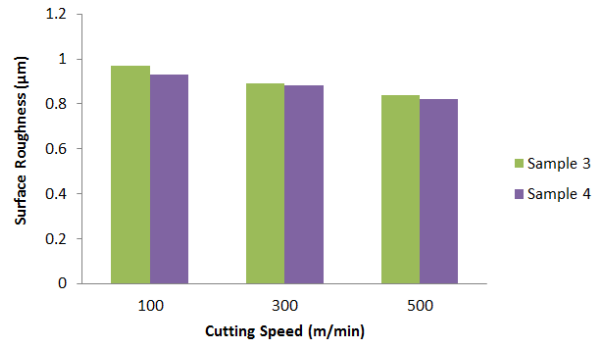
Considering the face milling was done at the same feed rate and using the same type of cutting tool, it was expected that the surface roughness to be similar, within the value of Ra between 0.8 and 1.2 μm . The results as shown in Figure-1 showed that the surface roughness values were within the expected range. However, it was found that there is tendency that the increase in cutting speed reduces the surface roughness.

Figure-1. Surface roughness versus cutting speed for two selected samples

Although not as expected, the trend that the surface roughness is inversely proportional to cutting speed is in agreement with previous work [9]. However, in the reference, there was no satisfactory explanation on why the phenomenon occurred.

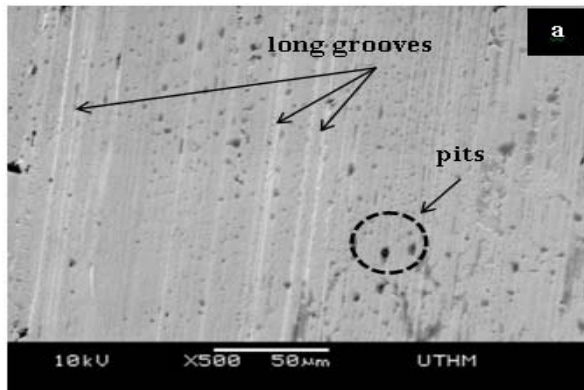
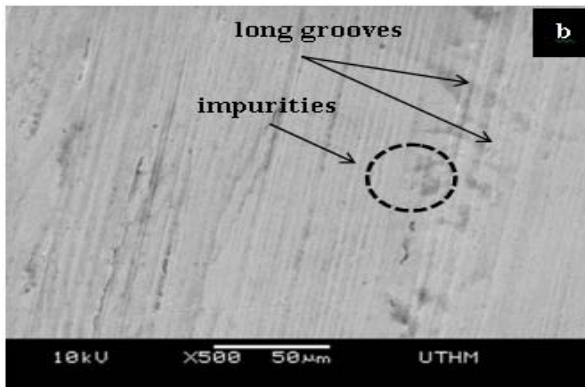
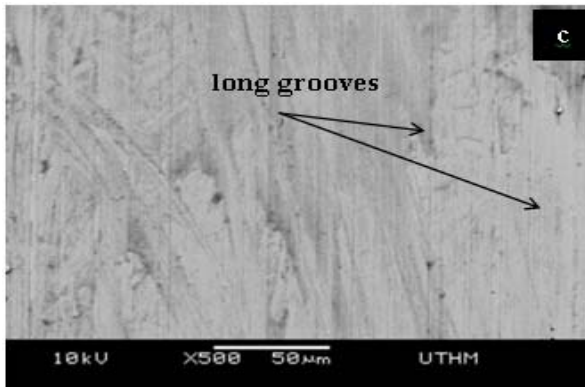
Figure-2 represents the surface of machined samples under observation using Scanning Electron Microscopy (SEM) with 500x magnification to assess the surface morphology. The machined surface consists of long straight grooves as the feed marks and of ridges in between the grooves from the tool's rubbing action. This is typical on surface of machined steel [9]. The machined surface produced at cutting speed of 100 m/min shows pits. For surface produced at higher cutting speeds, the presence of pits was fewer. There was less clear differentiation between feed marks and ridges at surfaces produced by high cutting speeds. From these, the finer surface produced at higher cutting speed was likely due to less defects on the machined surface. Such fewer defects might be the result of machining at higher temperature induced by higher cutting speed.

Figure-2. The surface microstructure examined by SEM with cutting speed: (a) 100m/min, (b) 300m/min, (c) 500m/min.

The results showed that there is apparent difference in corrosion rate for the AISI 316L stainless steels machined at different cutting speeds. Generally, corrosion rate is lower for samples produced at higher cutting speeds. Possible reasons for this include the less surface area for samples produced at higher cutting speeds. Referring to the morphology, pits were more in existence for samples machined at low cutting speed. Also, referring to the surface roughness, there is good chance that lower surface roughness (which is produced at high cutting speed) means less surface area. Another possible reason is there were less peaks on the surface of the samples produced at higher cutting speeds. It is known that peaks are the sites prone to corrosion attacks. The higher the cutting speed, the less obvious the difference between feed marks and ridges, which means the peaks (and also the valleys) were less in sharpness and/or fewer in number.

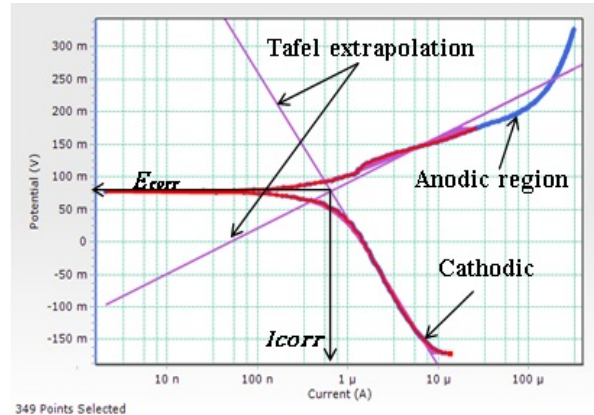
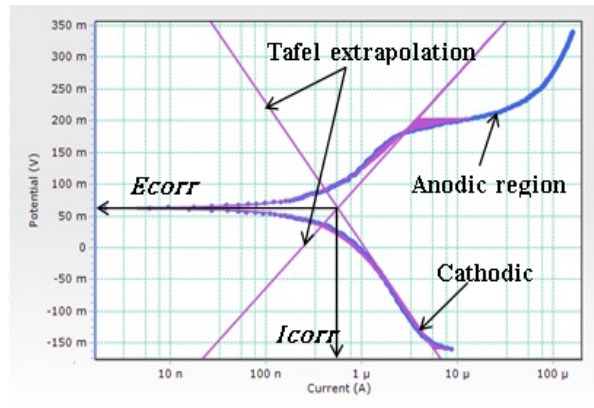
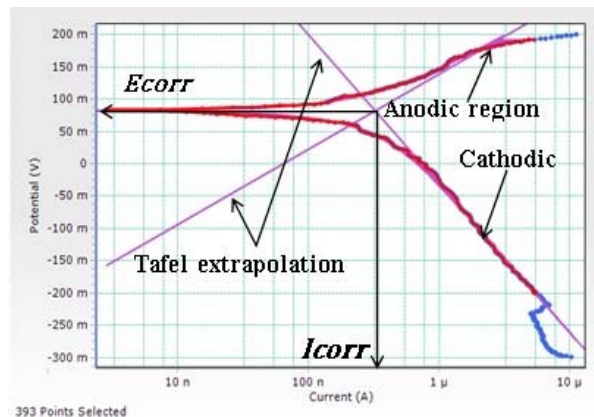
Bio-corrosion test in order to observe the corrosion behavior on the AISI 316L stainless steel using Potentiodynamic Polarization Test resulted in polarization curves as shown in Figure 3. The curves could then be processed to extract the corrosion potential, corrosion current density, and corrosion rate, as shown in Table 1.

Figure-3. Tafel extrapolation at polarization curves of three cutting speed: (a) 100 m/min, (b) 300 m/min, (c) 500m/min.

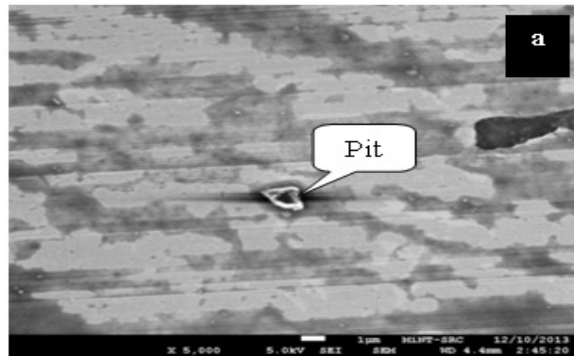
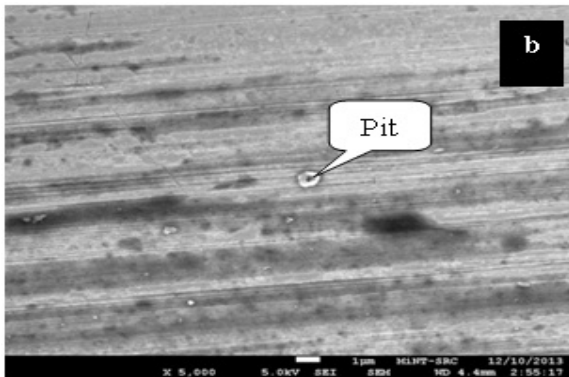
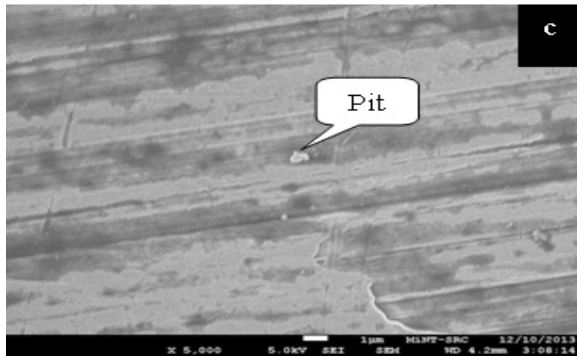
From Figure-4 which shows the surface morphology after the potentiodynamic polarization test, the corrosion product on the surface was not apparent. It was as expected considering the high corrosion resistance nature of stainless steel.

Figure-4. The surface microstructure examined by SEM after potentiodynamic polarization test. The mark area was the pit initiations occur at the surface with cutting speed at (a) 100 m/min, (b) 300 m/min and (c) 500 m/min.
