Aging Detection of Glass Disc Insulator by Using Infrared Camera

Mohammed Imran Mousa^{*1}, Zulkurnain Abdul-Malek², Zainab I. M.³

^{1,2}Institute of High Voltage and High Current, Faculty of Electrical Engineering, Universiti Teknologi Malaysia, Johor Bahru, Malaysia

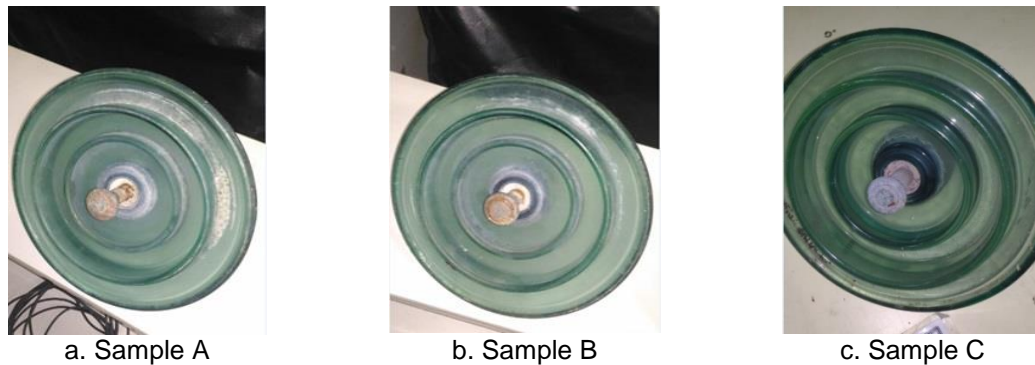
Figure 1. Glass insulator samples used in the experimental

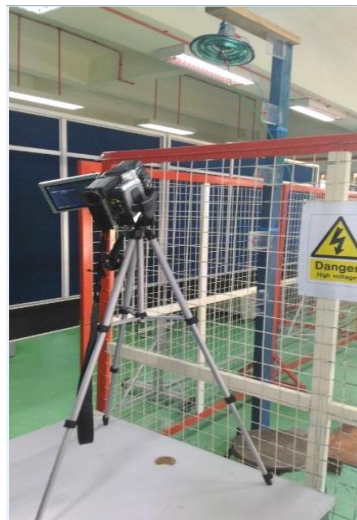
Figure 2. Experimental setup showing the thermal camera positioning

passing through the pollution and due to the electric field intensity once high-voltage was applied [1], [37, 38]. The magnitude of the applied voltage is known to have direct relationship with the leakage current [39]. The leakage current is also known to have direct relationship with the pollution thickness and type [39]. The glass insulators were previously under service in the TNB system and were randomly selected. The pollution layers accumulated on the glass insulator was non-uniform as shown in Figure 1. Supply voltage was made using a high-voltage transformer which was connected to a voltage regulator. The thermal images were captured by NEC H2640D_NS9500PRO infrared thermal camera. Figure 2 shows a photo of the measurement setup.

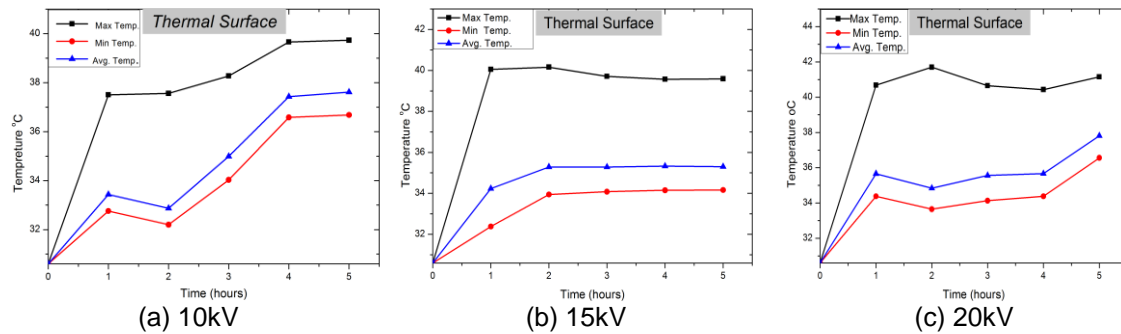
Figure 3 shows the maximum temperature of the glass insulator surface, and it is seen to drastically increase with time during the first hour. The average and minimum temperature behaviors follow the same trend. The average and minimum temperature increments from an ambient temperature through the first hour are shown in Figures 3 (b) and (c).

The surface of the glass insulator heated up due to the applied high voltage across the insulator. After a certain time, it reached the steady-state condition. The larger the applied voltage, the larger would be the steady state temperature. In addition, the average and minimum temperatures, which are also plotted on the same respective graphs, were affected by the level and distribution of the maximum temperatures (appeared as hot spots when using infrared camera).

Figure 3. Thermal profile over five-hour period of the insulator surface for sample D, (a) 10 kV, (b) 15kV, and (c) 20kV

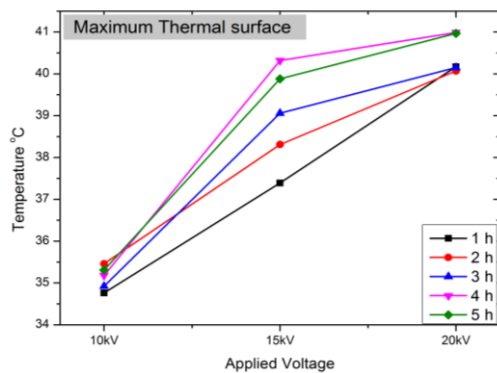
Figure 4 shows the effect of the applied voltage on the temperatures of the insulator surface. Sample Chad been stressed with various voltages (10, 15, 20 kV) for five hours. The behaviors of the maximum temperatures with time are almost similar for different voltages. The surface temperatures were seen to increase significantly with the applied voltage. The influence of the time period on the thermal surface was also seen to be affected by the applied voltage. Figure 5 shows the maximum temperatures after five-hours for sample B. The behavior is almost similar with previous results but the maximum temperature is a bit higher in this case.

Figure 4. The effect of the applied voltage on the maximum temperature for sample C (for varying stress time periods)

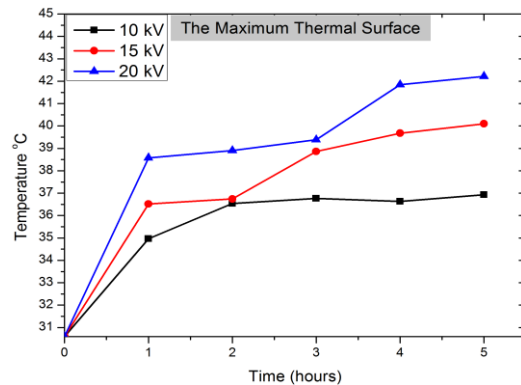
Figure 5. The effect of stress time on the maximum temperature for sample B (for varying applied stress level)

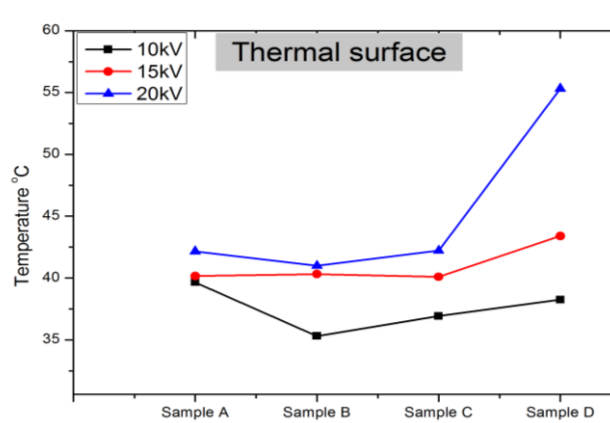
Figure 6 shows the influence of the maximum temperatures of surface with different samples, when applied 10kV, 15kV and 20 kV. The behavior of the surface temperatures effected by the magnitude of the voltage applied. The increment of applied voltage has similar influence with the four samples of the glass insulators that is the surface temperatures are raised up. In spite of, the four samples have different rate of the thermal rise when the voltage increased regularly.

Figure 6. The maximum temperatures for various samples at varying applied voltages (stress time was 5 hours)

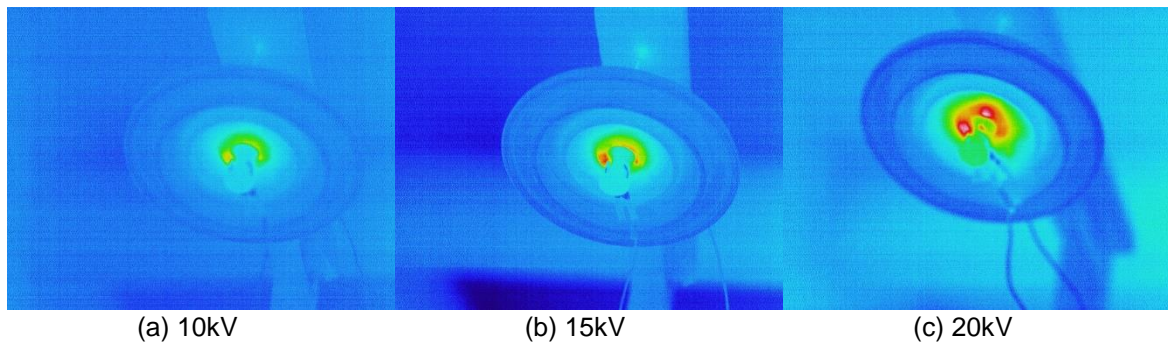
Figure 7 shows the thermal images representing the surface temperatures distributed over the surface of the insulator for various applied voltages (10kV, 15 kV and 20 kV) for sample C. The infrared camera shows higher temperatures were concentrated around the pin and gradually spreading and decreasing toward outer diameter of the glass insulator. The glass insulator surface was seen to have a hot spot. The hot spot becomes more intensified with the applied voltage. Figure 8 shows the histogram of the temperatures distribution on the surface of the insulator, for applied voltage of 10kV, 15 kV and 20 kV on sample B. The histogram analysed the thermal images by grouping the image pixels according to their temperature. The histogram is another way to show the temperature distribution of the glass surface. A higher applied voltage led to raised minimum limit of the surface temperatures, and hence the range of temperatures across the glass insulator became wider.

Figure 7. The thermal images of sample B for various applied voltages; (a)10kV, (b) 15 kV, and (c) 20 kV

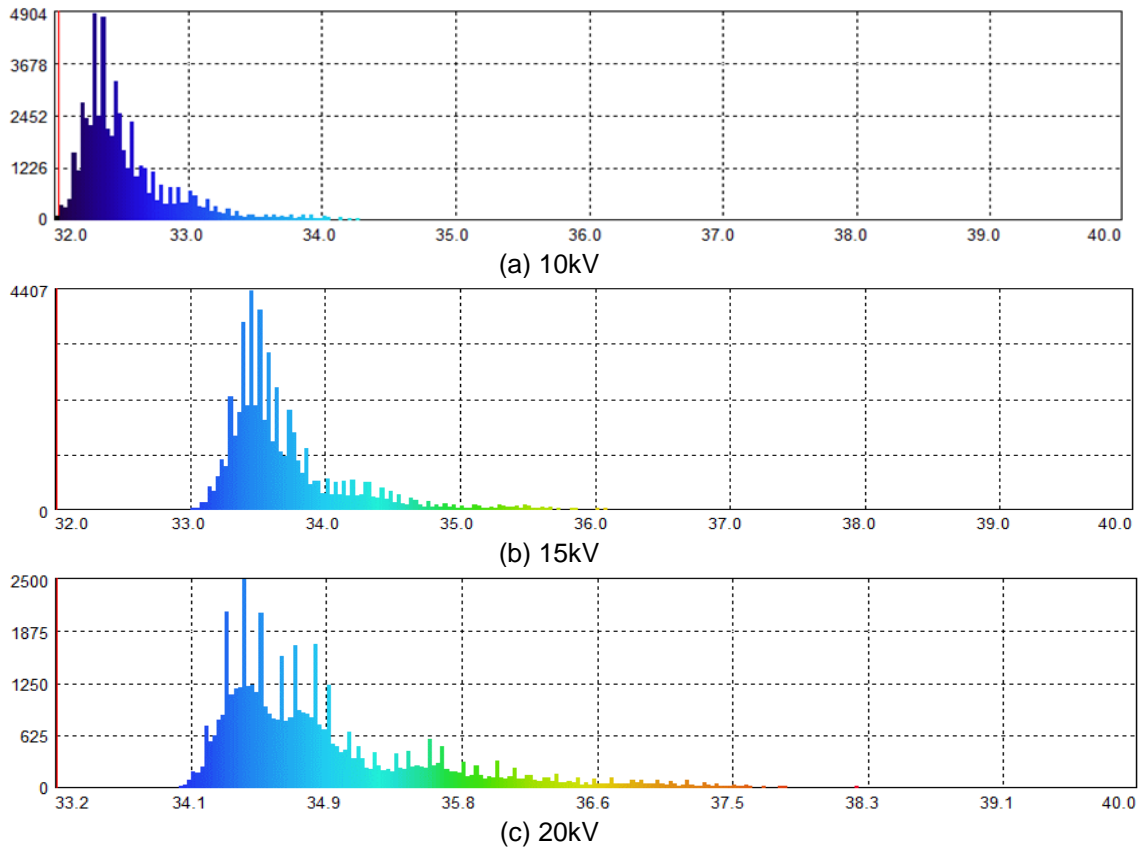
Figure 8. The histogram of the temperature distribution along the insulator B surface, for various applied volatges; (a) 10kV, (b) 15 kV, and (c) 20 kV

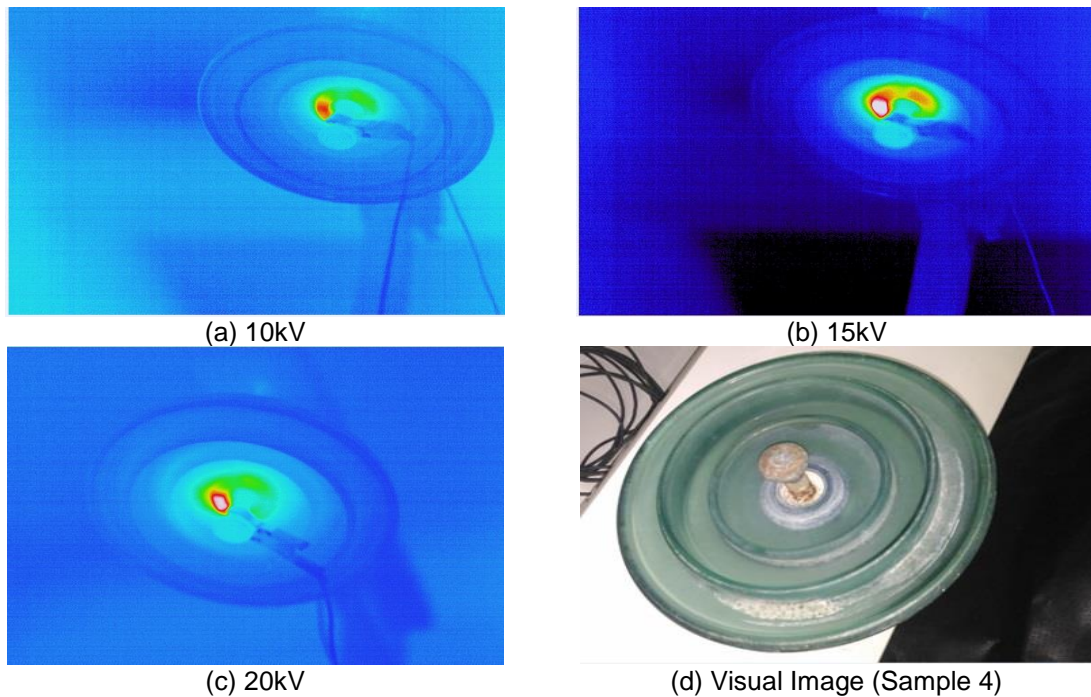
Figure 9 shows thermal images for sample A after five hours, when various voltages were applied. The invisible damage can be indicated in the thermal image as a hot spot, where it can be seen that the hot spot brightness increases with the applied voltage.

Figure 9. Thermal images of sample A after 5 hours, when applied with various voltages; (a) 10kV, (b) 15kV, and (c) 20 kV; and (d) Visual image of the insulator
