THERMAL IMAGE, PARTIAL DISCHARGE AND LEAKAGE CURRENT CORRELATION OF CERAMIC INSULATOR UNDER DIFFERENT CONTAMINATION LEVEL

Keywords: ceramic insulator, leakage current, partial discharge, infrared images, pollution.

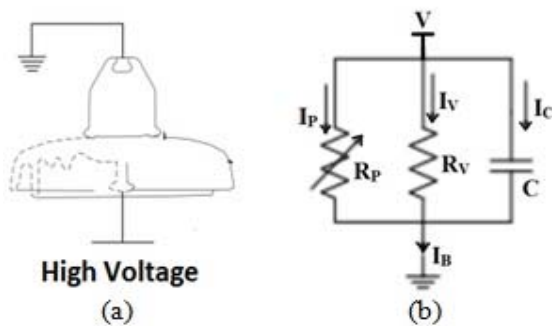
Figure-1. Leakage current on the insulator surface, (a) schematic diagram of the insulator, (b) equivalent circuit of the insulator.

If the high voltage AC [2, 6] was applied across the insulator, the surface current, I_P volume current, I_V and capacitive current, I_C would flow thru the insulator as shown in Figure-1. Capacitive currents occur because of the capacitance formed by the electrodes as insulators Figure-1(b). The leakage current, I_B flowing on the clean insulator surface will be capacitive, but if the surface of the insulator is contaminated, the resistive current will

From Figure-1(b), the flow volume can be ignored because the volume resistance is relatively large compared with the surface resistance so that the total leakage current becomes:

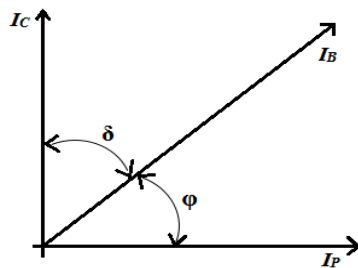
Figure-2. Phasor diagrams of the leakage currents.

with phasor diagrams as depicted in Figure-2, the magnitude of leakage current, I_B is;

$$I_B = \sqrt{I_P^2 + I_C^2} \quad (2)$$

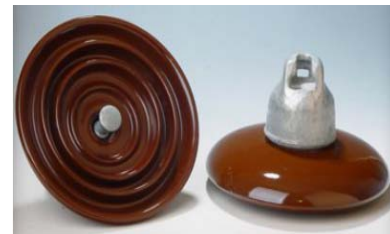
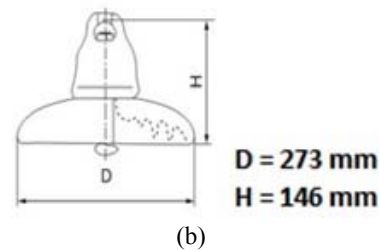
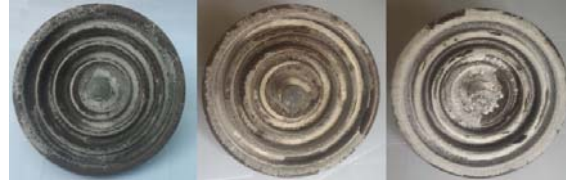
Figure-3. The 20 kV of ceramic insulators, (a) clean insulator, (b) insulator dimension, and (c) polluted insulators.

The 20 kV ceramic insulators used in this work are depicted in Figure-3. The tested insulator was suspended vertically [3, 7, 11, 12, 14, 15, 18-20] facing the thermal camera in the space (0.5x0.5x1.3 m³) as shown in Figure-4. The test voltage is in the range of 12 to 18 kV rms at 50 Hz frequency. Room humidity is in the range of 60% to 100%. The tests were performed according to IEC 60507 test procedure of clean fog. Before the test, the insulator surface was cleaned with isopropyl alcohol and rinsed with distilled water to remove any traces of dirt and grease [22]. The typical salt pollution of coastal areas was produced by creating a layer of insulator surface contamination. Contaminants are formed of NaCl with 40 g of kaolin were mixed with 1 liter of water. The salt concentration of NaCl varied to provide equivalent salt

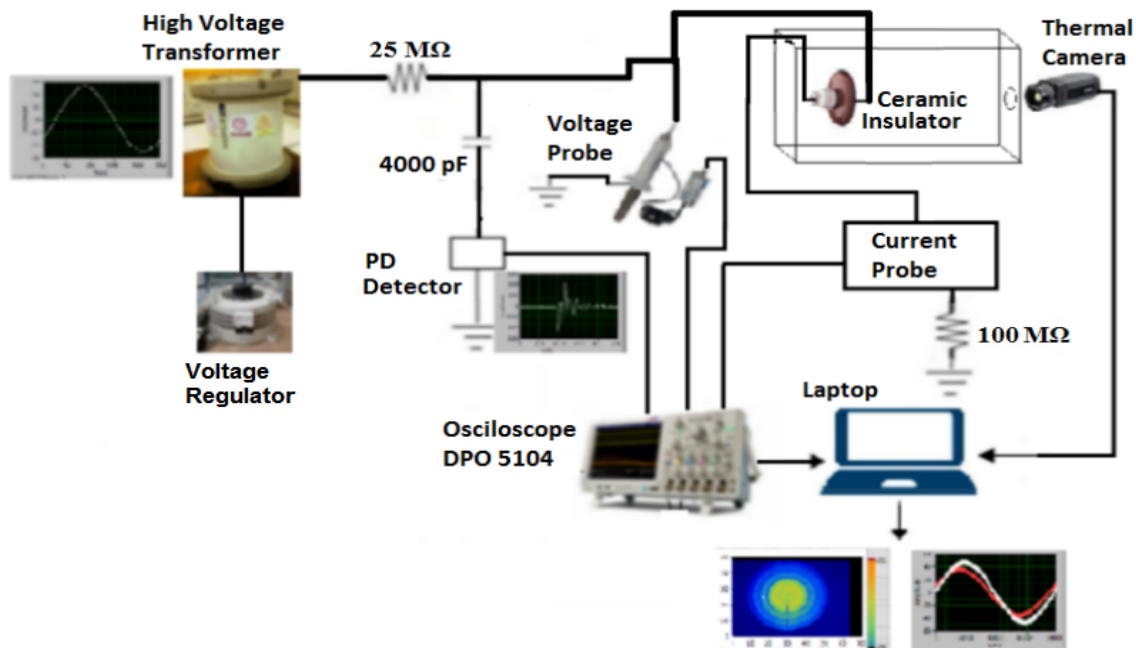
Figure-4. A schematic diagram of the experimental setup.

Figure-4 shows a schematic diagram of the experimental setup. The high voltage amplifier was used as a high voltage generator as well as the test voltage. The high voltage transformer (HVT) has a ratio 1: 2000. Voltage regulator was connected to the input of the HVT as a regulator of the test voltage. DPO 5104 oscilloscope was used to display the input voltage through a voltage probe P6015A, creeping leakage current ceramic insulators as well as recording the activity of PD which detected by PD detector (coupling capacitor and measuring impedance). The high voltage was subjected to the ceramic insulator and a 4000 pF capacitor charge for the case of measuring the PD events of the ceramic insulators, the capacitor will be throwing so PD detector will detect PD occurrences and shown on DPO 5104 oscilloscopes. Voltage Probe was used as a working voltage detection and test applied during experiment. With a ratio of 1: 1000V. The current probe P6021 was used as an insulator leakage current detection.

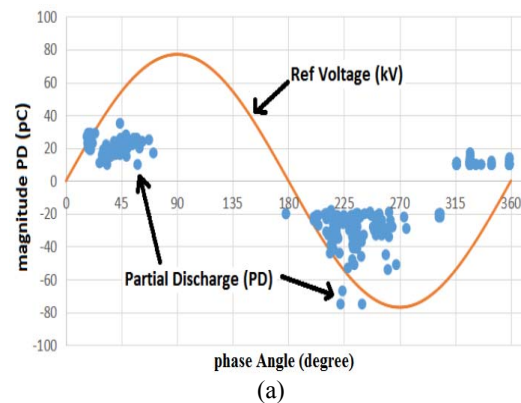
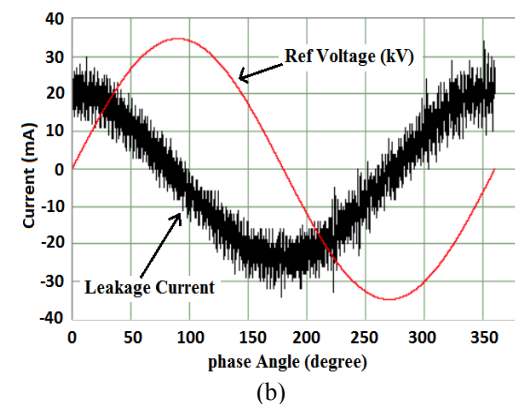
Figure-5. Polluted ceramic insulator at 14 kV and 60% RH (a) PD phase resolve (b) LC phase difference.

Figure-5 shows the PD pattern at different phases of the ceramic insulator that was moderately polluted, the reference voltage is 14 kV with 60% of humidity. Figure-5(a) is the chart patterns of the PD phase and Figure-5(b) is the graph of the phase difference between the reference voltage to the leakage current. It can be noted that the PD activity will increase when the humidity rises. Rising humidity will also result in the increase of leakage current [9, 12, 18-20]. Further result is the phase difference between the reference voltage to the leakage current will be smaller due to polluted insulator becomes more resistive.

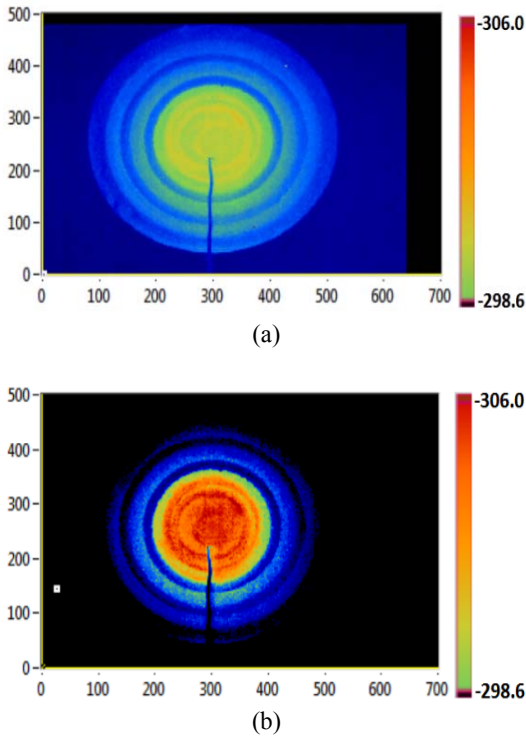
Figure-6. Thermal image of ceramic insulator under test, (a) low level of pollutant and, (b) highly polluted.

Figure-6 shows the thermal images of the tested insulators under voltage of 16 kV, 0.12 (heavily polluted) ESDD pollutant levels (mg/cm²), 80% RH, and the temperature of 24 °C. The yellow color in the center of high voltage insulator as shown in Figure-6(a) indicates less activity of PD, whereas on Figure-6(b) shows lots of PD activity on the centre of the insulator which indicated by reddish colour of thermal image.

The color variation of the insulator has physical correlation with number of PD activity. Also, Figure-6 shows two IR images obtained from the measurements with temperature indicator ranging from 298.60K (25.6°C) to 306.00K (33°C). This study has corroborated the works in reference [22] in which insulator temperature data obtained from the first step in the insulator segmentation of the background of the IR image and recorded the coordinates of the insulator region. Also, the second step was to read the temperature data corresponding to the recorded coordinates. Figure-6(b) shows the percentage of the color associated with the PD activity, and the temperatures of the surface of the insulator were shown in Figure-7.

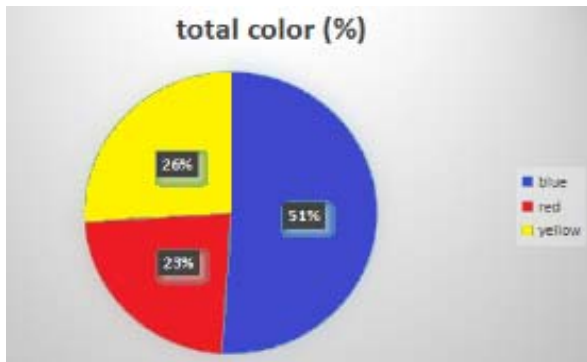
Figure-7. Colour percentage of thermal image of ceramic insulator.

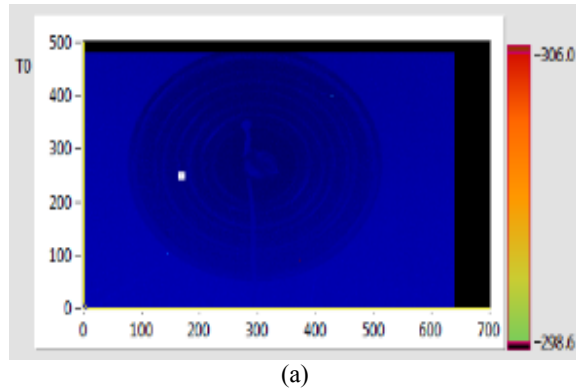
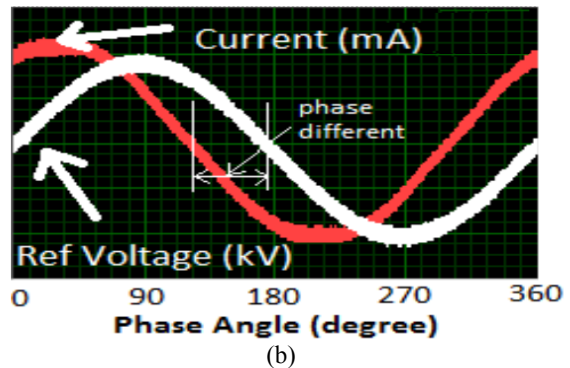
Figure-8. The ceramic insulator in clean condition rated voltage 14 kV, (a) thermal image and, (b) phase different.

In the same test, the color correlation of thermal images of the leakage current can be seen in Figure-8. When the ceramic insulator in a clean state and then tested with a voltage of 14 kV, the resulting thermal image was dark-bluish color and the phase difference between the leakage current and reference voltage are very large. Thermal image of dark-blue color indicates that the leakage current is highly capacitive.

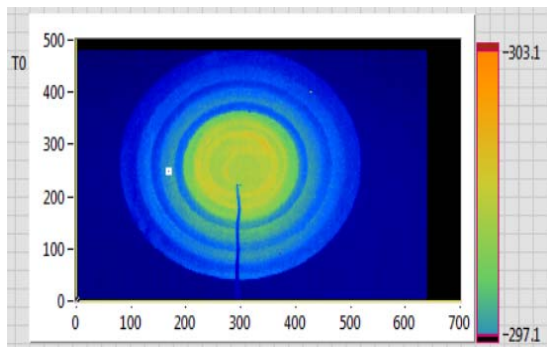
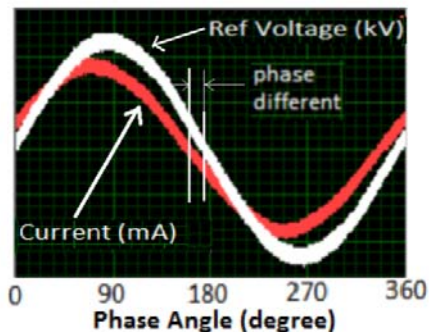
Figure-9. The ceramic insulator with the moderate pollutant was tested with 14 kV, (a) thermal image, (b) phase different.

Figure-9 shows the ceramic insulator which was tested with the same method as the previous test, but with a higher level of pollutants, 0.08 ESDD (mg/cm²). It was seen that the resulting thermal image was a blue-yellow and the phase difference was vanishingly small. The smaller phase difference was due to the more resistive leakage current flow on the surface of the ceramic insulator(see Figure-9). By applying higher level of voltage, 16 kV and pollutant, it is shown that the generated thermal image was also different with smaller phase different thereby indicating that resistive current became more dominant. (see Figure-10)

Based on the assumption, yellow thermal image in Figure-9(a) should be greater than or even become redder than the thermal image in Figure-9(a), but this did not happen. The greater the area of the yellow color of the image due to the corona 9(a) is happening at the bottom of the insulator. But by raising the voltage to 16 kV as can be seen in Figure-10(a), the insulator surface becomes dry faster and corona is significantly reduced, so that the

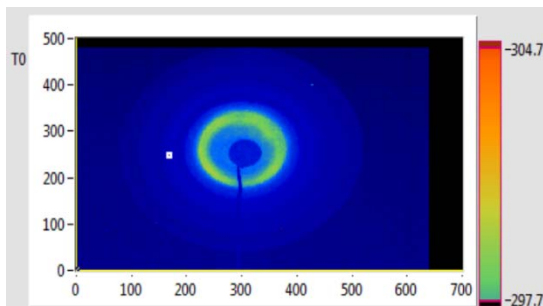
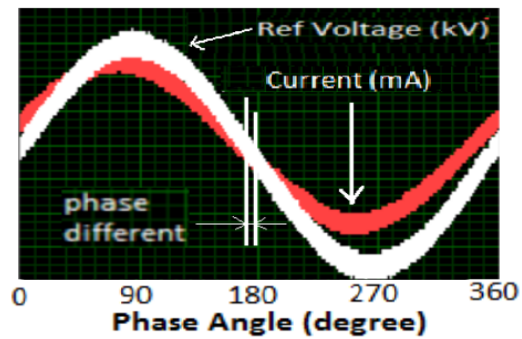
Figure-10. The highly polluted ceramic insulator was tested with 16 kV, (a) thermal image, (b) phase different.

yellow thermal image becomes smaller as the temperature insulator is affected by PD activity alone. Based on the obtained results, insulator conditions detected by the thermal image associated with leakage current were categorized into the following 3 categories groups;
