APPLICATION OF ULTRASONIC GUIDED WAVE FOR STRUCTURAL HEALTH  
MONITORING OF PIPELINE

A dissertation submitted in partial fulfilment of the  
requirements for the award of the degree of  
Doctor of Engineering (Process Plant Management)

Faculty of Chemical and Energy Engineering  
Universiti Teknologi Malaysia

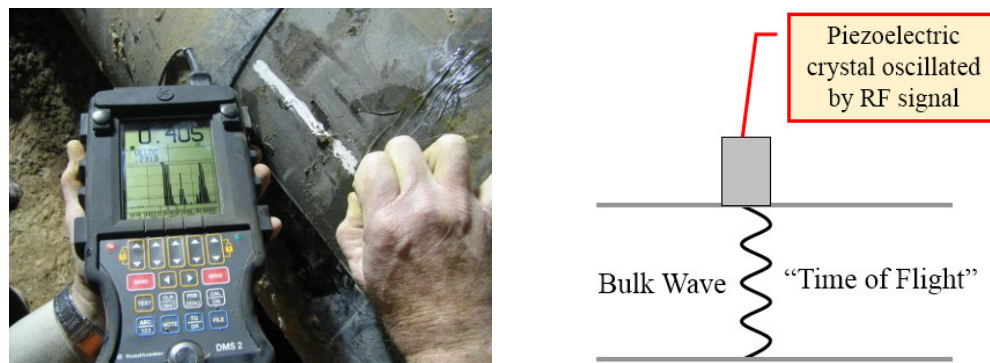
**Figure 1.1** Principles of conventional UT

Ultrasonic testing (UT) is a family of non-destructive testing techniques based on the propagation of ultrasonic waves in the object or material tested. In most common UT applications, very short ultrasonic pulse-waves with centre frequencies ranging from 0.1-15 MHz, and occasionally up to 50 MHz, are transmitted into materials to detect internal flaws or to characterize materials. A common example is ultrasonic thickness measurement, which tests the thickness of the test object, for example, to monitor pipework corrosion. The “Time of Flight” of an ultrasonic wave is directly proportional to the thickness of the material measured. This is described in Figure 1.1.

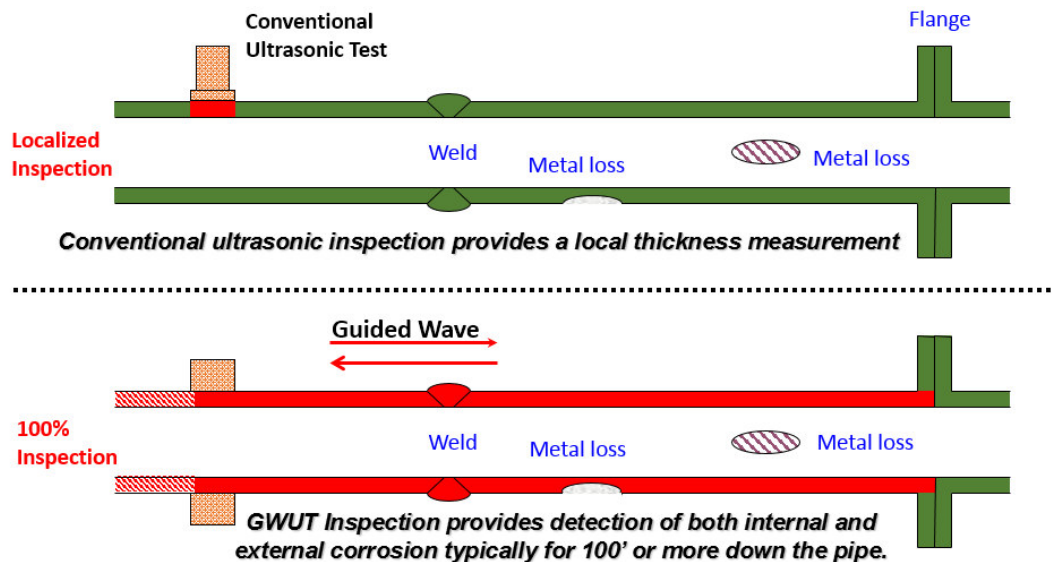
**Figure 1.2** Comparison between conventional ultrasonic testing (UT) and guided wave ultrasonic testing (GWUT)

While conventional UT measures the wall thickness at a spot, advanced guided wave ultrasonic testing (GWUT) can identify locations of metal loss along a length of the pipe (Guided Ultrasonics, 2010).

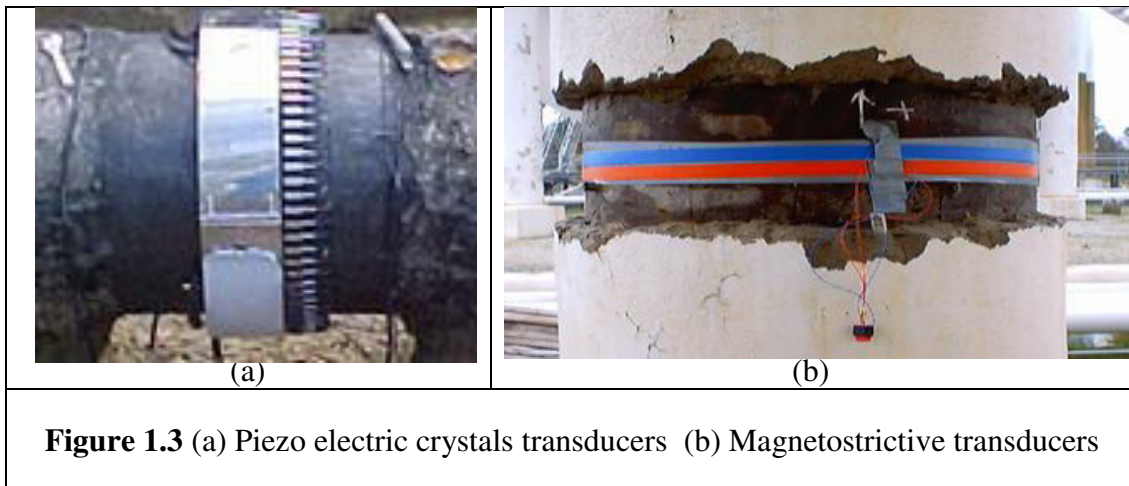
**Figure 1.3** (a) Piezo electric crystals transducers (b) Magnetostrictive transducers

- b) Coils of insulated wire are wrapped around the pipe. An alternating current is passed through the coils, and an oscillating magnetic field is produced. Due to the magnetostrictive effect of ferromagnetic materials, this produces a wave in the pipe which can be amplified by using a nickel or cobalt strip bonded to the pipe under the coil.

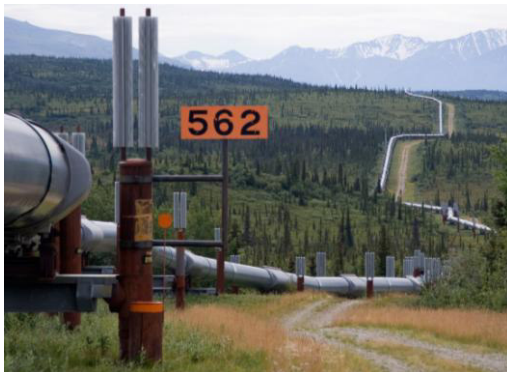
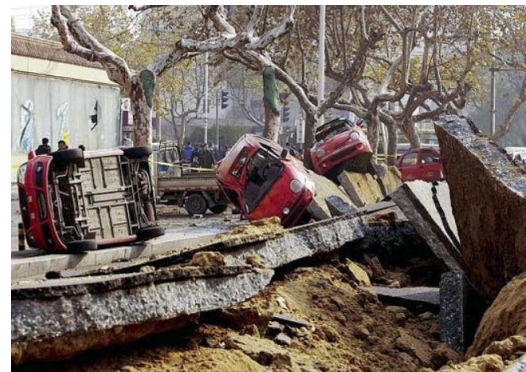
(a) Trans-Alaskan oil pipeline leak  
(The Guardian, 2011)

(b) Qingdao city oil pipeline leak  
(The Telegraph, 2013)

**Figure 1.4** Examples of oil pipeline leakage accidents which had caused the loss of human lives, environmental contamination and major financial loss

For example, oil production from Alaska's Prudhoe Bay field was reduced by 95% (of its daily production of 630,000 barrels of oil) after a leak was discovered in the Trans-Alaska Pipeline resulted in an increased in crude oil prices by over 2% (to nearly USD90). British Petroleum (BP) suffered major losses which saw their share value dipping by 2.5% at the FTSE 100 stock exchange in London (The Guardian, 2011).

In another example, the death toll from two huge blasts caused by leaked oil from a ruptured pipeline in an eastern Chinese port city (Qingdao, China) had taken 62 lives with 150 injured and contaminated approximately 3,000 square feet of the city. The pipeline owned by China's largest oil refiner, Sinopec, ruptured and leaked for about 15 minutes onto a street and into the sea before it was shut off. Hours later, as workers cleaned up the spill, the oil caught fire and exploded in two locations. This incident was classified as one of the country's worst industrial accidents of the year.

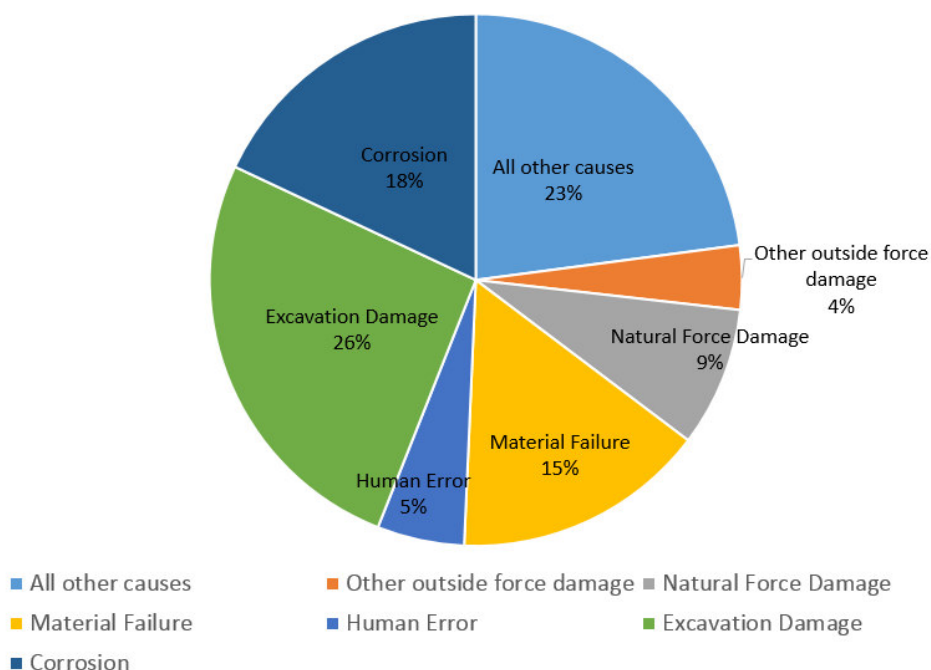
**Figure 1.6** Causes of 5960 significant incidents in onshore and offshore pipelines as adapted from (Baker, 2008)

Corrosion and erosion induced pipe failures can either be pipe rupture or leaks, with the latter being more common. As seen in Figure 1.6, excavation damage and corrosion has been reported to be responsible for 1550 and 1073 significant incidents respectively in both onshore and offshore US transmission pipelines, from

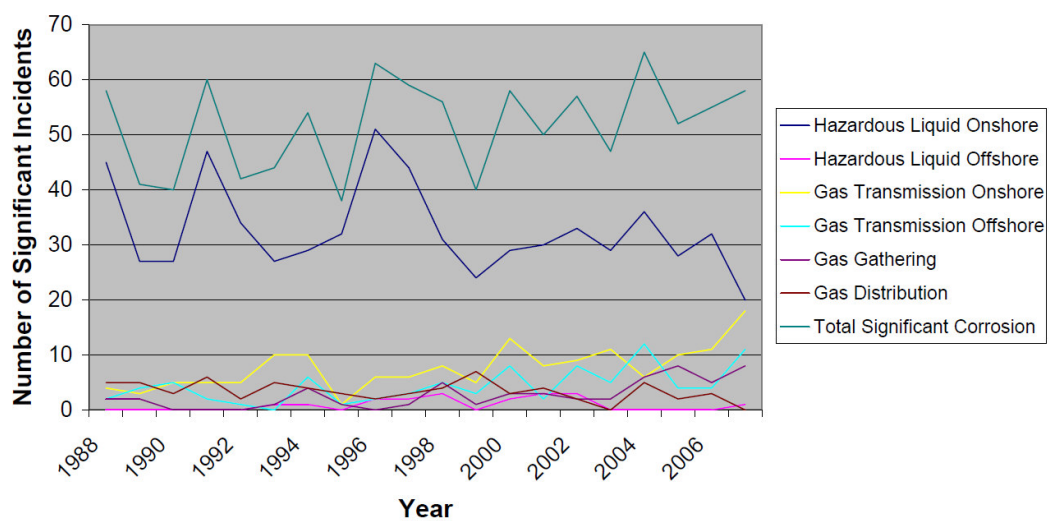
**Figure 1.7** History of significant corrosion incidents in the US, extracted from (Baker, 2008)

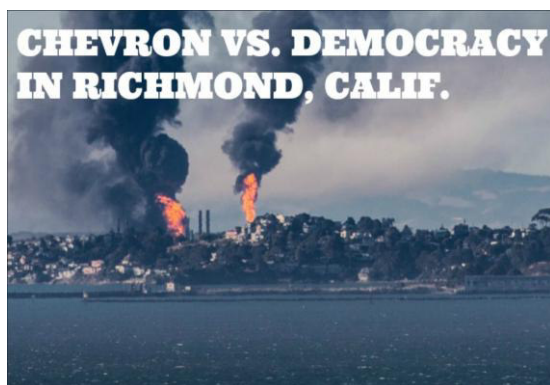
**Figure 1.8** Explosion and fire caused by leakage in a 1.5m 8-inch carbon steel pipe suffering from sulphide corrosion – HTM PSM Case Reference

general public as well as to the assets and resources of the city of Richmond”, which is still an on-going case at the time of writing of this thesis. See Figure 1.8 and Figure 1.9. This case study was adopted by HTM as their “accident case reference”.

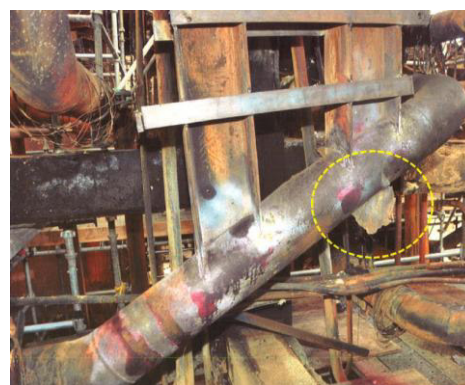
**Figure 1.9** Evidence of sulfidation corrosion in the ruptured pipe

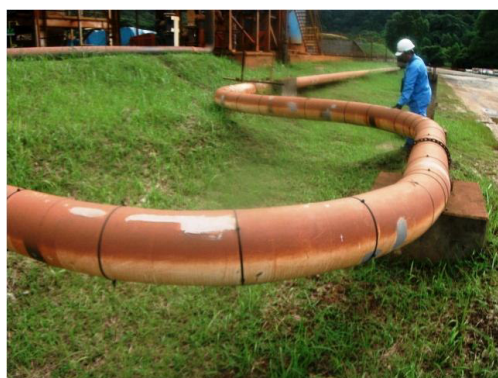
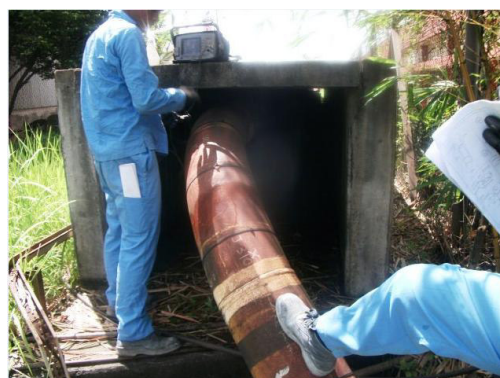
**Figure 1.10** Typical sulphuric pipeline installed at HTM a) over ground pipeline b) inside containment (or buried pipe)

Corrosion and erosion of sulphuric acid pipelines causing non-uniform wall thinning are the major problems at Huntsman Tioxide Malaysia. This phenomenon occurred more severely at pipe bends (see Figure 1.10a) than at the straight pipes (see Figure 1.10b).
