ROAD CONDITIONAL MAPPING USING TERRESTRIAL LASER SCANNING  
METHOD

A project report submitted in partial fulfilment of the  
requirements for the award of the degree of  
Master of Science (Geoinformatics)

Faculty of Geoinformation and Real Estate  
Universiti Teknologi Malaysia

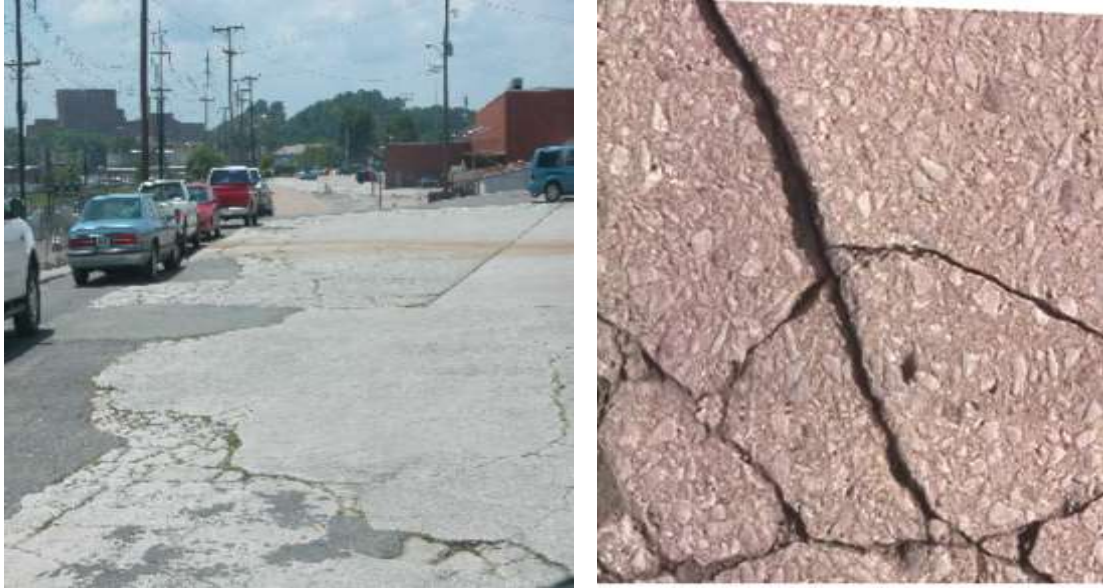
**Figure 1.1.** Image showing road cracking (Yu et al, 2005).

Ordinarily pavement condition data were collected by human inspectors who travel along the road to measure the distress and come out with a report. This method is time consuming, costly and is not safe (Sufiyan and ir zulakmal, 2009) rehabilitation and road conservations is not only time-consuming, but it also creates traffic instabilities and is also very costly, these have made visual inspection less capable (Patrick et al. 2012) Figure 1.1 shows an example of road crack.

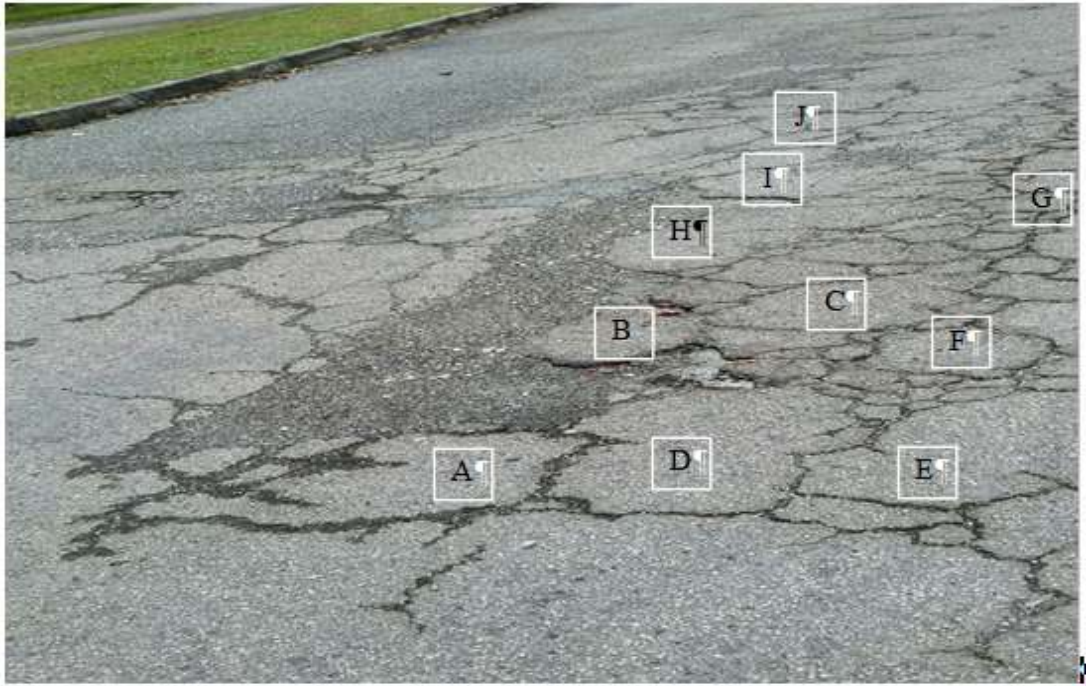
**Figure 1.3.** Study Area.

This research was carried out at University Teknologi Malaysia Skudai Johor Bahru. Figures 1.2 and 1.3 shows the map of University Teknologi Malaysia and image of the study area.
