MECHANICAL PROPERTIES OF CONCRETE CONTAINS WASTE TIRES EXPOSED TO HIGH TEMPERATURE

Abstract: Concrete contains crumb rubber and steel fiber from waste tires has recently gained interest among researchers as an alternative material to be used in the construction field. Mechanical properties of the concrete containing crumb rubber replacement and steel fiber at high temperature was investigated experimentally. The waste crumb rubber was chemically treated by using sodium hydroxide (NaOH). Water cement ratio of Treated Rubberized Steel Fiber Concrete (TRSF-Con) was modified to get similar strength as Normal Concrete (NC). A microstructure analysis using Scanning Electron Microscopy (SEM) test was conducted to investigate the bonding of crumb rubber in the concrete mix at ambient and high temperature. The TRSF-Con has performed satisfactory on reducing the growth and crack width compared with normal concrete when exposed to high temperature. The concrete containing crumb rubber and steel fiber have high potential to be utilized as insulating or reinforcement materials for non-structural composite member, which ensure the elements of the structure will not collapse for a prescribe peri

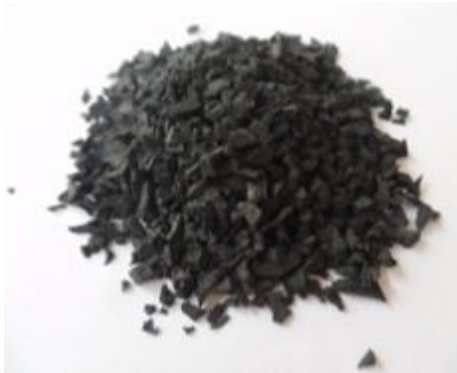
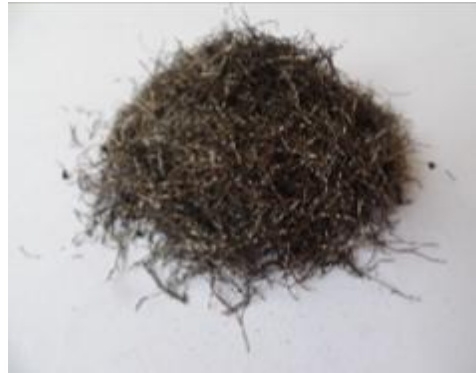
Figure 1: Crumb rubber and steel fiber used

In this research, Ordinary Portland Cement (OPC) was used for Normal Concrete (NC) and Treated Rubberized Steel Fiber Concrete (TRSF-Con). The natural fine aggregate passing through 4.75 mm while crush coarse aggregate passing through 10 mm and retained at 5 mm were used. The crumb rubber was treated with Sodium Hydroxide (NaOH) for 20 minutes and rinsed with water then dry for 24 hours at ambient temperature. This process was done to remove the impurities and dust on crumb rubber surface. Figure 1 (a) shows a crumb rubber that passing through 4.75 mm were used as fine aggregate replacement while Figure 1 (b) shows a steel fiber with diameter of 0.30 mm with average length of 2.35 cm.

(a) Crumb rubber

(b) Steel fiber

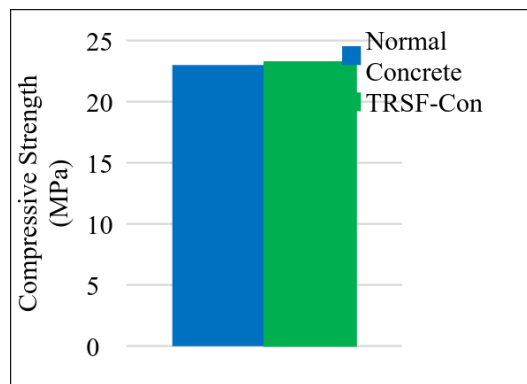
Figure 6: Compressive strength for fine crumb rubber after modification water cement ratio

The 0.55 water cement ratio was modified for Treated Rubberized Steel Fiber Concrete (TRSF-Con) containing 10% replacement of fine crumb rubber and 1% steel fiber, to get the similar strength as Normal Concrete (NC) as shown in Figure 6.
