VEGETATION ANOMALY INDEX FROM REMOTE SENSING FOR
LANDSLIDE ACTIVITIES MAPPING

A thesis submitted in fulfillment of the
requirements for the award of the degree of
Master of Philosophy

Faculty of Built Environment and Surveying
Universiti Teknologi Malaysia

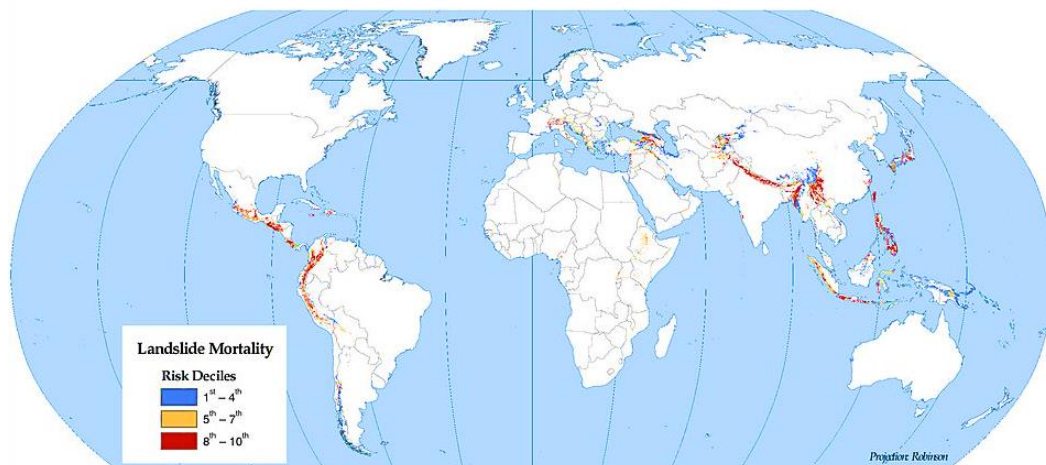
Figure 1.1: Global Mortality Risk Distribution Map (NASA Socioeconomic Data And Applications Center (SEDAC), 2005).

Mortality risk is found by weighting the value of population exposure to landslides for each grid cell by a vulnerability coefficient to obtain an estimate of risk. The vulnerability weights are based on historical losses in previous disasters. The mortality weights are applied to population exposure to obtain mortality risks. The weights are an aggregate index relative to losses within each region and country wealth class (classifications based on 2000 GDP) over the 20-year period from 1981 - 2000.

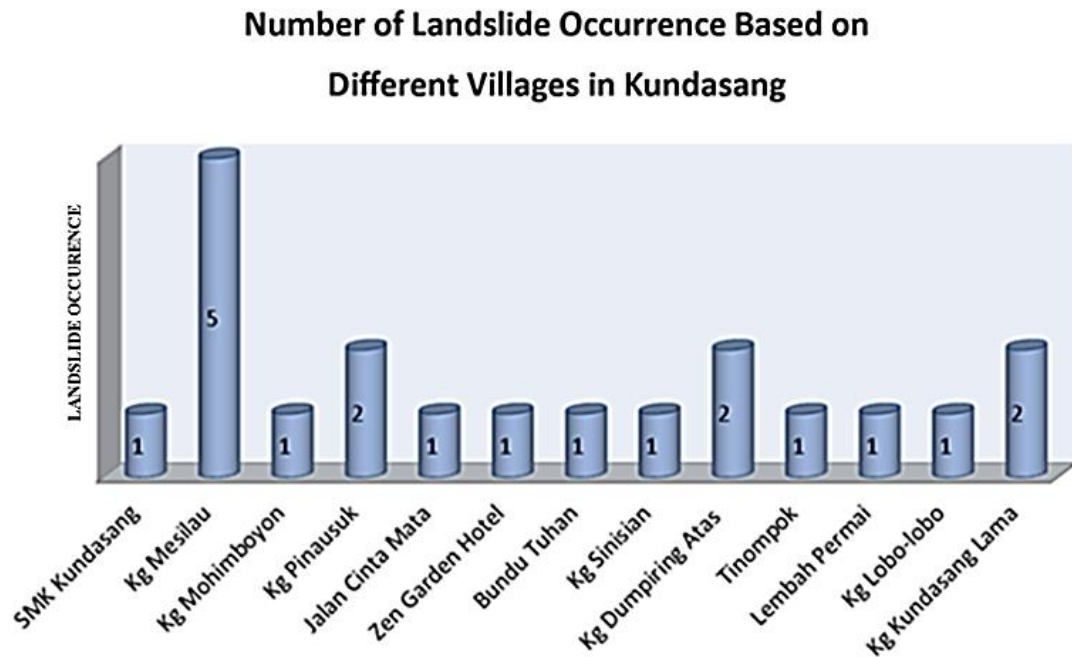
Figure 1.5: Landslide occurrence in Kundasang district based on area and villages.

Previous research has stated that in Kundasang, there have been more than 20 landslide occurrences from 1996 to 2015 (UTM PBRC, 2016). Figure 1.7 shows the distribution of landslide for the past 20 years in Kundasang district.

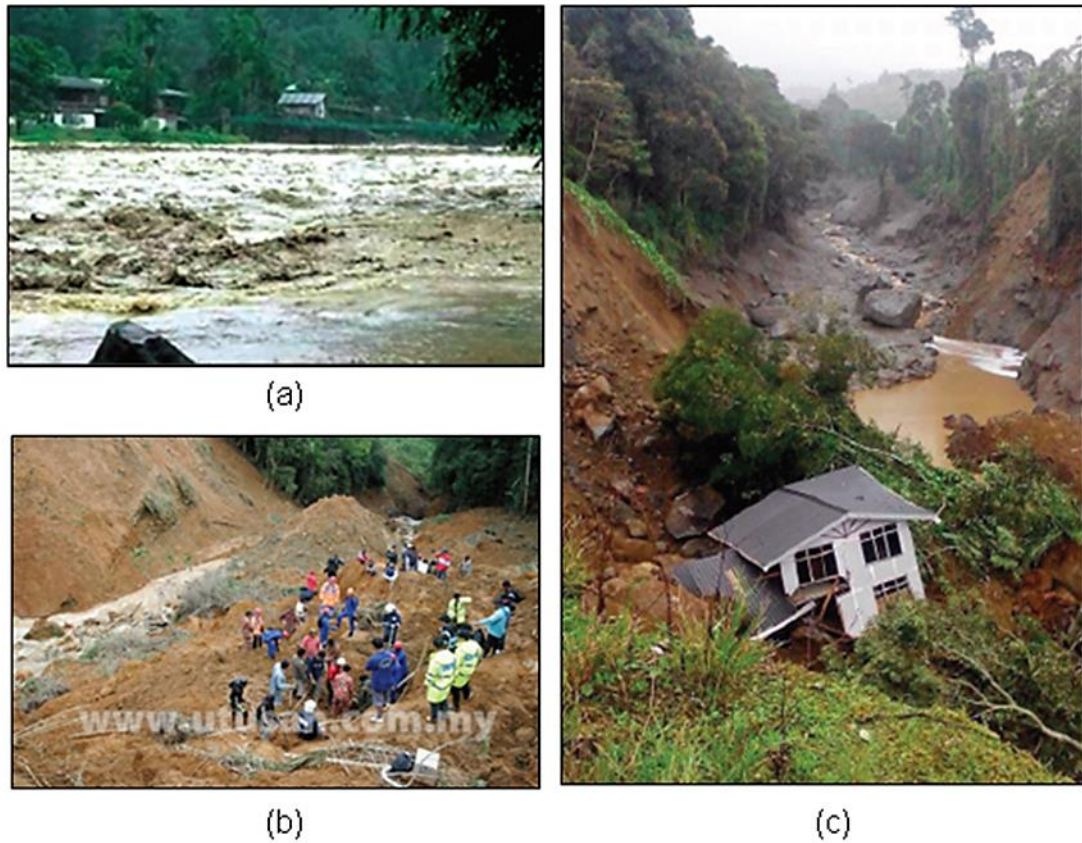
Figure 1.6: (a) Mud floods triggered by heavy rainfall in Kampung (Daily Express., 2015) (b) search and rescue operation (c) Damaged house in debris-flow channel of Sungai Mesilau (Ismayatim, 2015).

Figure 1.8 shows infrastructure damaged due to debris flow in Sg Mesilau channel. Along Sungai Mesilau channel, at least 5 events were recorded from 2008 to 2015. Most of the landslides occurred in this area due to heavy rainfall and the recent landslide that occurred was due to earthquake that occurred in Sabah, which lasted for 30 seconds. The earthquake was the strongest to affect Malaysia since 1976 (The Borneo Post, 2015, Tongkul, 2016).

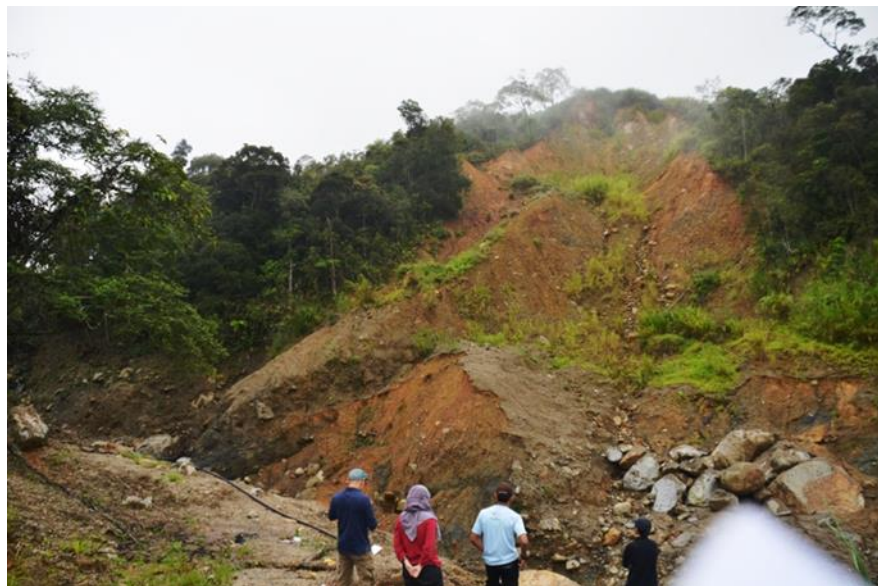
Figure 1.7: Vegetation distribution on the landslide body of Sungai Mesilau.

Figure 1.9 shows the landslide on the Sungai Mesilau channel. This landslide began in 2009 (Google Earth Pro, 2009). From the landslide area, it is shown that the landslide body is mainly covered by shrubs, which indicated the presence of water and active movement of the terrain (A.B. Orodho, 2006). The figure shows the current image of one of the active landslides that caused damage to the roads, agricultural terraces and residential area. This landslide was characterized as one of the largest landslides to have occurred along the Sungai Mesilau area
