A STUDY OF HYDROGEN EMBRITTLEMENT (HE) ON TEMPERED CARBON STEEL

ABSTRACT

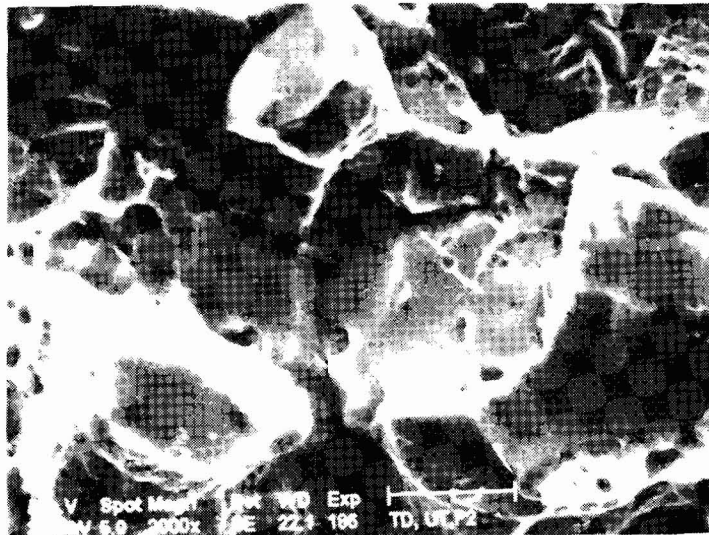
Fig. 1 SEM Fractograph of Tempered Steel at 200°C Showing a Predominantly Intergranular Fracture with Some Fine Dimples

Metallographic and fractographic investigations by SEM examination were carried out on a series of specimens, with and without corrosion environment, paying particular attention to the fracture surface characteristics as function of tempering temperature. Fractographic observations revealed more clearly the influence of the tempering temperature. Figure 1 shows that the fracture in the steel tempered at 200⁰C was predominantly intergranular. By contrast, the fracture mode in steel tempered at a higher temperature, i.e. at 500⁰C was predominantly transgranular, Fig. 2. The features shown by HE on the fracture surfaces include ductile hair lines and micropores at the grain boundaries⁷ as shown schematically in Fig. 3. These characteristic features of micropores and ductile hairlines were observed in the present study as shown in Fig. 1. Similar

Previous work [10] on the permeation of hydrogen in tempered martensite structures showed the predominance of weak traps in the tempered martensite structures, thereby providing an increased susceptibility to HE. As shown in Fig. 1 the fracture mode in the low tempered martensitic structure was predominantly intergranular with fine dimples. These dimples are evidence of some local plasticity probably around a preferred site for hydrogen adsorption such as a non-metallic inclusion. The presence of ductile hairlines in hydrogen embrittled fracture surface, due to microplastic mechanisms [10] are also evidence of some local plasticity. In martensitic steels cracking occurs mainly along prior austenite grain boundaries, probably due to i) adsorption of hydrogen on grain boundary intersections such as triple points and ii) non-metallic inclusions located at prior austenite grain boundaries [11]. However, the dominance of the brittle intergranular fracture in low tempered martensitic specimens is clearly demonstrated and it seems more likely that the only crack initiation sites in tempered martensite structure are the prior austenite grain boundaries and that failure by HE is due to hydrogen adsorption at prior grain boundaries as shown in Fig. 5. A particularly important aspect of the microstructural state of the steel is the condition of the grain boundaries. Impurity segregation and carbide precipitation at the grain boundary may significantly modify its behavior. Thus, it is very likely that there is strong interaction between tempered embrittlement (TE) and hydrogen embrittlement (HE) [12]. Therefore, it is particularly important to obtain appropriate microstructure containing as many strong finely dispersed traps as is possible without any temper embrittlement.

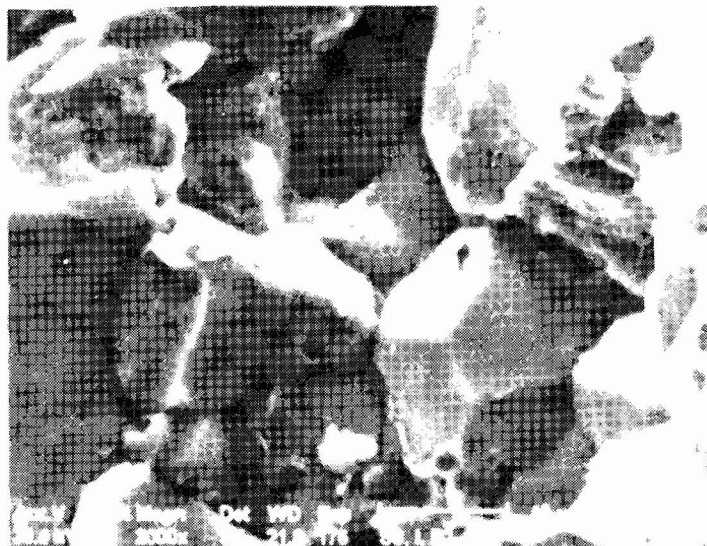
Fig. 2 SEM Fractograph of Tempered Steel at 500°C Showing a Predominantly Transgranular Fracture

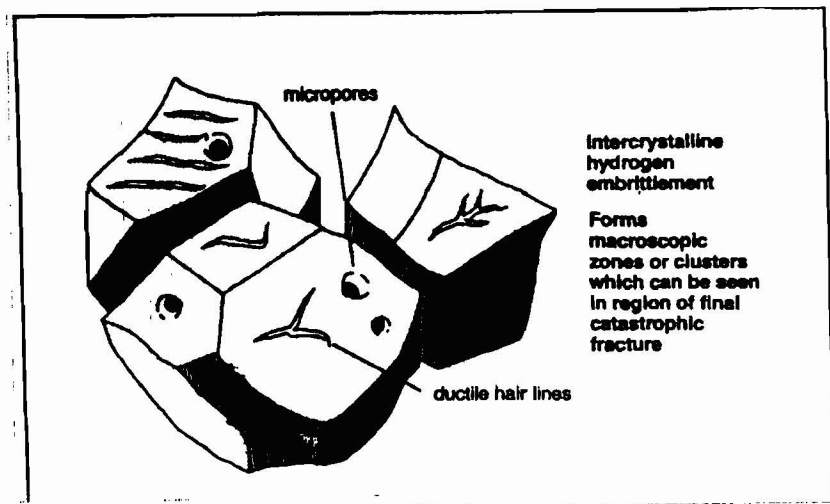
Fig. 3 Characteristic Features of Hydrogen Embrittlement (from Ref. 7)

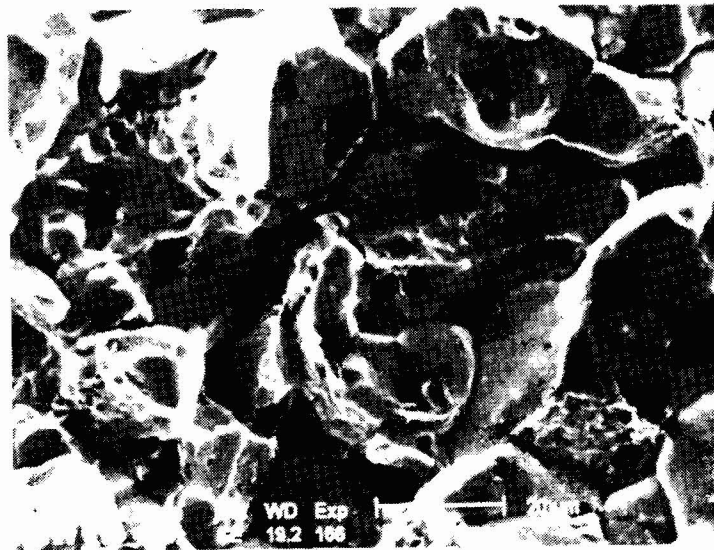
Fig. 4 SEM Fractograph of Tempered Steel at 200°C and Exposed to Saturated Sodium Chloride Solution Showing an Intergranular Fracture and the Crack Path Following the Prior Austenite Boundary

findings were also observed with the presence of a corrosive environment of both seawater and saturated sodium chloride, that is an intergranular mode of fracture at low tempering temperature and the crack path following the boundary of prior austenite phase, Fig. 4. As the tempering temperature is increased a mixed mode of fracture was observed. Such a change in fracture mode with tempering temperature has been found in low alloy steels [8, 9].

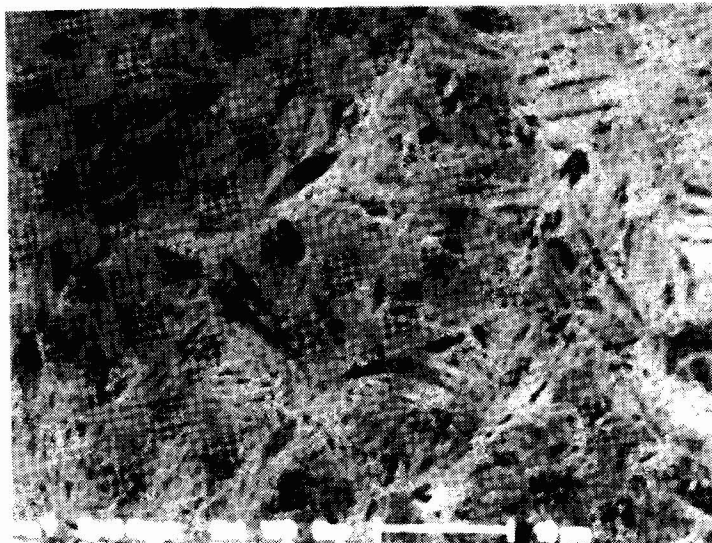
Fig. 5 SEM Micrograph Showing the Prior Austenite Grain Boundary as the Likely Site for Hydrogen Embrittlement
