MECHANICAL PROPERTIES OF CARBON NANOTUBES-MODIFIED EPOXY GROUT FOR PIPELINE REPAIR SYSTEM

Hanis Hazirah Arifin^a, Nurfarahin Zainal^a, Libriati Zardasti^{a*}, Nordin Yahaya^a, Lim Kar Sing^b, Norhazilan Md Noor^{a,c}

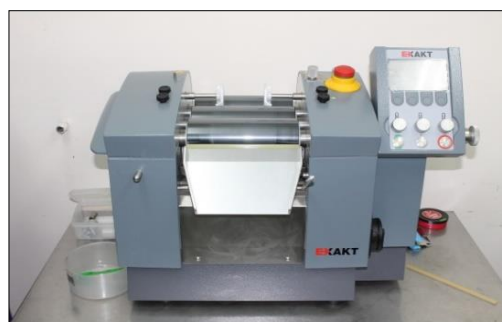
Figure 2 Dispersion process using three-roll mill machine

An appropriate dispersion technique was applied to CNTs in order to totally utilize the unique properties of this special material. Before the mixing process, these carbon nanoparticles were pre-dispersed in acetone using Hielscher Ultrasonic Homogenizers UP200s (Hielscher Ultrasonics GmbH, Germany) according to the prepared weight percentage and were left to evaporate for 24 hours at room temperature. It then underwent another dispersion using Three-roll mill EXAKT 80E (EXAKT Technologies, Inc.) with resin as shown in Figure 2. The calendaring process was applied four consecutive times. The resin with CNTs mixture was poured directly into the first roll, sheared in Gap 1, and followed by Gap 2. The sheared mixture was then manually poured back into the machine for the next process. The rollers turned at a speed ratio of 9:3:1 and the time taken for each calendaring was approximately 10 minutes. The parameter details of the three-roll mill process such as gap size between the rollers and the speed (represent the lowest speed) are tabulated in Table 1. Figure 1 and Figure 2 show the schematics and process of dispersion using the three-roll mill machine.
