Mechanical Properties of Graphene-Modified Epoxy Grout for Pipeline Composite Repair

Abstract: In general, when the pipeline experiences metal loss on the external surface, epoxy grout has always be used to fill the gap before fibre reinforced composite can be applied to recover the pipeline strength. In this research, the existing commercially available epoxy grout has been strengthened using graphene nanoplatelets (GNPs) at the amount of 0.1wt% to enhance its mechanical properties. Various mechanical tests were conducted on this modified epoxy grout to identify the compression, tensile, flexural and shear properties and were compared to the neat epoxy grout to observe its potential improvement. GNPs were dispersed using a sonication process followed by three-roll milling technique to ensure a uniform and homogeneous dispersion within the epoxy matrix can be well achieved. The experimental results clearly show an improvement in the strength and Young's modulus especially for tensile, flexural and lap shear test by incorporating GNPs as additives. The presence of GNPs has a significant reinforcement effect and has succeeded in increasing the ductility of the grout, thus reducing i

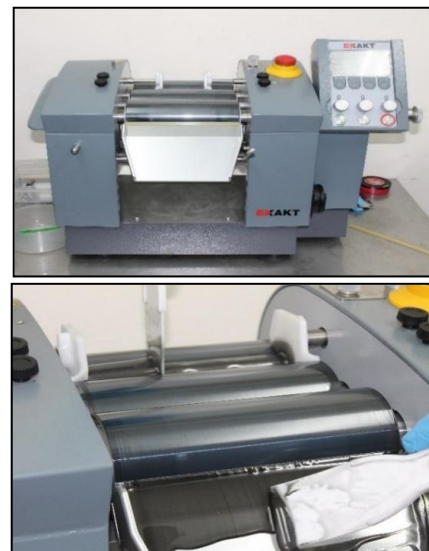
Fig. 1 Dispersion using three-roll mill machine.

A weighted amount of GNPs was prepared at the desired concentrations. First, the GNPs were pre-dispersed in an acetone solution for 45 minutes using Hielscher ultrasound sonicator and were left to evaporate for 24 hours at room temperature. Then, GNPs was mixed with resin until it was homogeneously distributed. The epoxy/GnP mixture was further dispersed using a three-roll mill machine (EXAKT 80E Advanced Technologies GmbH) to achieve homogeneous dispersion as shown in Fig. 1. The epoxy/GnP mixture was poured into the gap between the feed roller and centre roller and transported to the third roller as shown in Fig. 2. The dwell time of graphene suspension on the roll was approximately 1 minute while graphene was dispersed in the resin by enormous shear forces resulting from the rollers turning at a speed ratio of 9:3:1.

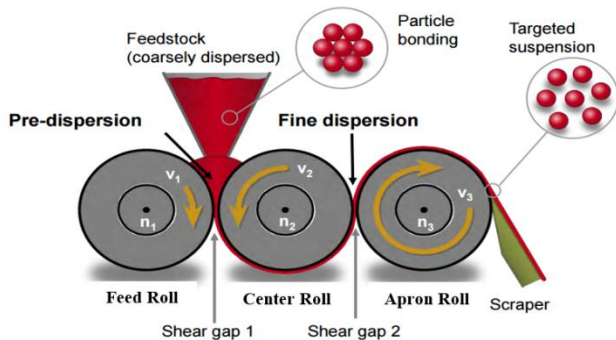
Fig. 2 Three-roll mill process (Source: EXAKT Advanced Technologies GmbH [20]).

The calendaring process was repeated for four consecutive times for each batch and the time required for each cycle was approximately 10 minutes. Details of the parameters of three-roll mill process such as the gap size between the roller and the speed (represent the lowest speed) are tabulated in Table 1. Fig. 3 shows the outcome of the dispersion process using three-roll mill machine. A homogeneous and well-dispersed mixture is a product obtained after the calendaring process was completed.

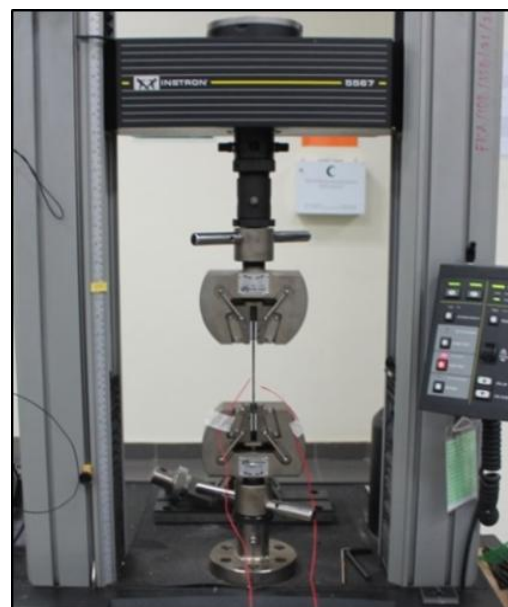
Fig. 5 Universal Testing Machine (INSTRON 5567)

Mechanical tests need to be carried out to determine the properties of modified epoxy grout and to investigate the contribution of graphene as nanofiller. INSTRON 5567 Universal Testing Machine with 25KN of capacity is used to test the specimens until failed as shown in Fig. 5.

In order to determine Young’s modulus and Poisson’s ratio, strain gauges were mounted on the surface of the compression and tensile specimens while Low Voltage Displacement Transducer (LVDT) was used in the flexural test to determine the deflection of the flexural specimen. Both strain gauge and LVDT were connected to a data logger (TDS-530) to record the strain and LVDT values throughout the testing. The reported test results are an average of five repetitive samples to ensure the consistent and reliable results. The details for tests conducted are given in Table 2. All mechanical tests were performed at room temperature and as per ASTM (American Society for Testing and Materials) standards as shown in Table 2.

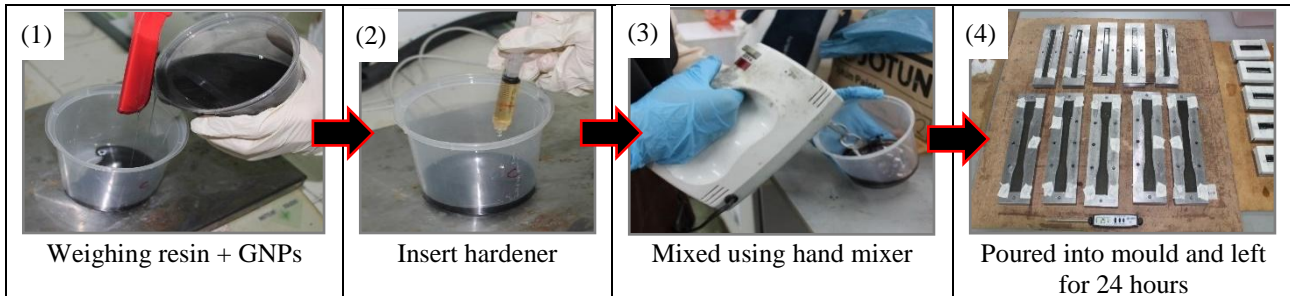
Fig. 4 Sample preparation of modified epoxy grout.

The preparation of graphene-based epoxy grouts was carried out as per manufacturer’s guideline [28]. The GNPs/epoxy nanocomposite was mixed with the hardener at the ratio of 2:1 and thoroughly mixed using an electric hand mixer at a lower speed for one minute to assure the mixture was well blended. The mixtures were cast into the designated mould and were cured at room temperature for 24 hours. The neat epoxy grout was prepared by the same procedure without adding nanomaterial. Prior to testing, all specimens were polished to eliminate any impurities and surface defects. Fig. 4 shows the sample preparation of the modified epoxy grout.

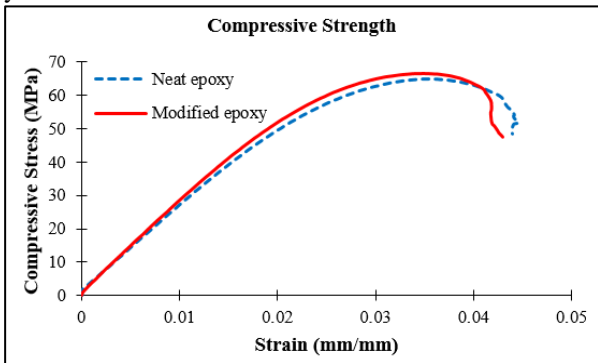
Fig. 6 Stress-strain curve for compression test

The stress-strain curve under a unidirectional compression load was depicted in Fig. 6. All grouts showed comparable strain value with similar behaviour to one another starting with linear elastic behaviour during the initial loading stage until it reaches ultimate compressive strength, followed by a strain softening and plastic deformation. Based on the graph, both grouts demonstrated ductile behaviour and no sudden failure occurs. Fig. 7 presents the failure patterns of the tested grouts. After the initial elastic behaviour, both grouts exhibit ductile behaviour with visible deformation. The specimen exhibit buckling and initial crack when the maximum stress occurred, and then the stress is gradually reduced prior to failure. This failure pattern can be seen at the top and bottom of the specimens for both grouts.

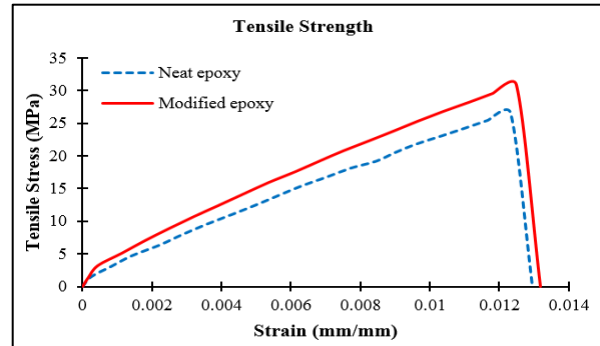
Fig. 8 Stress-strain curve for tensile test

Tensile properties of the test are summarized in Table 4 and Figure 8 illustrates the stress-strain curve under tensile loading conditions. Based on the results, the tensile strength of the modified epoxy grout is found to increase with the inclusion of 0.1wt% graphene nanoplatelets. A maximum increment of 24% in the tensile strength of modified epoxy grout is observed with 32.64 MPa as compared to neat epoxy grout with 26.42 MPa. It can also be noticed that graphene nanoplatelets has improved the tensile modulus of the neat epoxy grout. A gain of 14% in the tensile modulus is observed in the modified epoxy grout from 2.21 GPa to 2.52 GPa. As depicted in Fig. 8, the stress-strain curve for all grouts demonstrated comparable behaviour where linear elastic behaviour was observed from the beginning of the testing until the specimens reach ultimate tensile strength up to failure, indicating the brittleness of the grouts.

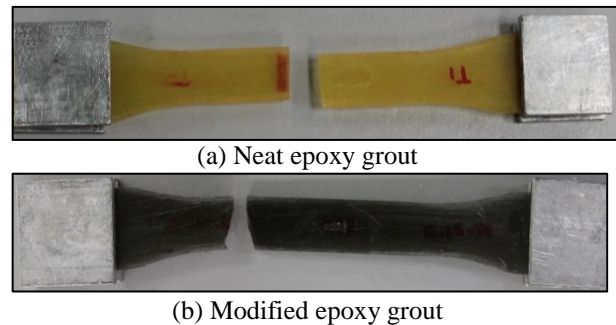
Fig. 9 Tensile specimens after failure

Besides that, it shows that the strain value of the neat epoxy grout is slightly lower than the modified epoxy grout. Fig. 9 shows failure pattern for the tensile test. All the specimens failed due to fractures that break the specimen into two part without any noticeable deformation or necking.

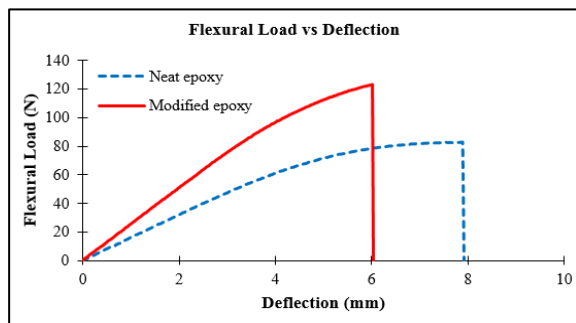
Fig. 10 Load-deflection curve for flexural test

Fig. 10 presents a comparison of the load-displacement curve for flexural specimens. Both tested grouts show linear elastic behaviour prior to failure. The modified epoxy grout exhibited higher flexural load but slightly lower in deflection and this behaviour is contrary to the neat epoxy grout with lower flexural load but has higher deflection value. Under flexural load, the incorporation of GNPs into the epoxy grout increases the surface area to volume ratio. GNPs has the capability of high endurance to deform during loading, thus enhances more loading ability and increasing the stiffness of the epoxy grout while decreased its deflection. The failure pattern of the neat and modified epoxy grout was presented in Fig. 11. It is observed that all grouts show similar failure pattern under flexural test with relatively prolonged deformation. The specimens were observed from the beginning of the test until the failure occurred and based on the observation, it showed that the crack formation was initiated at the middle of the specimen and forms a visible wedge.

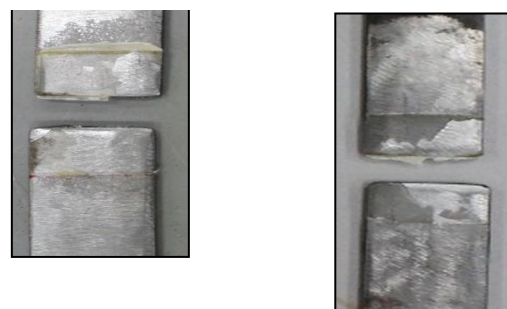
Fig. 12 Failure pattern of shear test

It shows that the inclusion of graphene nanofiller gives a higher shear bonding compared to grout without nanofiller. In addition, the modified epoxy grout shows the highest load during failure recorded at 2.06 kN while the neat epoxy grout failed at load 1.86 kN. Figure 12 presents the failure pattern of the tested grouts. As depicted in the figure below, both grouts show similar failure pattern as some parts of the matrix remains attached to both surfaces of the steel coupons, indicating cohesive shear failure. This behaviour implies that the bonding between the matrix and the steel coupon is much stronger than the strength of the matrix itself [33].

(a) Neat epoxy grout

(b) Modified epoxy
