INSULATION ASSESSMENT OF HIGH VOLTAGE OIL IMPREGNATED
PAPER BUSHING AND RESIN IMPREGNATED PAPER BUSHING

A project report submitted in partial fulfilment of the
requirements for the award of the degree of
Master of Engineering (Electrical Power)

School of Electrical Engineering
Faculty of Engineering
Universiti Teknologi Malaysia

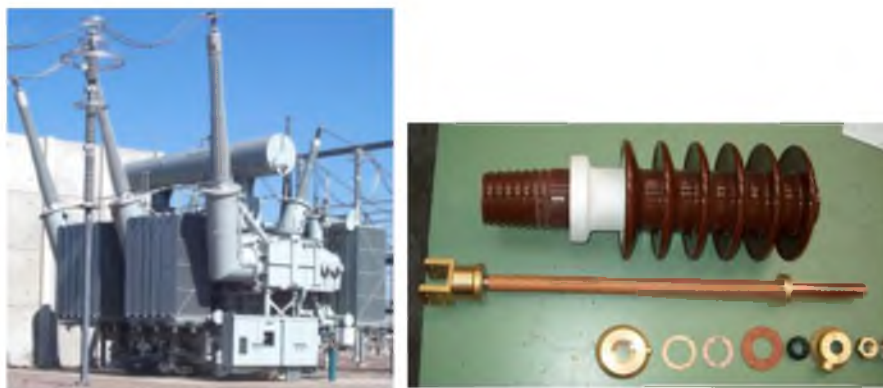
Figure 1.2 Power transformer HV and LV bushing

Figure 1.2 shows power transformer HV & LV bushing installed. Different power utilities have adopted various methods monitoring to ensure the healthy condition of this power equipment. Solid insulation paper impregnated with transformer oil work as the chief insulation component in the condenser bushing. Hence ageing of pure (cellulose) paper becomes important aspect in judging the life of high voltage bushing [2]. Operating records show that about 90% of all preventable bushing failures are cause by moisture entering the bushing through leaky gaskets or other openings [3].The moisture can root to reduction of the dielectric strength and could be further lead to discharges or tracking which may bridge the insulation at over-voltage/transient stress during the event.
