Performance of ralumac micro surfacing at blackspot eastbound, LATAR highway

S Salleh*¹, R Muhamad¹ and M H Abdillah²

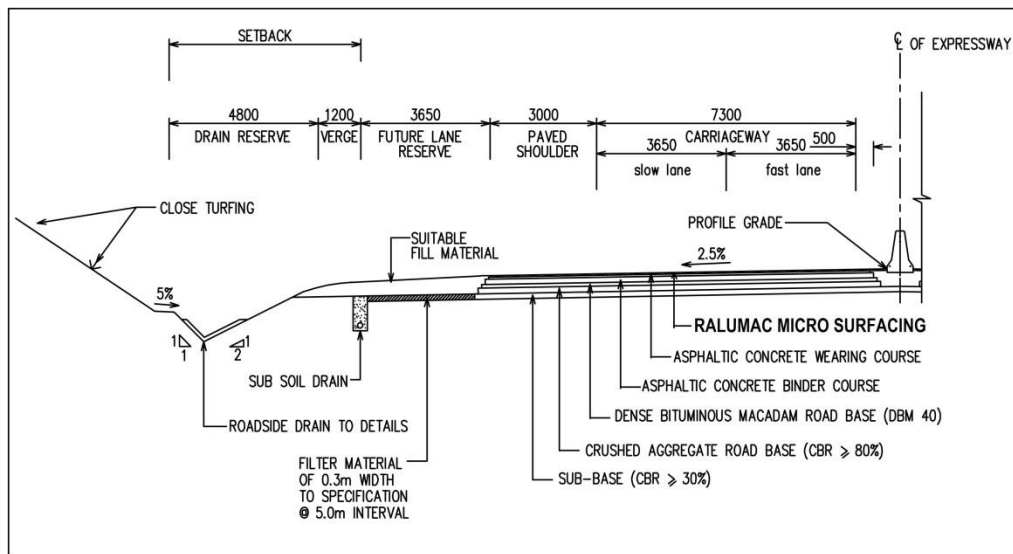
This study has been carried out to determine the performance of Ralumac Micro surfacing system at blackspot KM23.7 Eastbound, LATAR highway. These performance tests are roughness, rutting and skid resistance. Evaluations have been measured on the Ralumac Micro surfacing installed at slow lane and fast lane from KM23.7 to KM24.1 LATAR highway as illustrated in Figure 1.

Figure 1. Pavement cross section at KM23.70 Eastbound, LATAR highway.

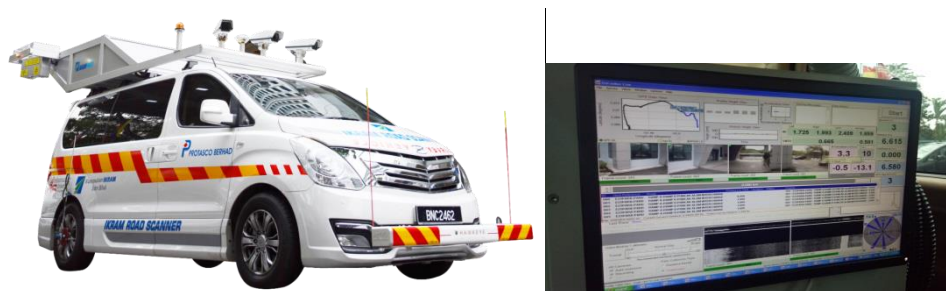
IRI and rutting are measured by the Road Scanner as shown in Figure 2 along the pavement lanes [2]. Road Scanner is able to capture pavement functional condition data, survey mapping information and roadside asset details whilst travelling at highway speed. This fully-featured vehicle contains a compact workstation capable of capturing and storing individual data elements for texture and surface condition, as well as providing high-detail video images of road and road side assets along the LATAR highway.

Figure 2. Road Scanner.

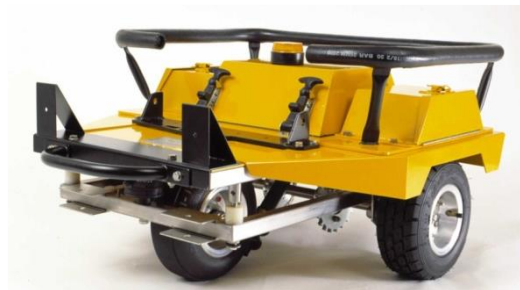
The sideway-force coefficient routine investigation machine (SCRIM) was developed by Transport Road Research Laboratory (TRRL) in the UK in the early-1970s and is frequently used in Europe and other parts of the world. A test wheel, mounted mid-machine in line with the nearside wheel track and angled at 20° to the direction of travel, is applied to the road surface under a known load. During a test run, a controlled water jet wets 0.25 mm thick water film the road surface immediately in front of the test wheel, so that when the vehicle moves forward, the test wheel slides in a forward direction on a wet road surface while rotating freely in its own plane. The force generated by the resistance to sliding is related to the wet skidding resistance of the road surface. The measurement of this sideways component allows the sideway-force or SCRIM coefficient to be calculated. The usual test speed is 50km/h [5]. Skid resistance at KM23.7 Eastbound was performed using the Grip Tester (GT) accordance to ASTM E 1844 (test tire specification) as illustrated in Figure 3. The information surveyed by GT was process and the Grip Number was converted to SCRIM value by the following relationship:

$$SCRIM\ value = 0.85 \times Grip\ Number \tag{1}$$

Figure 3. Grip Tester (GT).

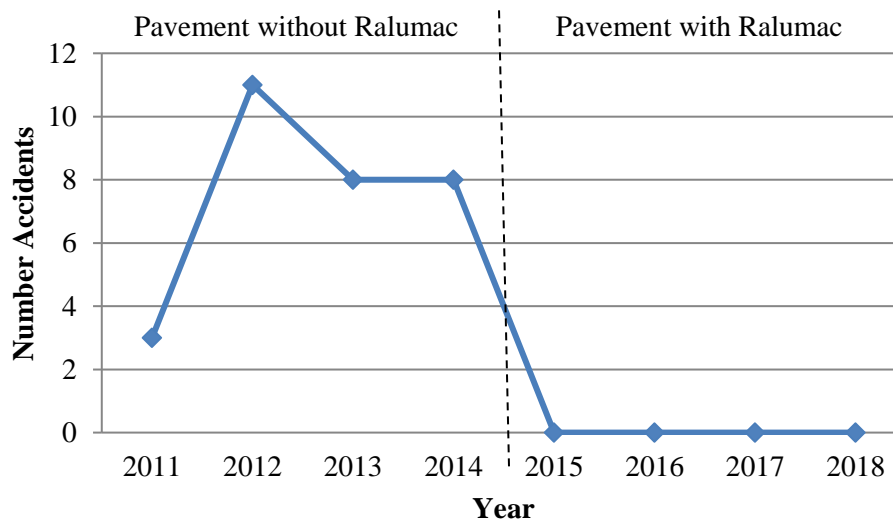
Figure 4 indicates sharp decline on traffic accidents at blackspot KM23.7 Eastbound LATAR since the Ralumac Micro surfacing had been installed in May 2014. Based on the test results, this achievement were mainly contributed from higher frictions of Ralumac Micro surfacing. Other studies also indicate improvement on pavement friction were found to yield significant reductions in wet-pavement crash rates averaging 68% [12]. The skid resistance of Ralumac Micro surfacing have shown uptrend meanwhile downtrend for roughness and rutting. The downtrends performances of roughness and rutting were not impact to the road user safety at this moment as the test results are still above the MHA's requirement.

Figure 4. Traffic accidents at blackspot KM23.7 Eastbound, LATAR.
