# Degradation of limestone exposed to drying and wetting cycles – experimental study

**Abstract.** Degradation of rock is the deterioration of the rock forming materials and the reduction of strength and stiffness within time. It is responsible for the failure of rock slopes and landslides as the drying and wetting cycles in long-term will extensively reduce the strength of the rock and eventually end up as a soil-like material. Weathering rate is very crucial, and it is the main parameter inducing and accelerating degradation of rock. This study focuses on investigating and evaluating the effect of degradation on cored samples of limestone. Limestone was collected from the state of Perak, Malaysia and the samples were cored, trimmed and cut into 50 mm diameter and 80 mm height. A total number of 30 samples were exposed to different number of drying and wetting cycles in the laboratory. A total number of 27 samples were tested using the Uniaxial compression test after 0 – 14 cycles while three samples were exposed to exactly 14 cycles to observe the reduction in weight. The results showed the strength of limestone to decrease gradually with the increment of drying and wetting cycl

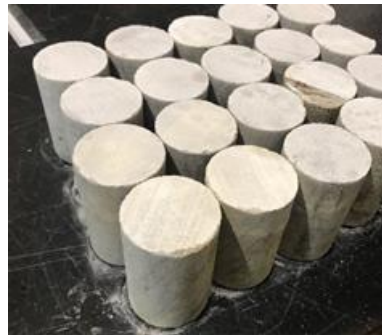
**Figure 1.** Cored limestone samples

Samples of limestones were collected, transferred, and stored in the laboratory. The preparation of the samples started by coring the limestone blocks into a uniform size of 50 mm diameter and 80 mm height. The dimensions and weight of the samples were checked at the end of the coring processes and the cored limestone samples are shown in Figure 1. Following the coring of the samples, samples were saturated

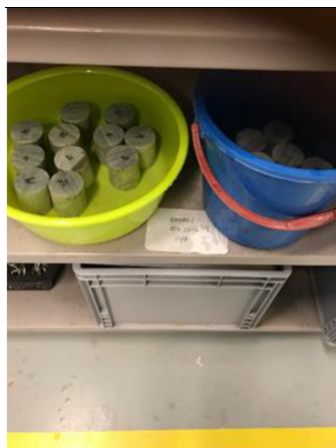
**Figure 2.** Wetting process of limestone cored samples

and submerged in water for a minimum period of 24 hours. This step is attempted to simulate the wetting process during the rainfall in the real environment. Then, the samples were oven-dried in the oven for another 24 hours at 105 °C in order to simulate the hot weather at the field. Samples were left to cool down in the room temperature for a period of 12 hours and then the processes was repeated for the required numbers of wetting and drying cycles. Figures 2 and 3 shows the samples exposed to the wetting and drying processes respectively.

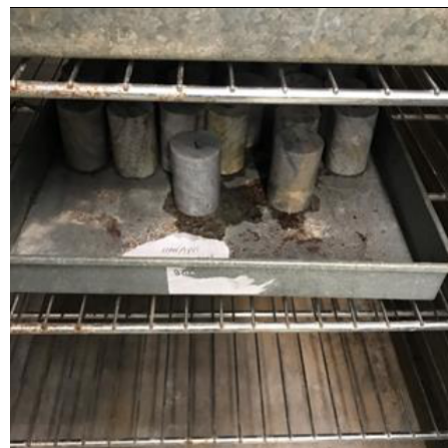
**Figure 3.** Drying process of limestone cored samples

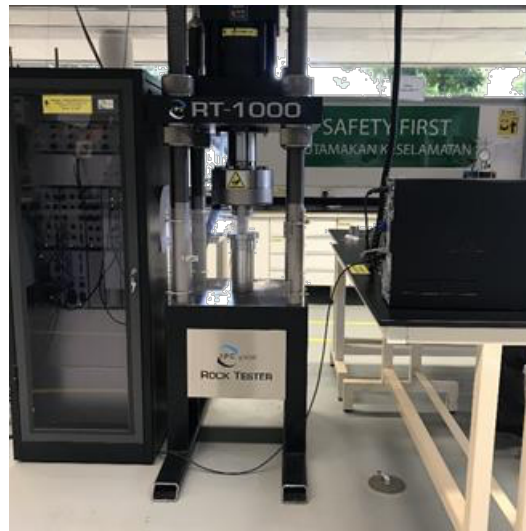
**Figure 4.** Uniaxial compressive test machine used for testing

The uniaxial compressive strength test was used to test the strength of the samples after being exposed to the required numbers of wetting and drying cycles. During the uniaxial compressive test, the load was applied vertically and the sample was loaded until failure and the peak strength was recorded. Figure 4 shows the uniaxial compressive strength machine used for the testing. Samples were tested under the uniaxial compression test at 0 wetting and drying cycles and also at 2<sup>nd</sup>, 3<sup>rd</sup>, 5<sup>th</sup>, 6<sup>th</sup>, 8<sup>th</sup>, 9<sup>th</sup>, 13<sup>th</sup>, and 14<sup>th</sup> cycles of wetting and drying. On the other hand, samples were also subjected to weight degradation test at which the reduction of weight after 0, 1, 2, 3, 4, 5, 6, 7, 8, 9, 10, 11, 12, 13, and 14 cycles was recorded and analysed.

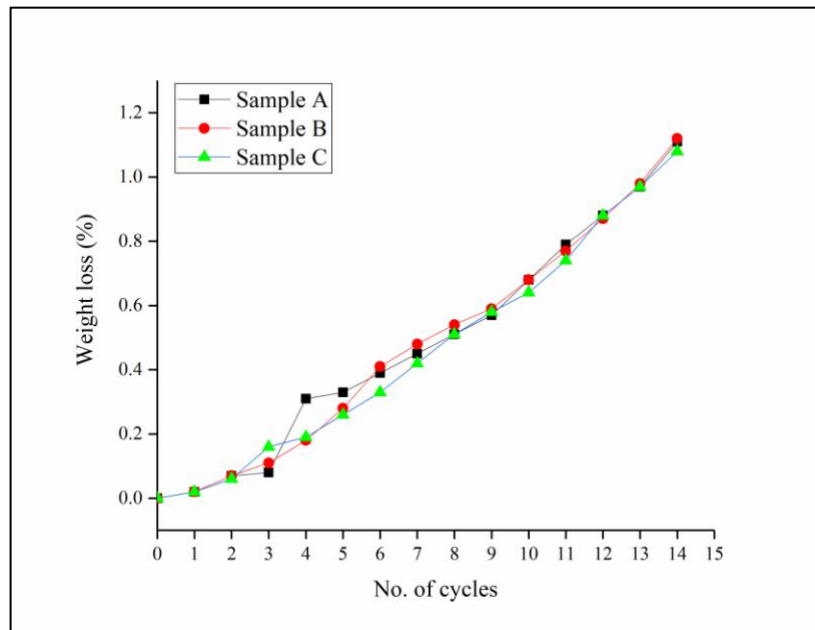
**Figure 5.** Weight loss of limestone samples versus the number of wetting and drying cycles

Moreover, Figure 5 shows the degradation of strength by the increase of the wetting and drying cycles. The Figure reveals almost linear relationship between the weight lost and the number of wetting and drying cycles. When the number of cycles was increased, the reduction of weight was increased. When comparing the weight reduction of samples A, B, and C, it is clearly seen that they had a similar trend and the difference was very minor. Those results simulate the degradation of limestone rock at site due to the rainfall and high temperatures events. Similar observations were found by Labus and Bochen [12] who tested the degradation of sandstone under accelerated weathering. It was found that the sandstone samples were deteriorated as a result of the experiment and was associated by weight reduction.

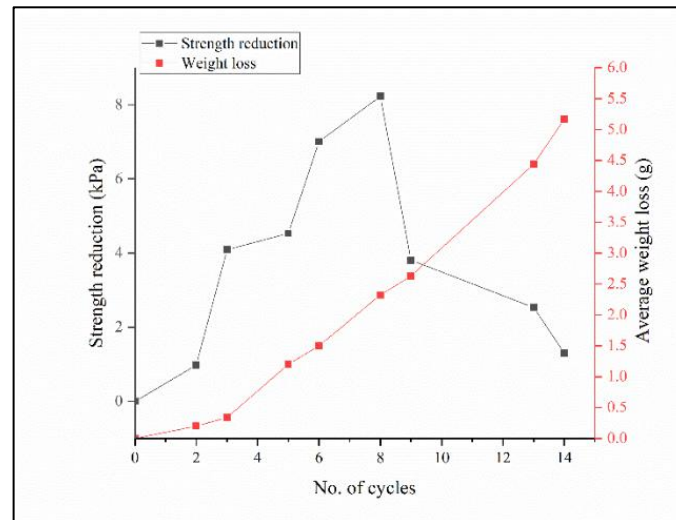
**Figure 8.** Strength reduction and average weight loss of limestone samples versus the number of wetting and drying cycles

The uniaxial compressive strength test was used in this study to assess the reduction of the strength in samples subjected to various numbers of wetting and drying cycles compared to the control samples which was not subjected to any cycle. Table 3 shows the testing program and detailed results of all the limestone samples tested in this study. A total of 27 limestone samples were tested under the uniaxial compressive strength test as shown in Table 3. Samples subjected to higher number of wetting and drying cycles had a significant weight loss due to degradation. Three samples were subjected to the same number of cycles in order to have an average value of the strength and weight reduction. Figure 6 shows the average compressive strength of all the limestone samples versus the number of cycles. It can be observed from the Figure that the average compressive strength of the control samples that were not subjected to the weathering cycles was 108.28 kPa. The average compressive strength of samples subjected to weathering cycles was reduced with the increased number of cycles. Similar results were obtained by Qin et al. [13] who investigated the damage of rock under drying and wetting cycles. Besides, Figure 7 shows the strength reduction versus the number of weathering cycles. It can be seen that the strength was decreased with the increased number of cycles until reaching cycle number 8 where the rate of the strength reduction was decreased rapidly. This can be explained as the surface of the rock sample is considered severely weathered due to the increased number of cycles and the surface materials are degraded when subjected to the weathering cycles ranging from 1 to 8. Weathering cycles after the cycle number 8 started to affect deeper surface material that is still considered strong and require higher number of cycles in order to degrade it. Therefore, long term degradation can only be achieved by applying higher number of weathering cycles. Figure 8 shows a comparison between the strength reduction and the average weight loss of samples. The reduction of the strength and also the weight loss

were increased with the increased number of cycles until cycle number 8 at which the rate of strength reduction was decreased while the weight loss continued to increase. This explains the reason behind the reduction of strength after cycle number 8. As the weight continued to decrease, this proof that the surface layers were degraded at the earlier 8 cycles and further cycles started to degrade new core layer. This new layer will require another round of wetting and drying cycles in order to deteriorate its materials. Yang et al. [14] tested the effect of weathering cycles on rock samples and found continuous decrease of the strength with the increased number of cycles.
