# Non-Destruction Method for Detecting Corroded Underground Pipe Using Ground Penetrating Radar

**Abstract.** Ground-penetrating radar (GPR) is a geophysical method that can accurately map the spatial extent of near-surface objects or changes in soil. It also produce radargram of those features. The demand for underground utility mapping in Malaysia is increasing rapidly for construction and non-construction activities. However, implementation of GPR in detecting corroded underground pipe in Malaysia can considered unpopular due to less exposure and exploration. Over the time, underground utility pipe will undergo corrosion process. Thus, is it relevant to detect old corroded pipe using GPR? On this basis, the aim of this experimental study was to validate the condition of corroded pipe by comparing its radagram profiles and to evaluate the significant signal reflectivity which were tested on three different pipe condition, namely new, average and old corroded pipe. The result of GPR calibration and data on GPR were processed using Reflex 2D software. In this study, with the aid of Time-Domain Reflectometry (TDR) sensor was used to obtain the soil moisture as it is one of the bigg

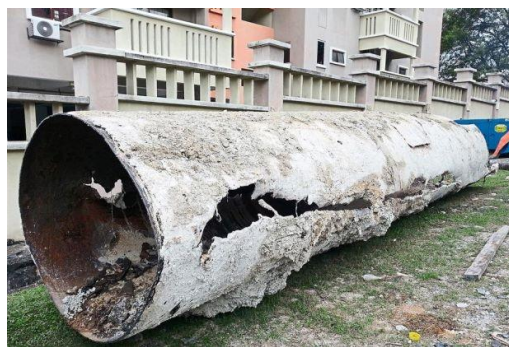
**Figure 1.** Old sewerage after the excavation in Puchong. (Source: The Star newspaper)

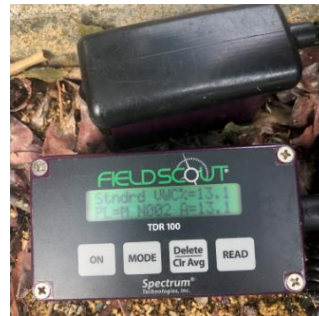
**Figure 7.** TDR sensor.

For this study, the RIS HI-MOD GPR is used. This equipment used with its dual frequency 400 MHz and 900 MHz antenna systems. Time domain reflectometry sensor (TDR 100) with rods from FieldScout Company was used to perform soil moisture measurement in research area.

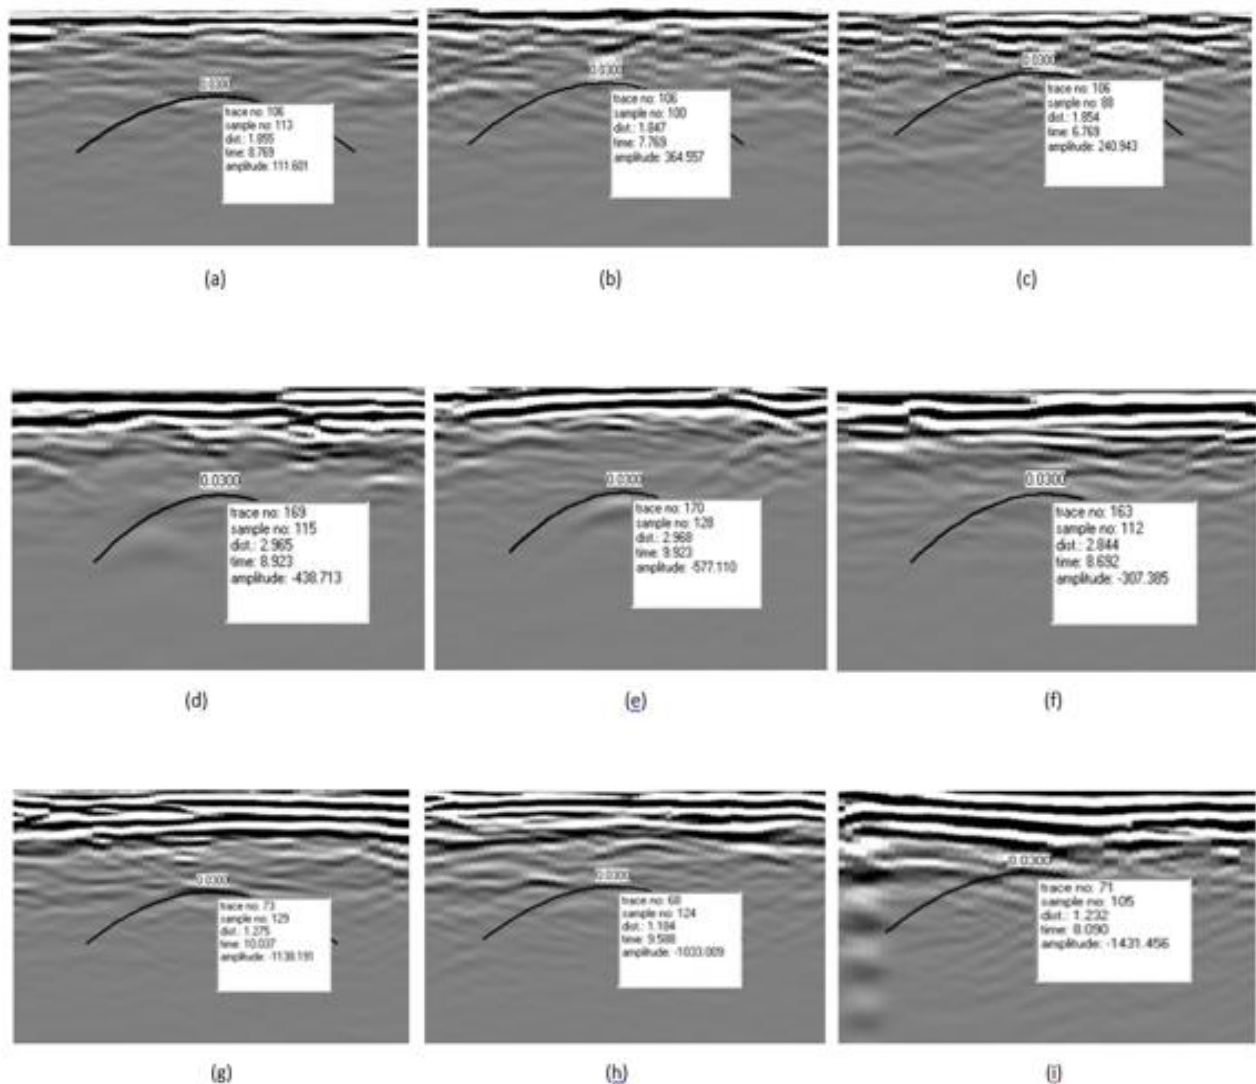
**Figure 11.** B-scans for three types of underground pipes conditions which are (a)-(c) for new pipe, while (d)-(f) for average pipe and B-scans (g)-(i) is the corroded pipe.

These GPR radargram profiles from three types of underground pipe conditions were shown with the same dimension of area which was 8.0 x 3.0 m. It was taken with the same dimension in order to keep it as a constant variable. Three B-scans from each pipe conditions were best-picked due to its better resolution with 400 MHz Tx, which helps to make analysis of this study more realistic and understandable.

Based on figure 11, after each radargram profiles from different conditions have been processed, the quantitative comparison can be made for each pipes condition. It is noted that once the signal travelled underneath, hit or meet the initial part of the pipes, it gives value of signal reflectivity. In other

words, with appropriate GPR formula, user can determine the actual depth of the pipe from its signal reflectivity.

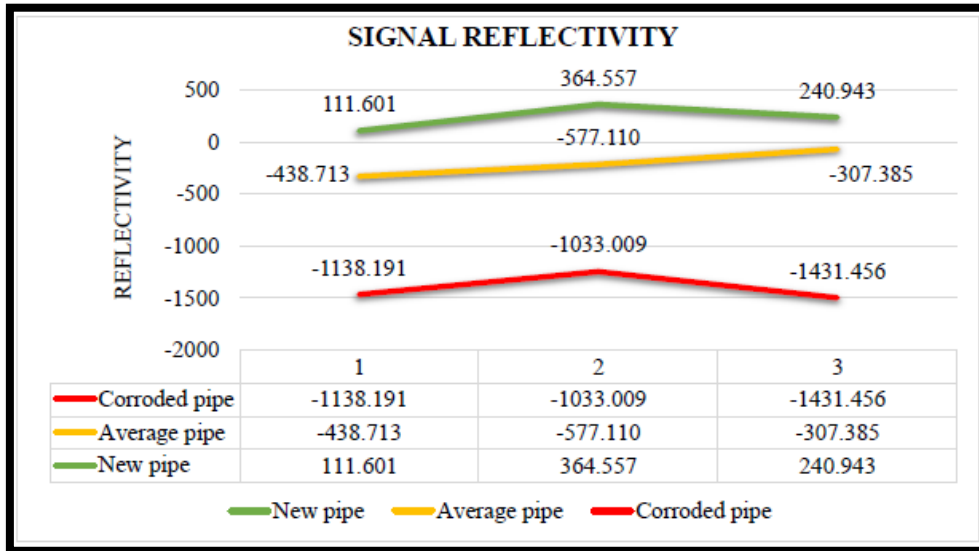
**Figure 12.** Graph of signal reflectivity of three B-scans from different type of underground pipe conditions. Note that reflectivity is unit less.

From line chart shown in figure 12, it is a graph that shows GPR signal reflectivity for different underground pipe conditions. For new condition pipe (green line) shows positive value of reflectivity of signal as compared to those two pipe conditions which it was ranged between 100 to 250. Average and old corroded condition pipe shows negative value of reflectivity which were range between -300 to -600 and -1110 to -1450 respectively.
