Building Condition Assessment (BCA) on school building in Sabah, Malaysia

Abstract. The standard guideline for Building Condition Assessment (BCA) [7] has been introduced by Public Work Department of Malaysia to manage the government's building in Malaysia especially in Peninsular Malaysia. Whereby, BCA has never been implemented in Public Work Department of Sabah. Since there is so many buildings need to be maintained especially existing school building, it is the right time to introduce a systematic assessment method for managing the maintenance work. Visual inspections for the selected building have been done with reference to Standard guideline for Building Condition Assessment (BCA) [7] by Public Work Department of Malaysia. Building Condition Assessment online system (BCA-OS) by Universiti Teknologi Malaysia Forensic Centre was used to analyse the existing physical condition of the building in order to determine the rating of the buildings. By using this system, the building will be rated 1 (good) to 5 (critical). Material testing will be conducted to building with rating 3, 4 and 5. This paper will discussed the results obtained from Building Condition Assessment online sys

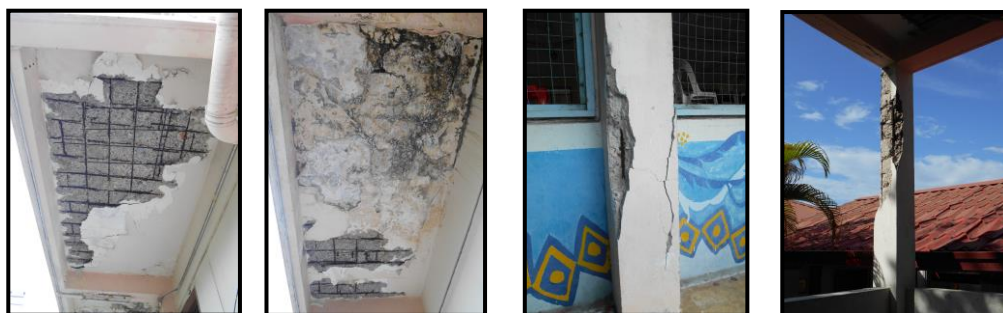
Hostel Block in School A has the most concrete spalling problem, with exposed corroded reinforcement bar. Meanwhile, for Block A and Block B of School B, most of the defects found were shear crack and flexural crack. Figure 2, Figure 3, Figure 4 and Figure 5 shows some of the defects photos taken during visual inspection.

Figure 2. Photos of ceiling and column defect.

- 1) The outcome from the visual inspection are clearly shows that both school need to be repaired or rehabilitated. Most of the concrete structures in both of the schools have undergone deterioration process and the defects found were concrete spalling (ceiling and beam), corroded reinforcement bar, cracks on beam, slab and column. School B have the least concrete spalling problem but it has shear crack and flexural crack shows on the main beam. Further investigation on the building structure design has to be conducted to identify the root cause of the cracks and the remaining life cycle of the building for safety reason.

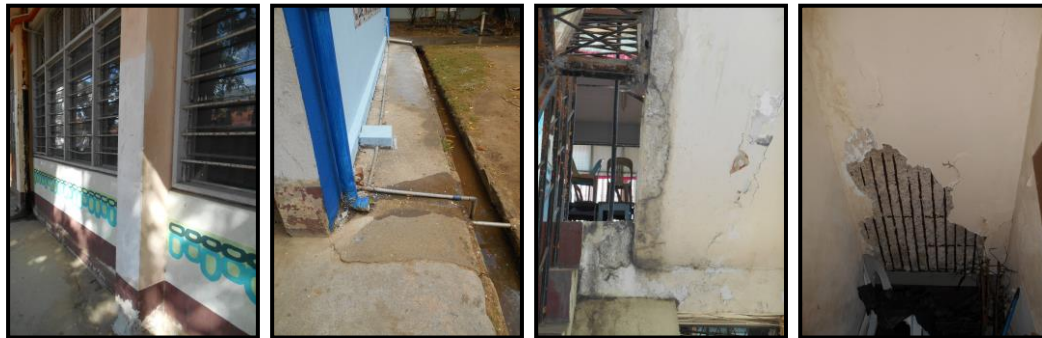
Figure 3. Photos of settled apron and staircase defect.

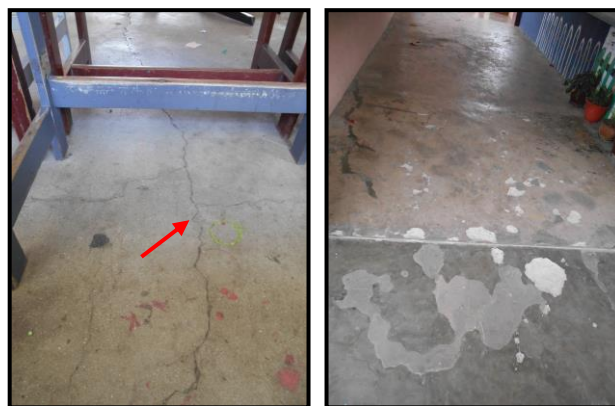
Figure 4. Photos of slab defect.

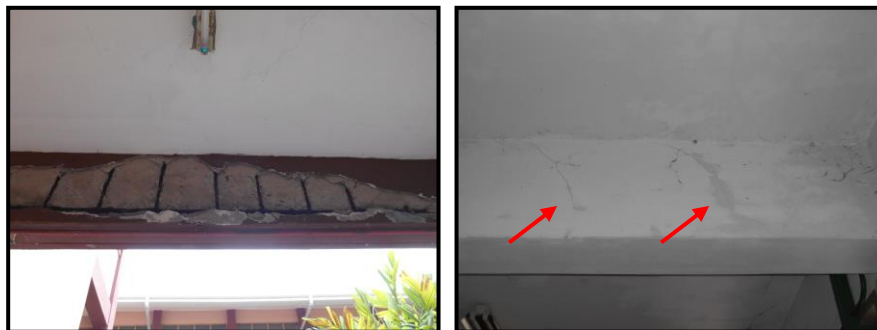
Figure 5. Photos of beam defect.

The result from the Building Condition Assessment online system shows that Block A and Block B of School B is at the rating 2 and no further investigation was proposed. By judging from the observation from visual inspection, it was detected that the respective building's main beam has shear crack and flexure crack that need to be closely monitored and investigate. This kind of crack is the sign shows that the building is under distress. Due to this reason, it is recommended for future study to improve the building assessment system so that any sign of structural crack that can lead to structural failure can be detected in the system even though the user of the system is a layman or have a minimal basic knowledge on structural design.

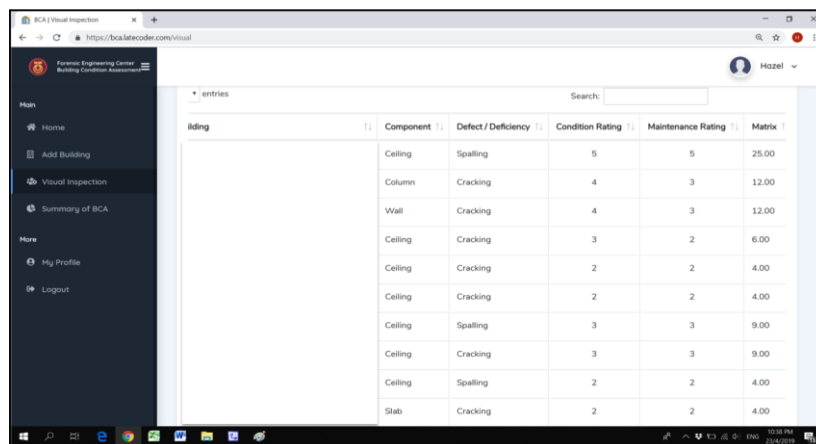
In this study, there are four numbers of buildings were inspected and need to be rated. Figure 7 shows the summary of condition rating, maintenance rating and matrix in uploading all the photos and information into BCA-OS. While Figure 8 shows the summary of BCA-OS, it shows that Block A and Block B of School B were in the rating number 2. Classroom Block and Hostel Block of School A were in the rating number 3.

Figure 7. Summary of condition rating and maintenance priority rating.

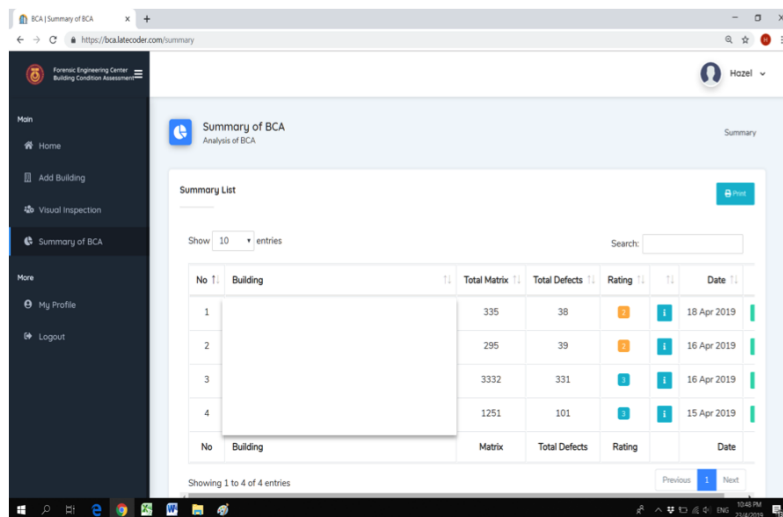
Figure 8. Summary of Building Condition Assessment.

The calculation for the rating of the building is tabulated in Table 6 by using the reference from Figure 8. In BCA-OS, the ratings of the buildings were identified as in Table 7. In Building Condition Assessment online system (BCA-OS), the rating is using numbering system, which is 1 to 5 (very good to very critical). While in Public Work Department manual for building inspection and rating for existing building [7], the rating is using alphabet system. The rating is from A to E (very good to very poor). Table 8 shows the overall conclusion on the rating system in BCA-OS.

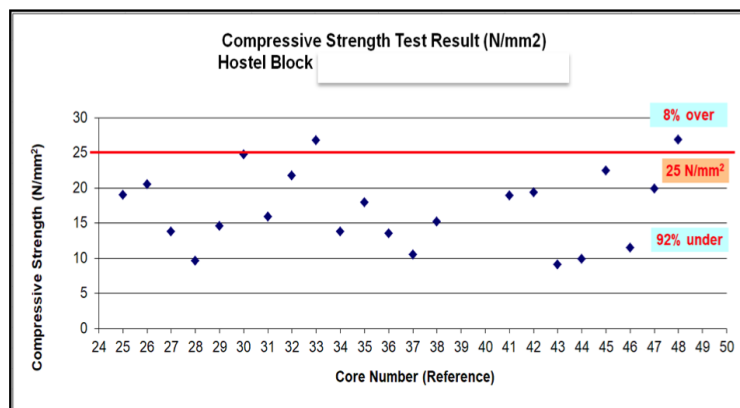
Figure 10. Compressive strength test result for Hostel Block.

The core compressive strength ranges from 4.7 N/mm² to 31.2 N/mm² obtained from the results shown in Figure 9 and 9.1 N/mm² to 26.9 N/mm² in Figure 10. The average cube strength is 13.9 N/mm² for Block Classroom and 17.1 N/mm² for Block Hostel. Only one (1) sample was found to have concrete strength above 25 N/mm² for Classroom Block and two (2) samples for Hostel Block. It is core number S-24, S-33 and S-48. The values are 31.2 N/mm², 26.8 N/mm² and 26.9 N/mm².

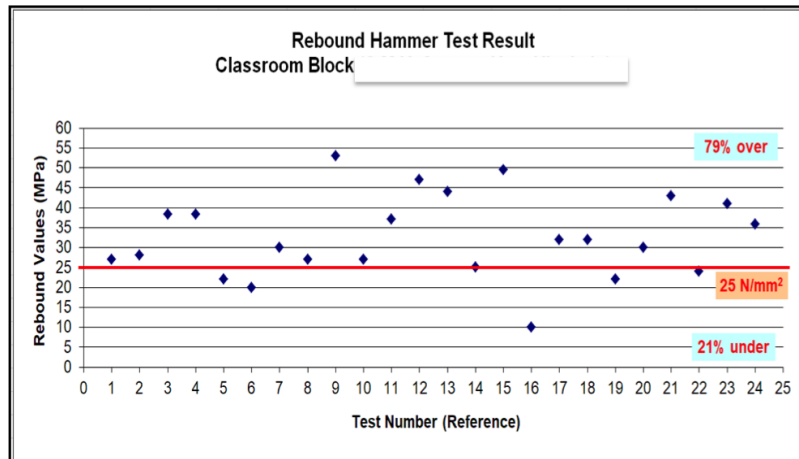
Figure 13 and Figure 14 shows the result of rebound hammer test of Classroom Block and Hostel Block. Based on the result, 21% of the total test have rebound value less than 25 N/mm² for Classroom Block and 21% of the total test have rebound value less than 25 N/mm² for Hostel Block.

Figure 13. Rebound hammer test result for classroom block.
