Alternative design of pipe sleeve for liquid removal mechanism in mortar slab layer

To cite this article: W M H Wan Nazri *et al* 2017 *IOP Conf. Ser.: Mater. Sci. Eng.* **271** 012024

W M H Wan Nazri¹, N Anting¹, A J M S Lim², J Prasetijo³, S Shahidan¹, M F Md Din⁴ and M A Mohd Anuar¹

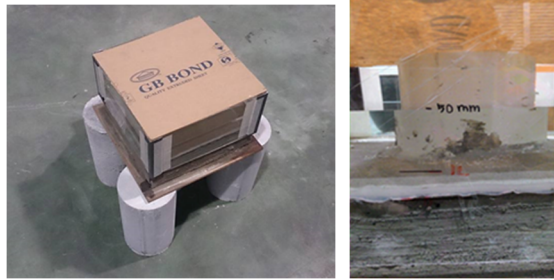
There are two main parameters have been conducted in this study which are infiltration and flow rate. The infiltration test was conducted to obtain the infiltration rate of water that penetrates in mortar layer that installed with 5 varieties design of the MPS. Three liters of water were pond on the mortar surface in a period of 12 hours and the result was recorded for every 30 minutes. Figure 2 reveals the infiltration rate test.

Figure 2. Infiltration test.

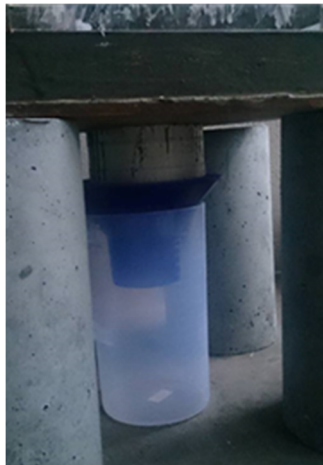
The flow rate test was conducted to determine the flow rate of water that drain out from the mortar layer through MPS. It is conducted simultaneously with infiltration test. Water pond that penetrates into the mortar layer will be drained out through the MPS. The drained out water then will be collected and measured. The test was carried out for 12 hours and the result was recorded for every 30 minutes. Figure 3 demonstrates the flow rate test that has been conducted.

Figure 3. Flow rate test.

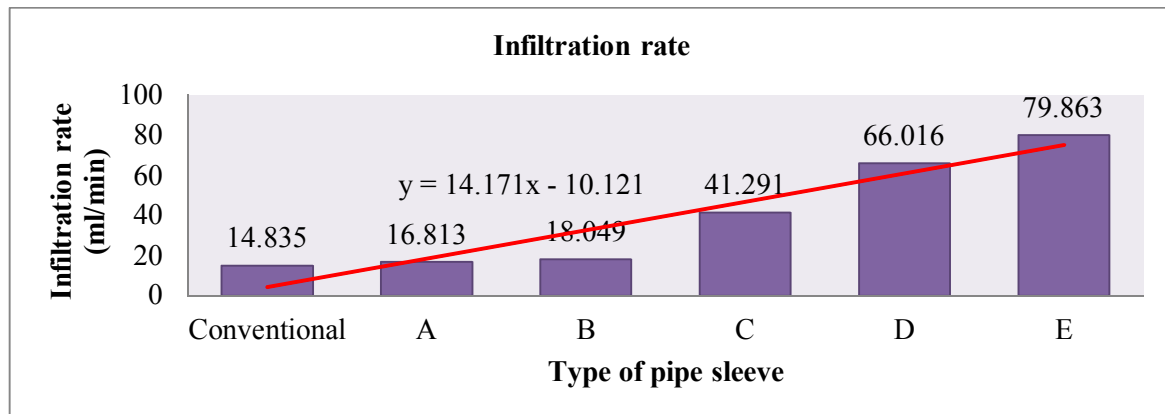
Figure 5 demonstrates the mortar layer that using pipe sleeve E design gives the highest infiltration result which is 79.863 ml/min. This is because of the water have an alternative way to drain out from the mortar layer which is the designated number of holes. Then, the infiltration rate of mortar for pipe sleeve D is less than pipe sleeve E which is 66.016 ml/min. The infiltration rate of mortar for pipe sleeve C was 41.291 ml/min. While the infiltration rate of the mortar layer of B, A and Conventional pipe sleeve design were 18.049 ml/min, 16.813 ml/min and 14.835 ml/min respectively. It is proved that the infiltration rate of mortar was influenced by the surface area percentage of the pipe sleeve design as the increase of surface area percentage of the pipe sleeve design, the increase the infiltration rate of mortar layer. The most effective design of pipe sleeve is pipe sleeve E as the infiltration rate of mortar layer was the highest among others.

Figure 5. Infiltration rate of water.

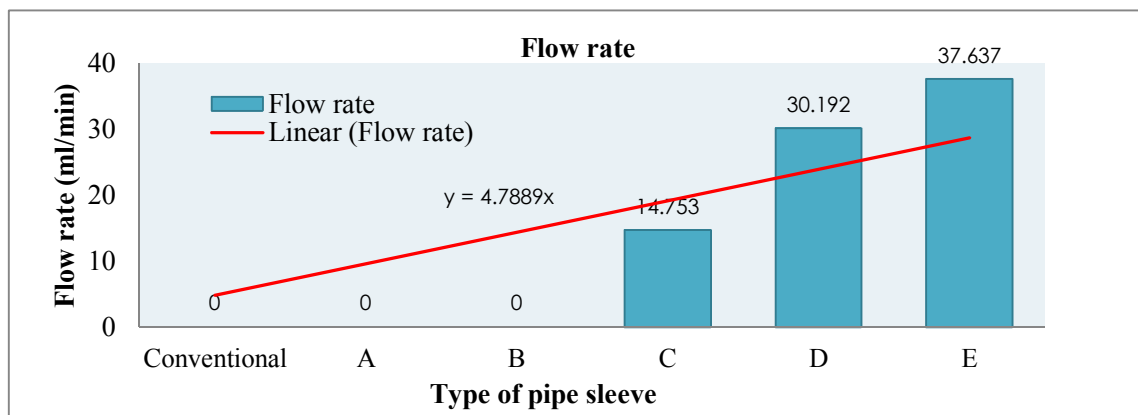
As depicted in figure 7, the flow rate of water in the mortar layer that using pipe sleeve E was the highest among all of them all. It is clearly shown that the alternative holes provided by pipe sleeve design at mortar layer were able to drain out the water from mortar layer. The flow rate that remains at zero value shows that the surface area covered was too small and it required more time to drain out water. Then, the flow rate of water in a mortar layer only started to increase when the pipe sleeve C has been used. The flow rate of water for C is 14.753 ml/min. Then, the flow rate of water increased rapidly for the D and E which is 30.192 ml/min and 37.637 ml/min respectively. The flow rate of water for pipe sleeve E recorded the highest rate and it shows that it was the best design compared to the other design.

Figure 7. Flow rate result.
