# Failure analysis of natural gas pipes

Article in *Engineering Failure Analysis* · June 2010

Incident involving failures of 6 months old API 5L X42 (NPS8) and SDR 17, 125 mm medium density polyethylene pipe (MDPE) supplying natural gas to an industrial customer has caused serious 7 h supply disruption. Study was performed to identify the most probable cause of the pipes failures. The study conducted by reviewing the existing design and construction data, visual physical inspection, pipe material analysis, structural analysis using NASTRAN and Computational Fluid Dynamics analysis (CFD) using FLUENT. Investigations revealed that high pressure water jet from leaked water pipe had completely mixed with surrounding soil forming water soil slurry (high erosive properties) formed at a close vicinity of these pipes. Continuous impact of this slurry upon the API 5L X42 pipe surface had caused losses of the pipe coating materials. Corrosion quickly ensued and material loss was rapid because of the continuous erosion of oxidised material that occurred simultaneously. This phenomenon explains the rapid thinning of the steel pipe body which later led to its failure. Metallurgical study usin

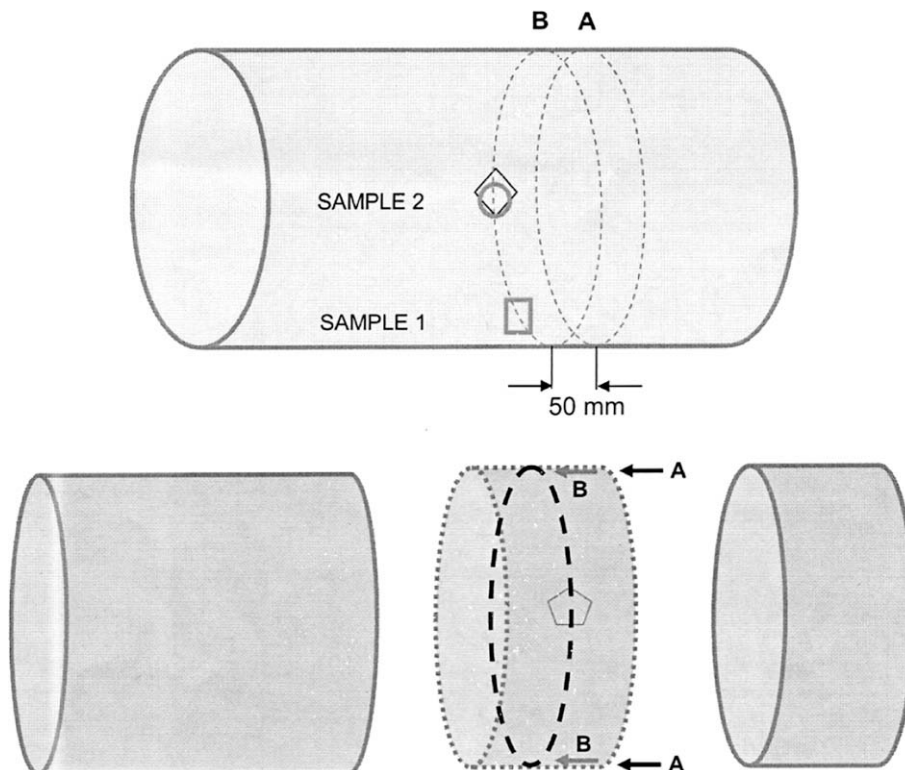
Dimensional mapping was conducted on the two half circles, where the hole is located, about 50 mm apart as shown in schematic diagram in Fig. 9. Results are illustrated in Fig. 10a–c for specimen A and specimen B, respectively. Results obtained clearly showed that the thickness of the metal decreased substantially closer against the jetting orifice position. In other words, metal loss has occurred on the area facing directly to the water pipe orifice jet resulting in a hole which increased in its dimensional size with severed metal losses. This indicates that the hole was caused by drastic erosion probably from the failed water pipe buried in the vicinity of the gas pipe.

**Fig. 9.** Schematic of steel gas pipe showing procedures of dimensional mapping and specimen preparation.

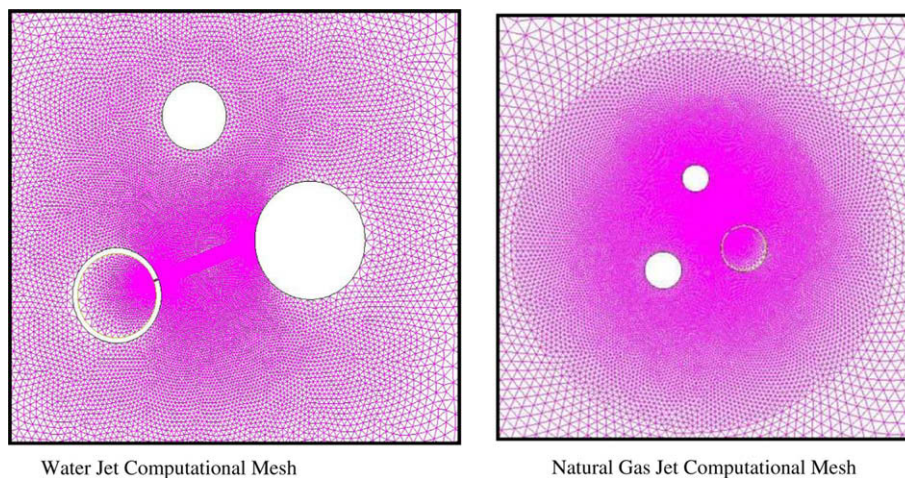
The pre-processing included physical modeling, setting-up appropriate boundary condition and construction of the computational mesh. Around 50,000 computational nodes (Fig. 12) were built and found to be sufficient in resolving computational domains. Boundary conditions that relate to geometric entities set up for this particular work are shown in Table 4.

Fig. 12. Computational mesh for water jet and natural gas jet.

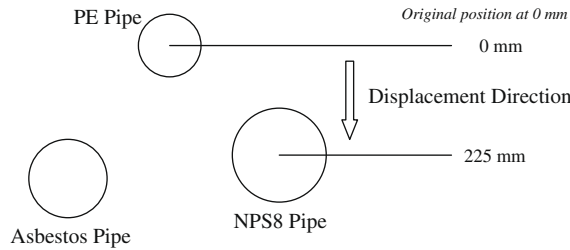
- iii. MDPE pipe vertical position tends to be lowered (moving downward) due to lack of tangential support.
- iv. As the medium was moving due to the jet flow from water pipe and steel pipe, MDPE pipe began to drop due the gravitational force and subsequent soil weight that vertically act on the MDPE pipe section (Fig. 15).

Fig. 15. Schematic of PE pipeline displacement.

The following are the discussion of the probable cause and events that may had occurred as the MDPE pipe moves downwards (Fig. 15) due to the displacement and loss of supporting underneath materials, brought about by the continuous water and natural gas jetting streams.

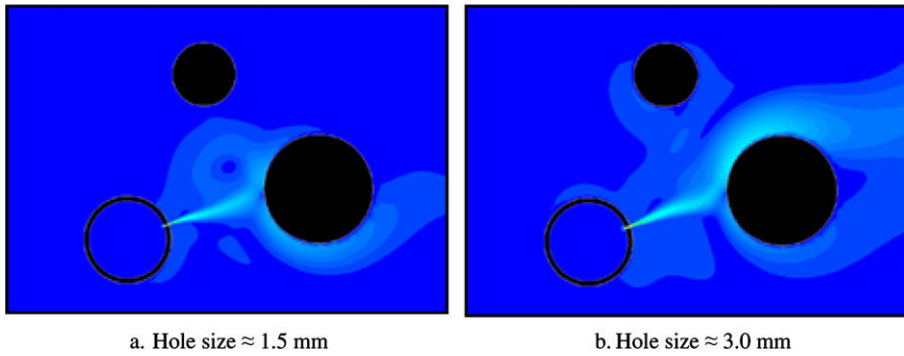
- i. Failure started as a small crack, possibly longitudinal in direction. The simulation was initiated when the crack size has an effective diameter of 1.5 mm. The flow trajectories of the jet are shown in Figs. 16a and 17a.

- ii. As the effective diameter increased to 3.0 mm, it was shown that the force of the jet impacting on the steel pipe surface was getting much more significant (Figs. 16b and 17b). It was strongly believed that the water/slurry were strong enough to cause coating losses on the steel pipe surface.

Fig. 16. Result of water jet simulation (2D velocity profile).

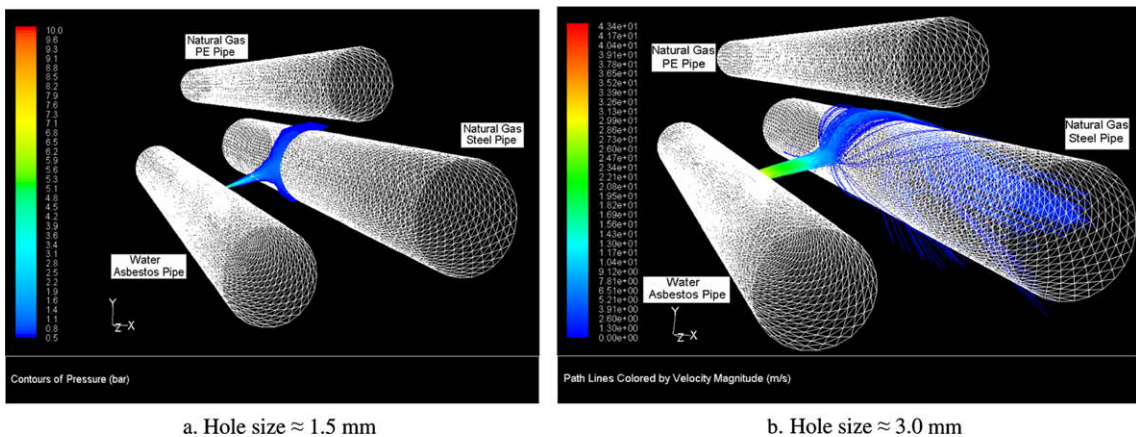
Fig. 17. Result of water jet simulation (3D velocity profile).

As the MDPE pipe dropped vertically around 150 mm, the gas jetting direction directly hit the MDPE pipe, thus start to shear by the high impact high pressure gas jet flow. The pressure at this stage was around 1.7 bars with its flow velocity around  $400 \text{ m s}^{-1}$ . Fig. 17 indicated that the MDPE pipe may had experienced rapid failures.

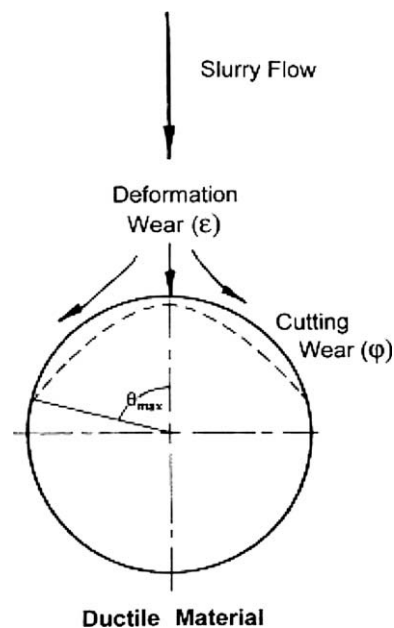
- iii. The flow trajectory was also shown to move along the upper surface of the steel pipe. This fact supports the finding of the metallurgical study which shows a faster thinning process took place on the upper part of the pipe (Fig. 10c). This phenomenon totally agreed with the study conducted on cylindrical specimen using slurry pot erosion tester as shown in Fig. 18 [11].

Fig. 18. Schematic diagram of slurry flow and distribution of deformation wear and cutting wear on a ductile material.

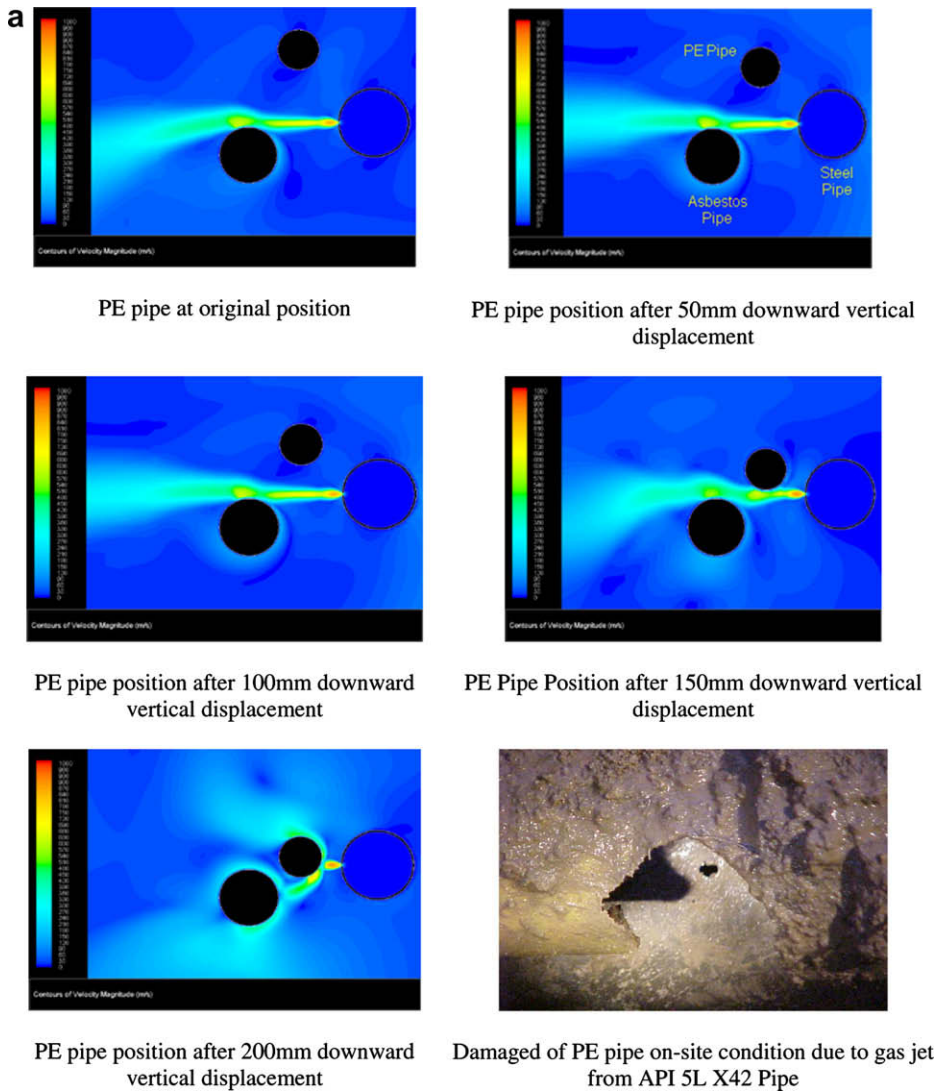
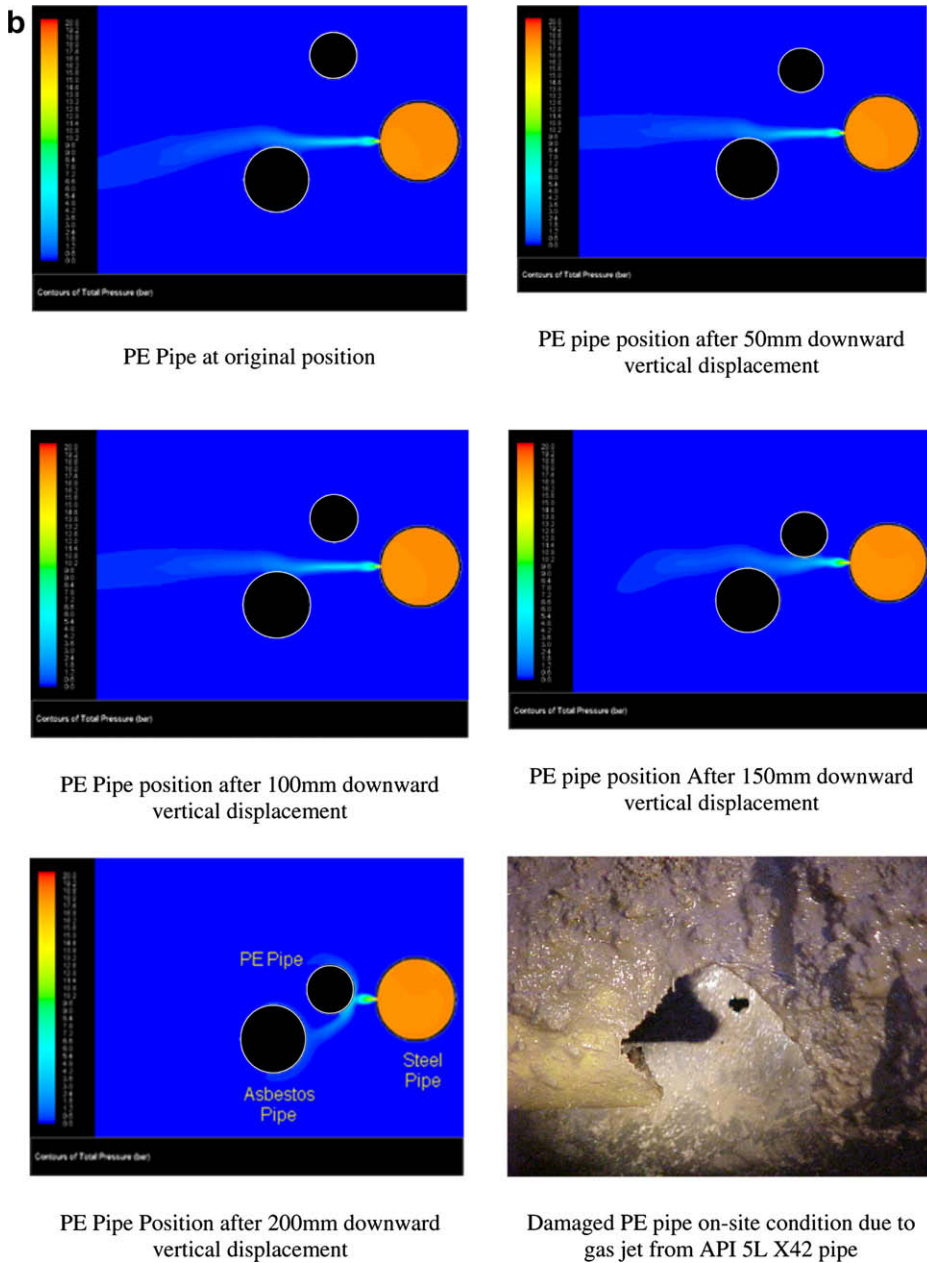
The results for the simulation of the NPS8 pipe leak in term of pressure and velocity contour are given in the picture sequence as in Fig. 19a and b, respectively.

Fig. 19. Gas flow pressure and velocity contours for the API 5L pipe leak. (a) Gas pressure contours for the API 5L X42 pipe leak. (b) Gas flow velocity contours for the API 5L pipe leak.

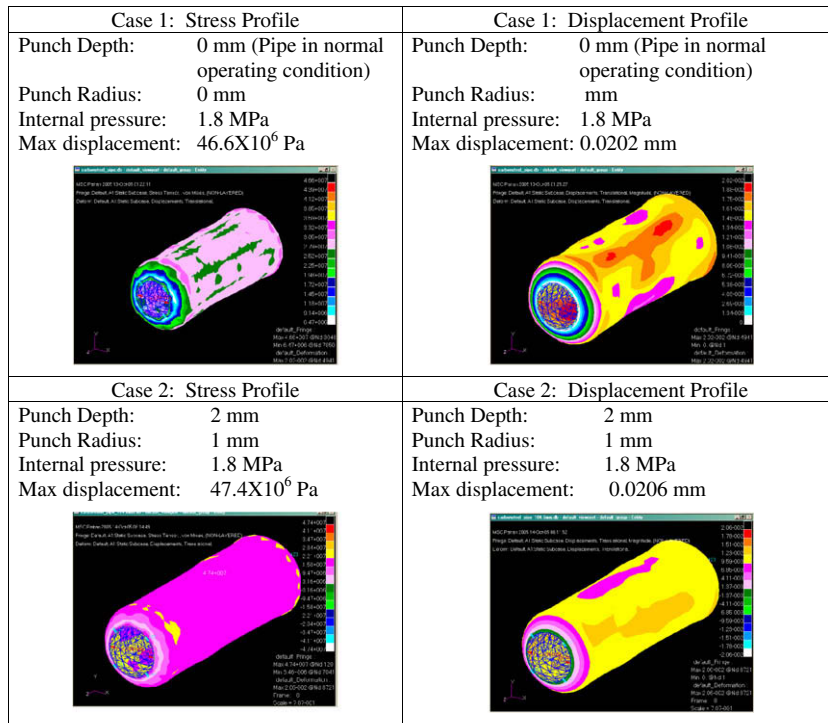
Fig. 21 shows four samples of finite element simulation results obtained. Summary of results (Table 5) shows that as the punch depth gets deeper, the critical pressure due to the surface thickness reduction will subsequently increased. The critical element displacement also increased as the wall thickness is further reduced.

Fig. 21 and Table 5 (3D analysis) represent pipe wall stress and displacement distribution, which indicate substantial increment as wall thickness reduces. The thickness reduction then lead to pipe failure is indicated by profile 7 (Fig. 22).

Fig. 21. Stress profile on API 5L X42 pipes.

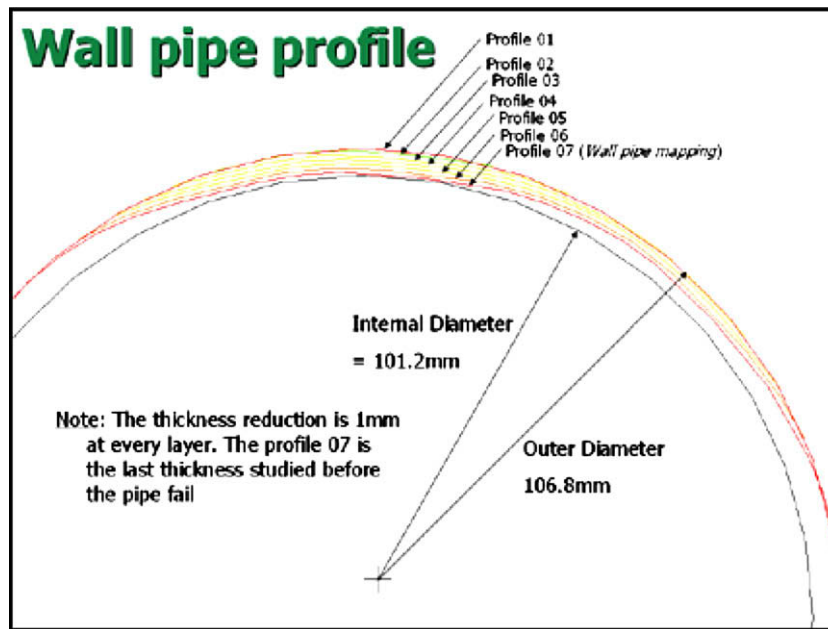
In the simulation process, 1800 kPa (18 bar) internal pressure was applied from inside the pipe structure. Using pipe thickness mapping, the pipe thickness is modeled and simulated for different cases. The pipe thickness dimension model has been based on its initial size of 5.8 mm. The simulations were subsequently executed for every 1 mm reduction of pipe thickness shown in Fig. 22.

Fig. 22. Steel pipe wall profile.

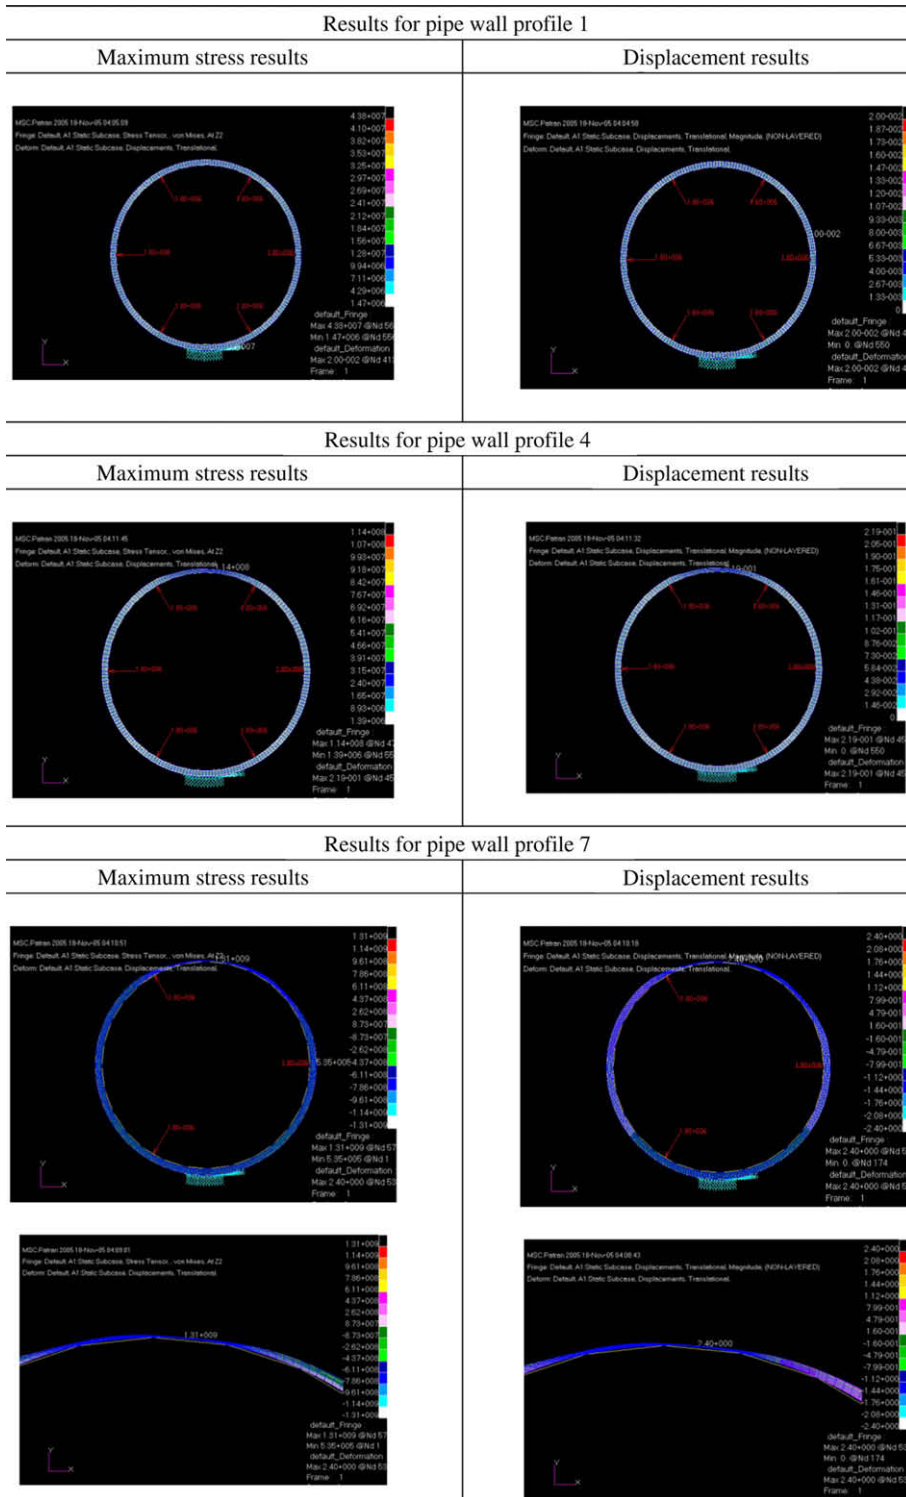
Results of 2D wall thickness reduction study are shown in Table 6, Figs. 23–25. It is clearly shown that the thickness reduction is directly due to the erosion effect. From the wall thickness profile, if the wall thickness is lower than 1.5 mm, the strength of the wall pipe is becoming weaker and the minimum thickness prior to failure is 1.25 mm limit.

Fig. 23. Max stress and displacement results at pipe wall.

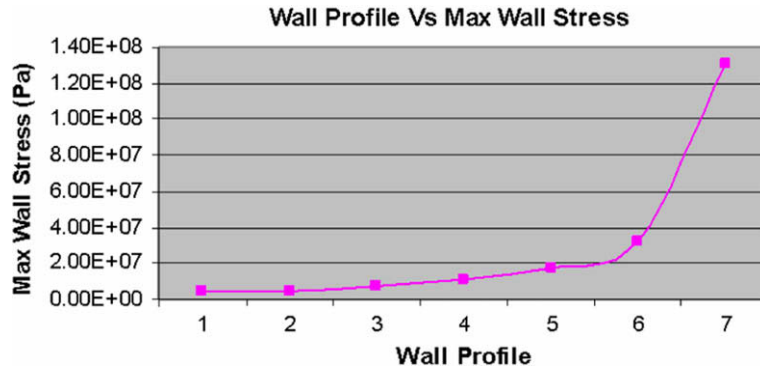
Fig. 24. Maximum stress.

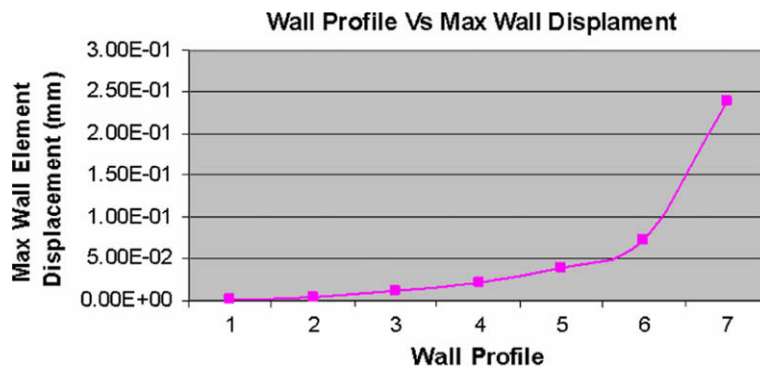
Fig. 25. Maximum displacement.
