Failure analysis of natural gas pipes

Z.A. Majid^{a,*}, R. Mohsin^a, Z. Yaacob^a, Z. Hassan^b

^a Gas Technology Centre, Universiti Teknologi Malaysia, 81310 Johor, Malaysia

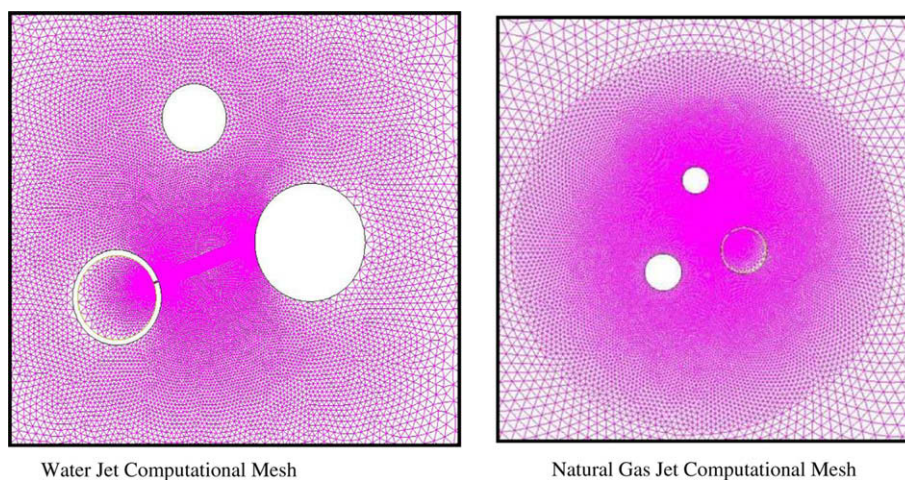
Fig. 12. Computational mesh for water jet and natural gas jet.

The pre-processing included physical modeling, setting-up appropriate boundary condition and construction of the computational mesh. Around 50,000 computational nodes (Fig. 12) were built and found to be sufficient in resolving computational domains. Boundary conditions that relate to geometric entities set up for this particular work are shown in Table 4.

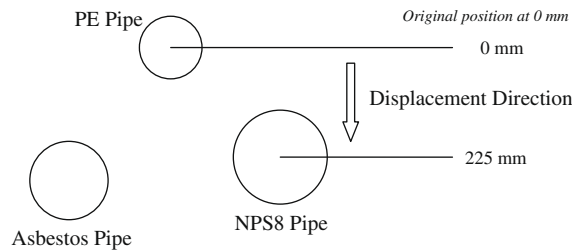
Fig. 15. Schematic of PE pipeline displacement.

- iii. MDPE pipe vertical position tends to be lowered (moving downward) due to lack of tangential support.
- iv. As the medium was moving due to the jet flow from water pipe and steel pipe, MDPE pipe began to drop due the gravitational force and subsequent soil weight that vertically act on the MDPE pipe section (Fig. 15).

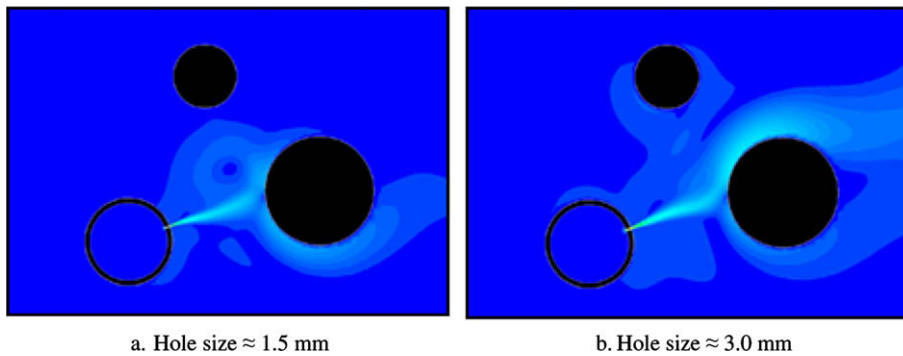
Fig. 16. Result of water jet simulation (2D velocity profile).

- i. Failure started as a small crack, possibly longitudinal in direction. The simulation was initiated when the crack size has an effective diameter of 1.5 mm. The flow trajectories of the jet are shown in Figs. 16a and 17a.

- ii. As the effective diameter increased to 3.0 mm, it was shown that the force of the jet impacting on the steel pipe surface was getting much more significant (Figs. 16b and 17b). It was strongly believed that the water/slurry were strong enough to cause coating losses on the steel pipe surface.

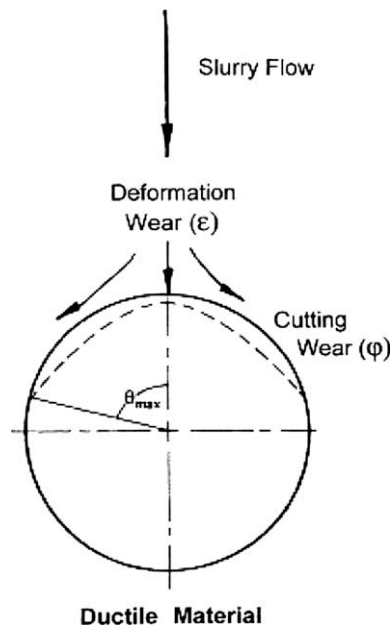
Fig. 18. Schematic diagram of slurry flow and distribution of deformation wear and cutting wear on a ductile material.

- iii. The flow trajectory was also shown to move along the upper surface of the steel pipe. This fact supports the finding of the metallurgical study which shows a faster thinning process took place on the upper part of the pipe (Fig. 10c). This phenomenon totally agreed with the study conducted on cylindrical specimen using slurry pot erosion tester as shown in Fig. 18 [11].

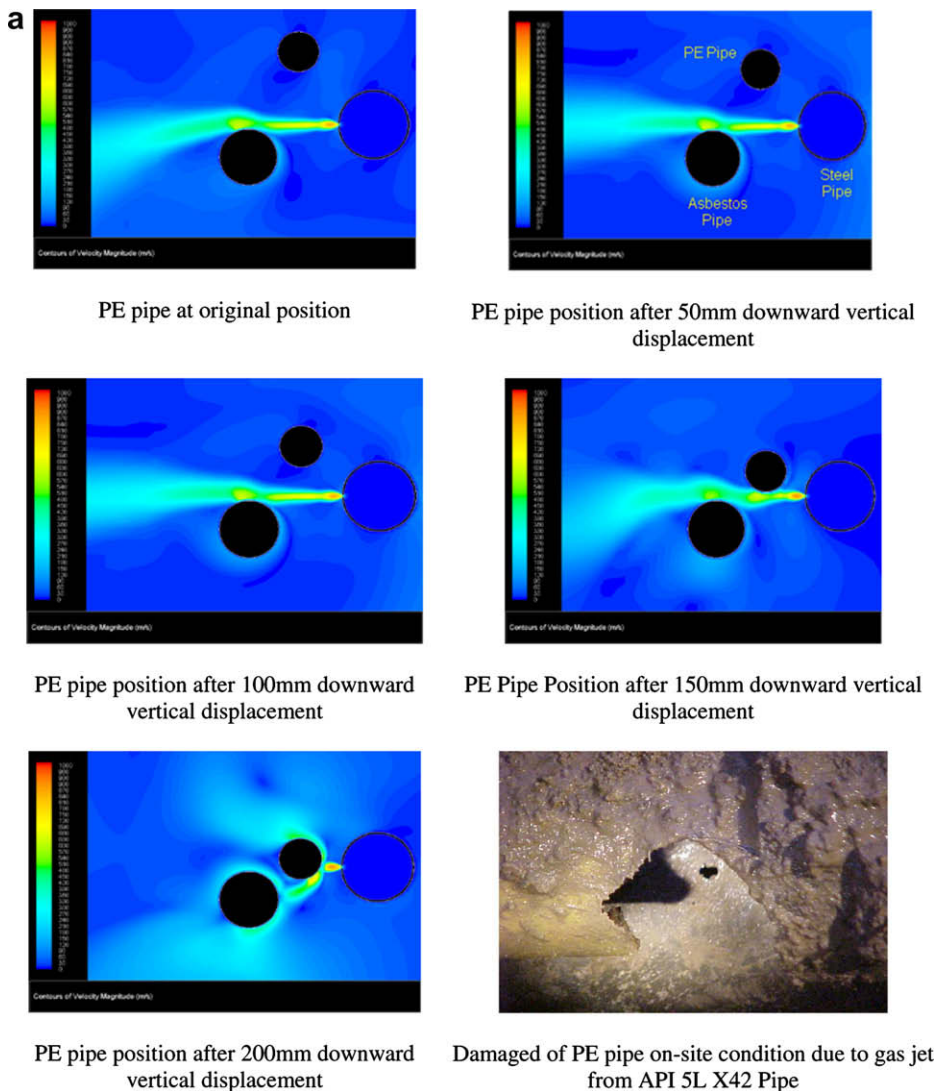
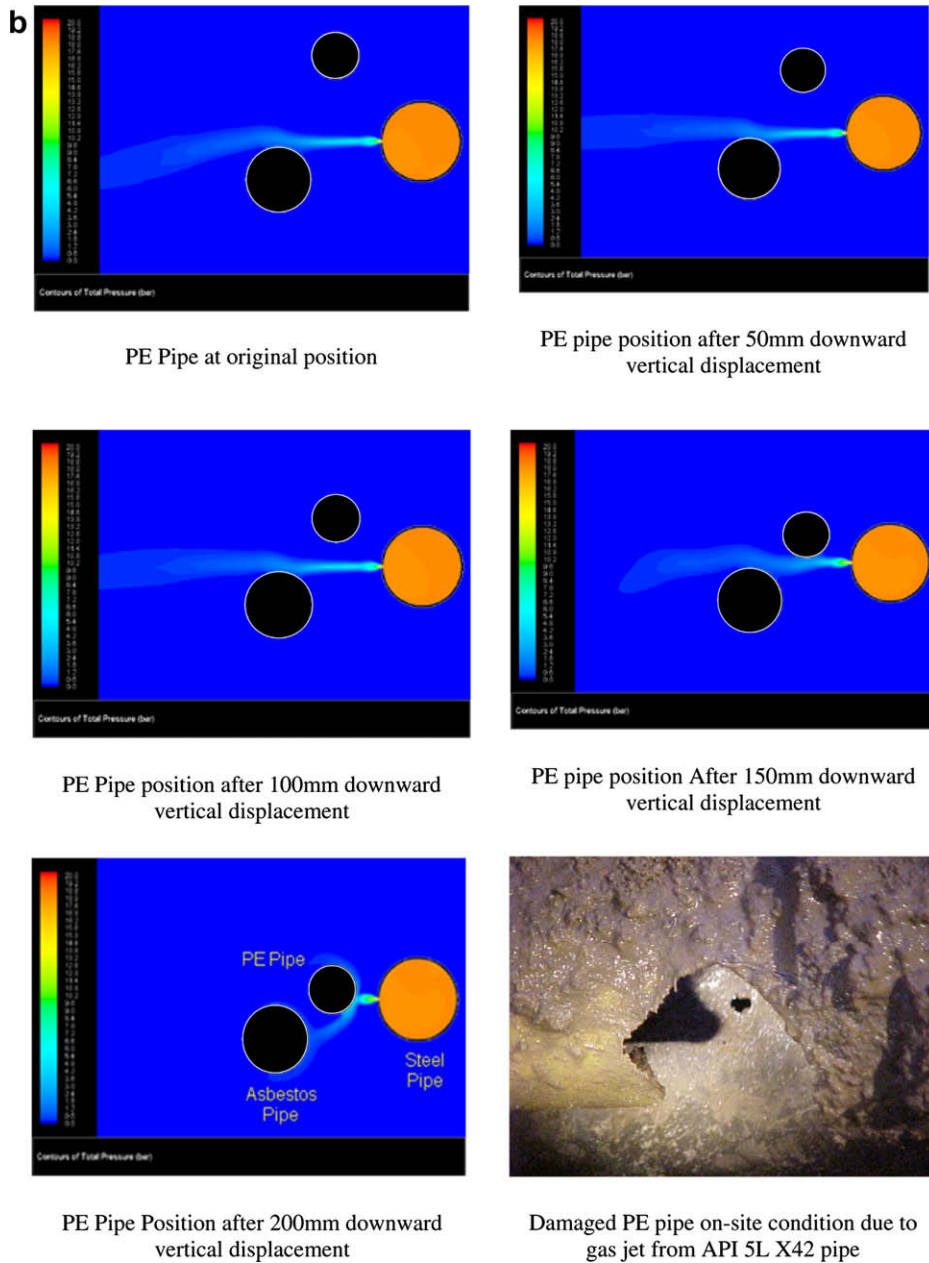
Fig. 19. Gas flow pressure and velocity contours for the API 5L pipe leak. (a) Gas pressure contours for the API 5L X42 pipe leak. (b) Gas flow velocity contours for the API 5L pipe leak.

The results for the simulation of the NPS8 pipe leak in term of pressure and velocity contour are given in the picture sequence as in Fig. 19a and b, respectively.

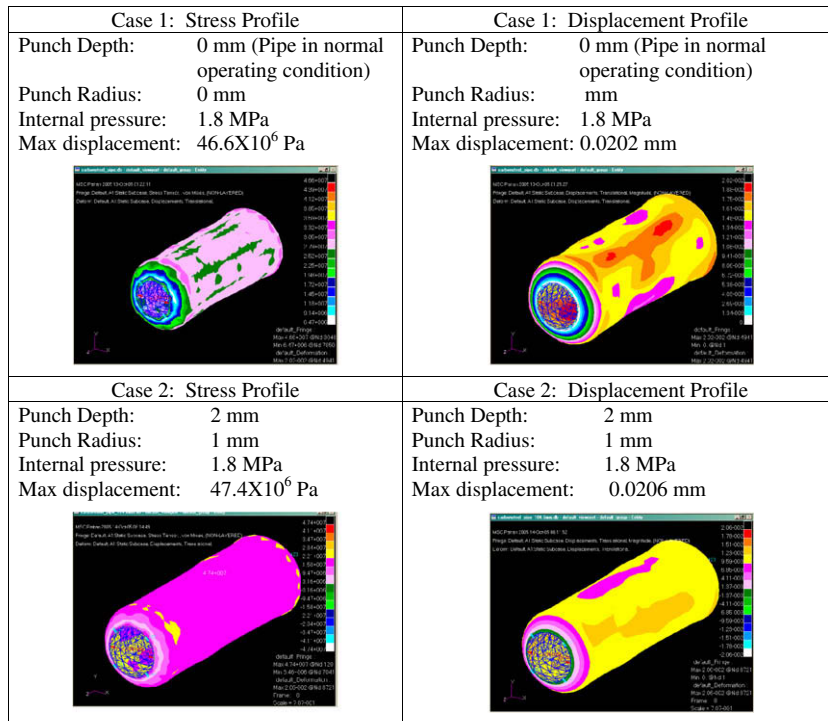
Fig. 21. Stress profile on API 5L X42 pipes.

Fig. 21 shows four samples of finite element simulation results obtained. Summary of results (Table 5) shows that as the punch depth gets deeper, the critical pressure due to the surface thickness reduction will subsequently increased. The critical element displacement also increased as the wall thickness is further reduced.

Fig. 21 and Table 5 (3D analysis) represent pipe wall stress and displacement distribution, which indicate substantial increment as wall thickness reduces. The thickness reduction then lead to pipe failure is indicated by profile 7 (Fig. 22).

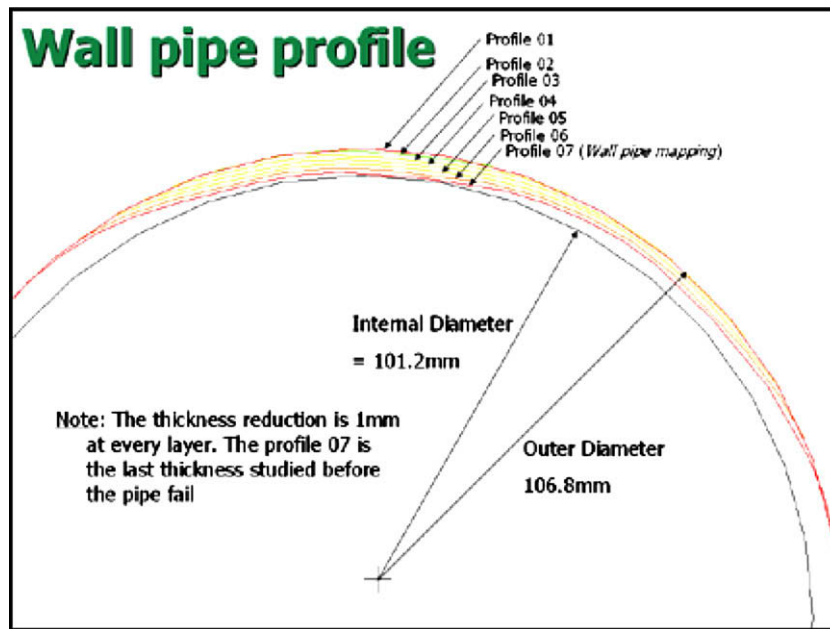
Fig. 22. Steel pipe wall profile.

In the simulation process, 1800 kPa (18 bar) internal pressure was applied from inside the pipe structure. Using pipe thickness mapping, the pipe thickness is modeled and simulated for different cases. The pipe thickness dimension model has been based on its initial size of 5.8 mm. The simulations were subsequently executed for every 1 mm reduction of pipe thickness shown in Fig. 22.

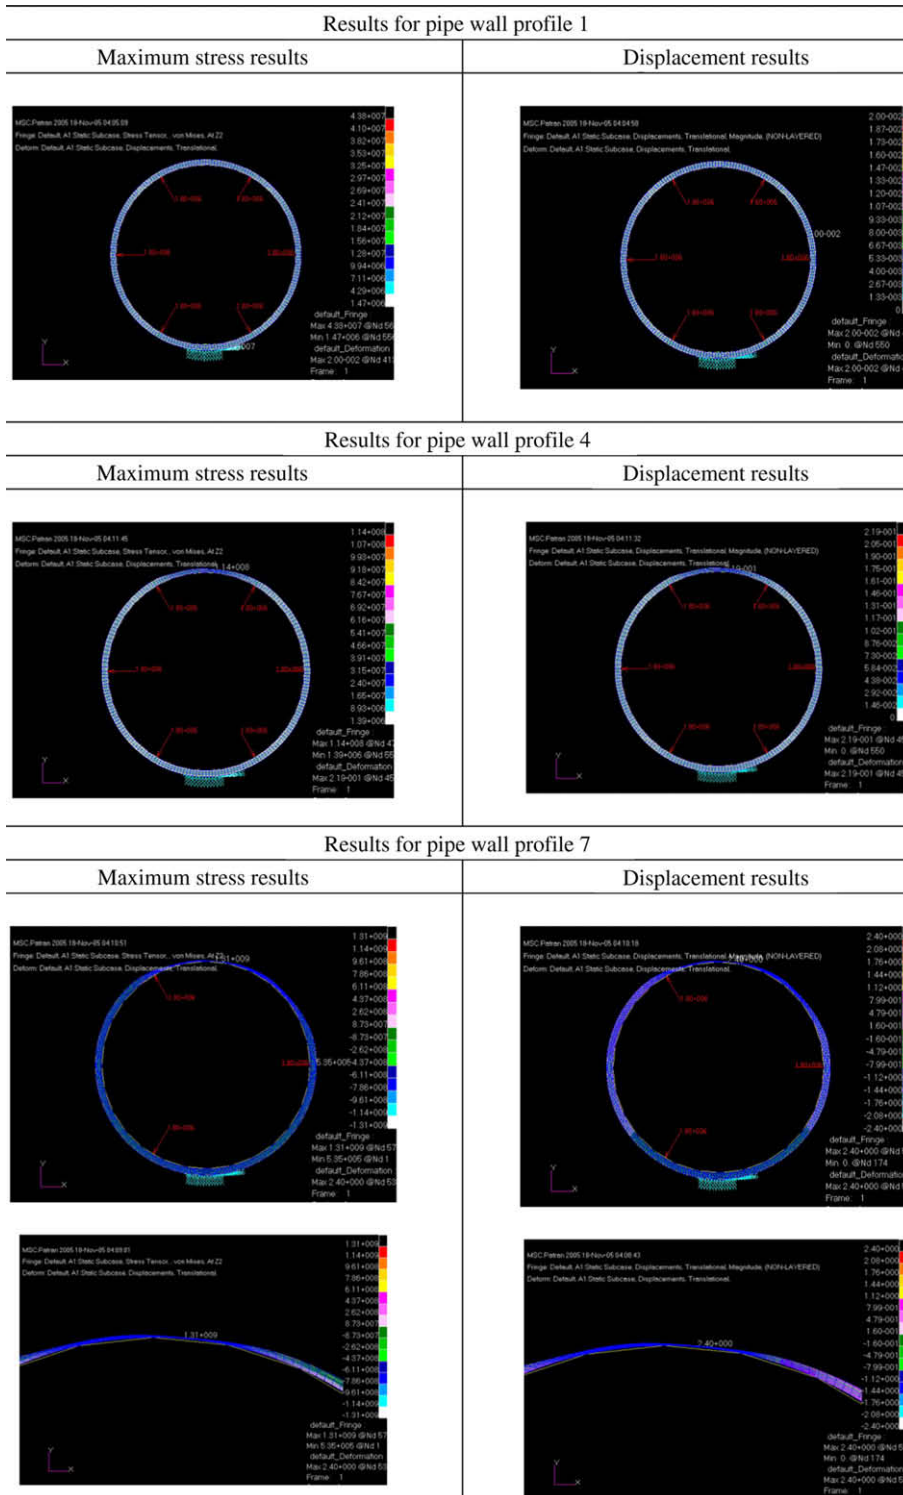
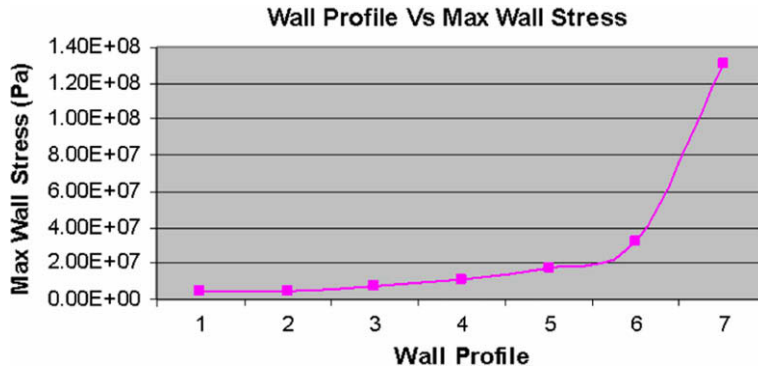
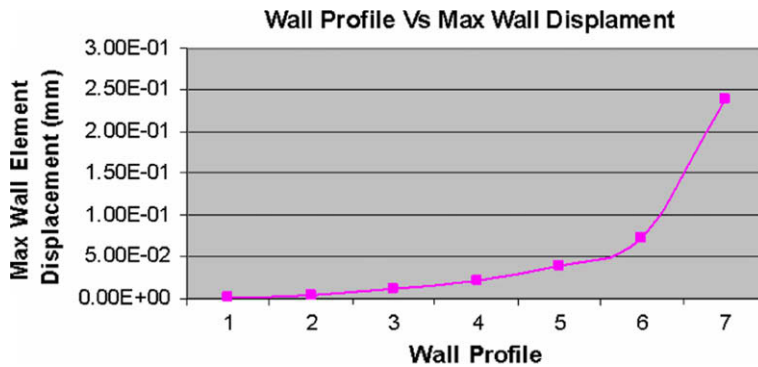
Results of 2D wall thickness reduction study are shown in Table 6, Figs. 23–25. It is clearly shown that the thickness reduction is directly due to the erosion effect. From the wall thickness profile, if the wall thickness is lower than 1.5 mm, the strength of the wall pipe is becoming weaker and the minimum thickness prior to failure is 1.25 mm limit.
