SLOPE ANALYSIS AND REMEDIAL WORK ON LANDSLIDE AT
TAMAN SETIAWANGSA KUALA LUMPUR

A project report submitted in partial fulfilment of the
requirements for the award degree of
Master of Engineering (Geotechnics)

Faculty of Civil Engineering
Universiti Teknologi Malaysia

DECEMBER 2016

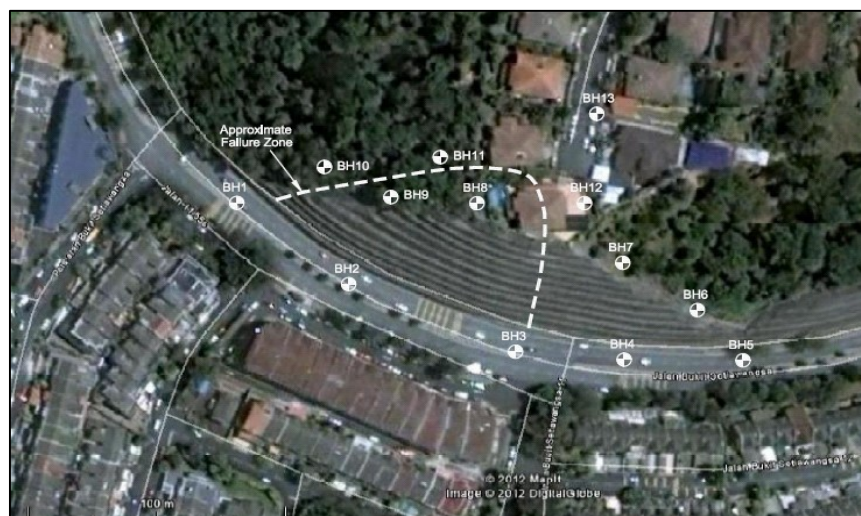
Figure 1.2 Location of the slope failure and borehole in Puncak Setiawangsa

Figures 1.1 and 1.2 show the front view of the slope failure and the location of the site. This failure caused a residential house located at the top edge of the slope to partly collapse. The failure also caused one carriageway of the dual carriageway at the bottom of the slope to be closed. The slope contain of 11 berm of cut and steep slope strengthened by permanent ground anchors constructed in the period 1989 - 1991. Each berm has as average height of 5.0m with the horizontal spacing of the anchors was approximately 1.5m.
