Development of Proving Ground Field Test for Establishment of Vehicle Accelerated Corrosion Test Procedure in Malaysia

L. Anuar^{1,2}, A. Amrin^{1*}, R. Mohamad¹, S. A. Aziz¹ and M. Toozandehjani¹

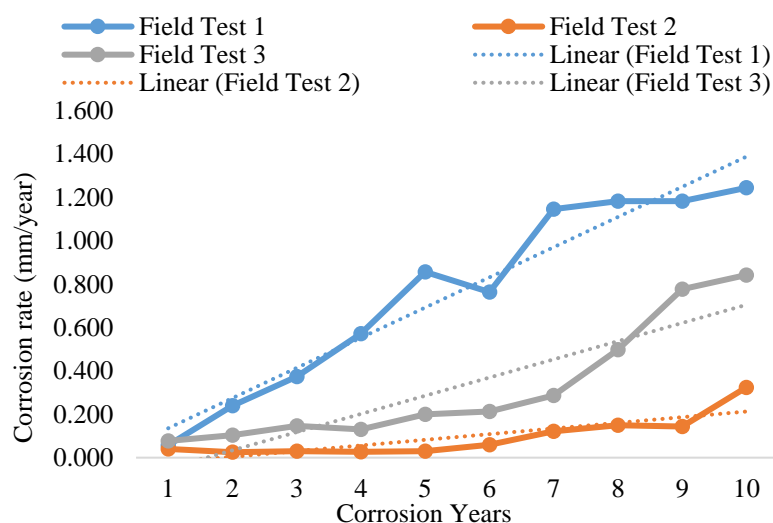
Figure 7. Corrosion rate measurements of different field tests.

Furthermore, corrosion rate measurements were conducted using weight loss technique of the test coupons. The corrosion rates of field test 1, field test 2 and field test 3 were 0.057-1.244, 0.040-0.324 and 0.077-0.842 mm/year, respectively. The corrosion rates of field test 1, 2 and 3 were overlayed in Figure 7. The field test 1 was found having the higher corrosion rate exposure compared to field test 2 and 3. This was due to high repetition of corrosion exposures of mud trough, salt trough and gravel road. Corrosion rates of field test 2 were found to be the lowest compared to field test 1 and 3. This was due to the lesser corrosion exposures given to the test vehicles while field test 3 was found experiencing a moderate corrosion exposures.
