SFRA Test Method Application for Turbo Generator Rotor Winding

Zakky Mubarak, and Eko Supriyanto

PT. Indonesia Power, Jakarta, Indonesia, Faculty of Engineering, Universiti Teknologi Malaysia, Malaysia

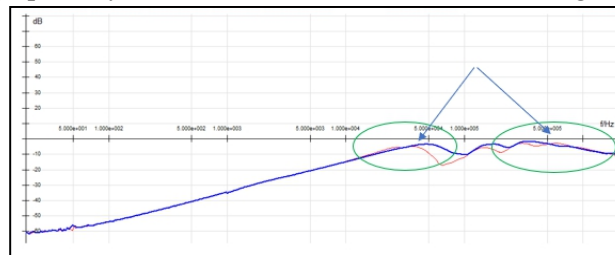
After dismantling and checking in the Gas Turbine rotor generator. After rotor disassembled and found interturn insulation damage at several layer. Rotor Generator fix to repair with Total Re insulation is performed by replacing interturn isolation between coil layers, insulation slot liner, filler slot wedges, block end winding. With this repair, the generator has returned to health condition. With this health condition a short interturn simulation and several other abnormal conditions can be performed. Figure 17 shows the short interturn simulation graph between 1 layer at coil number 7A. Short interturn simulation graph 3 layers at coil number 4-5A is shown in Figure 18.

Figure 17. Short interturn simulation graph 1 layer at coil number 7A

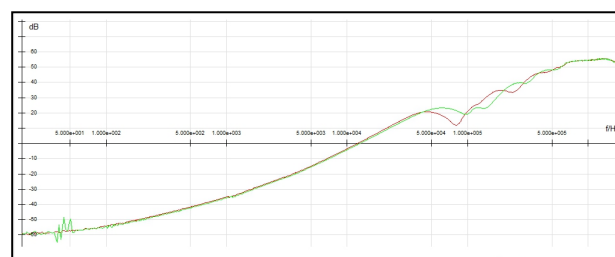
Figure 18. Short interturn simulation graph 3 layers at coil number 4-5A.

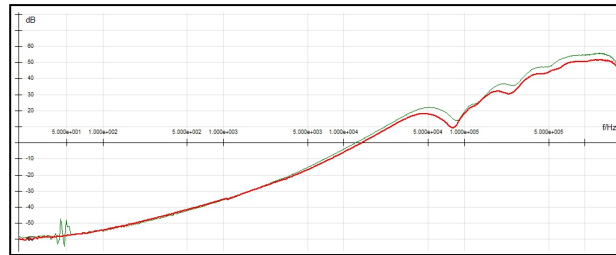
When the generator is operating, expansion occurs. Each winding rotor generator has a different resistivity value. This value will affect the elasticity when the coil expands during operation. Elongation is expansion during operation and the copper coil does not return to the initial dimensions due to different material values and types of copper resistance. Figure 19 shows the elongation simulated result.

Figure 19. Elongation simulated result.
