Influence of Iron Bacteria on the Corrosion Behavior of Carbon Steel: SEM Study

Graphical abstract

Abstract

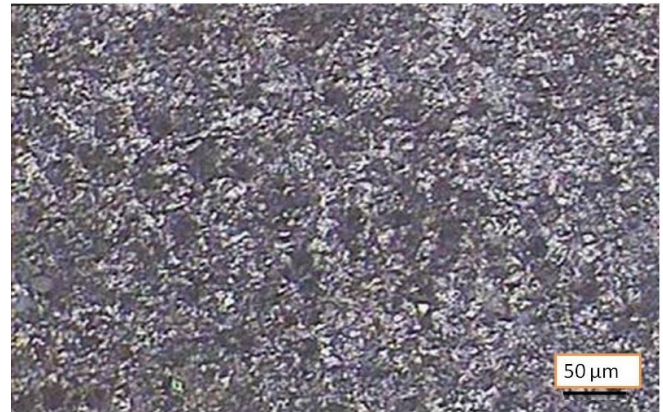
The optical micrograph and SEM image of steel exposed to bacteria inoculated medium for one month is shown in Figure 5 and 6 respectively.

Figure 5 Optical micrograph ($\times 570$) of uniform pitting on the carbon steel coupon exposed to iron bacteria inoculated medium for one month

The occurrence of uniform pitting corrosion on the steel surface is observed. In general, the appearance of steel due to MIC is accepted to be localized as it is under the influence of patchy biofilm that differential aeration cells and thus anodes and cathodes are formed. However, at some points on the steel surface, the pitted areas could be joint, thereby the appearance might look like a uniform pitting corrosion [10].
