Performance of Steel-Carbon Fibre Reinforced Polymer Plate Bonding System Under Various Environmental Conditions

Abstract. The use of Carbon Fiber Reinforced Polymer (CFRP) as strengthening material for reinforced concrete and steel has been a focused of many researched around the world. Superior properties of the CFRP plate including lightweight, high tensile strength, and corrosion resistance make it a favorable material in strengthening of existing structures. However, one of the main drawbacks is the long-term durability of the steel-CFRP bonding system against various environmental conditions. This study evaluates the durability performance of the steel-CFRP plate bonding system exposed to different environments. Experimental work was conducted in which the CFRP plate, adhesive coupons, and CFRP double lap shear samples were prepared and subjected to either continuous or wet-dry cycles in different exposures including plain water, salt water, acidic solution, and outdoor. The exposed samples were tested at different ages. The results show that the CFRP plate was quite durable and the change on the properties was negligible. However, the results indicated that exposure to diff

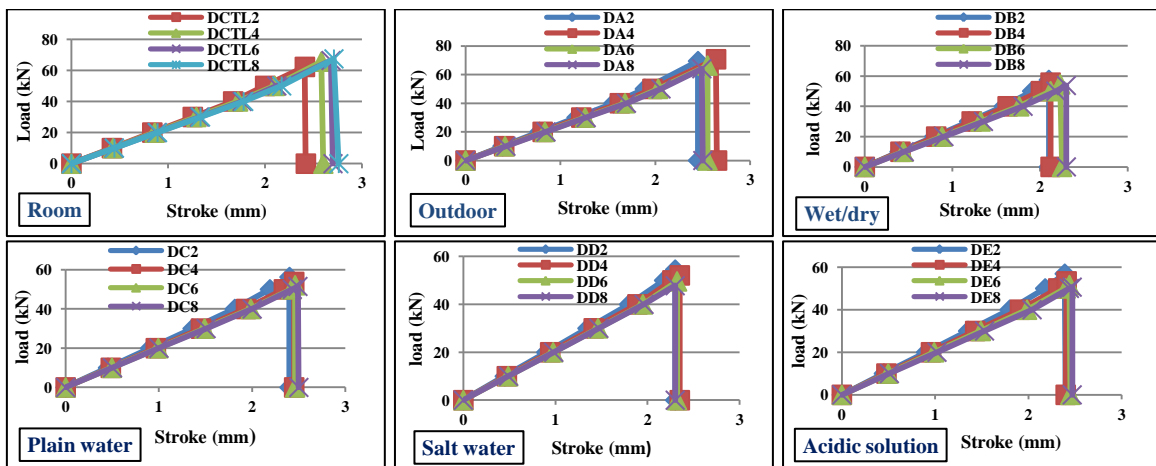
Figure 3: Load-stroke of DLS specimens exposed to various environmental conditions

The load-stroke relationship of the specimens is demonstrated in Figure 3. The graphs show almost linear behavior at the beginning but, it changed to slightly nonlinear before failure. It can be seen that the failure load was enhanced gradually when the time of exposure increased. The failure stress was found to increase from 60.5 kN to 67.4 kN which shows an enhancement of around 11%. Indeed, post curing of the adhesive in a moderate condition caused an increase in the bond strength with time. However, the tensile stiffness of the specimens was reduced by 8% at the end of exposure.

The graphs in Figure 3 illustrate the failure load increased significantly to 70.7 kN after 4 months of exposure which shows around 17% enhancement. However, it decreased to 64.1 kN after 8 months which indicates the outdoor environmental factors had degraded the bonding strength. Likewise, the stiffness of the specimens changed in the same trend. Basically, high temperature of the tropical climate accelerated the post curing of the adhesive and therefore, the properties improved significantly in a short period of time. Afterwards, the process of polymerization of the epoxy adhesive finished and the environmental factors began to influence it.

The load-stroke curves show the bonding strength and stiffness were degraded gently by about 11% and 9%, respectively after 32 cycles. These results may indicate water absorption and desorption degraded the bonding properties gradually. Overall, the properties were reduced compared to control specimens and showed the wet/dry condition slightly influence the bonding properties.

Almost the same degradation trend was observed for these environmental conditions as shown in Figure 3. The results indicate the strength of bonding and the tensile stiffness degraded in a range of 15% to 21% and 13% to 18%, respectively. In addition, the highest rate of degradation occurred within the first four months of exposure. The highest reduction in strength and stiffness was recorded for salt water and plain water specimens, respectively. This was because of the chemical attack by chloride ions which influenced the bonding and caused significant degradation in salt water exposure. In addition, water absorption had made softening and plasticization of the epoxy adhesive and reduced the stiffness substantially.
