EROSIVE WEAR OF NATURAL GAS PIPELINE

Abstract. Erosive wear can be caused by a water jet burst from leaked water pipe laid side by side to natural gas pipeline. The erosive wear behavior of natural gas pipeline eroded by sand and water jetting was investigated. This work present the erosive wear analysis of API 5L X42, steel grade pipeline which normally used for distributing natural gas to an industrial customers by gas utility company in Malaysia. Tests were carried out by recreating above mentioned situation through the usage of 5 mm diameter orifice as the source of jetting in sand particles towards the pipe specimen that was buried at 1 meter depth. The existence of tunneling effect was established by identifying the horizontal and vertical tunneling through physical examination of the impacted surface. It was determined that the thickness of the pipe decreases with time. Determination of time taken for the pipe to rupture was established at 220 hours after continuous jetting and zero effect distance is at 450 mm from the jetting source of the relevant tests condition.

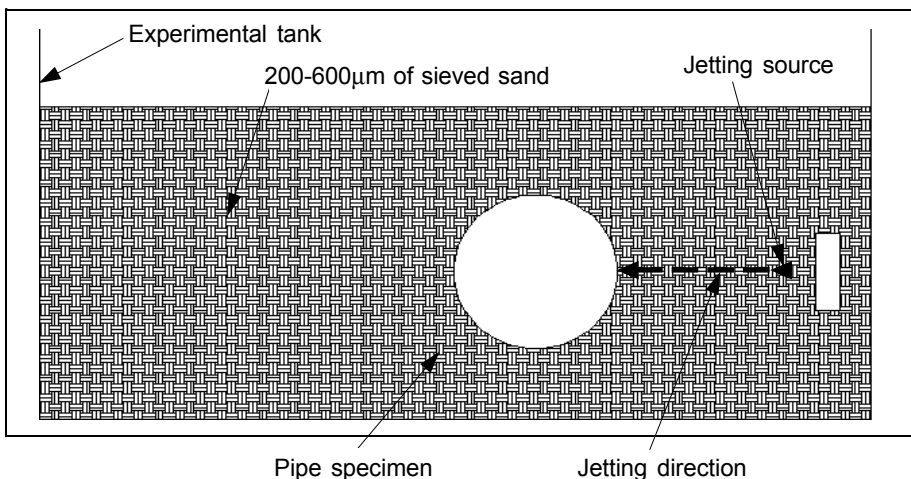
Experiment was conducted by utilizing a compartment (experimental tank) to simulate a buried piping system. Figure 1 is a diagram depicting the basic idea of the experiment. The piping system need not be an elaborate piping system as it is sufficient that a section of a pipe is buried in the compartment to symbolize a working buried natural gas piping. Fine sand without gravels was filled into the compartment thus burying the pipe. This sand will act as the erosive particles to be present in the water jet. Water jetting effect was created in the compartment by using different sizes of orifices pointing towards the buried pipe.

Figure 1 Basic concept of experimental apparatus

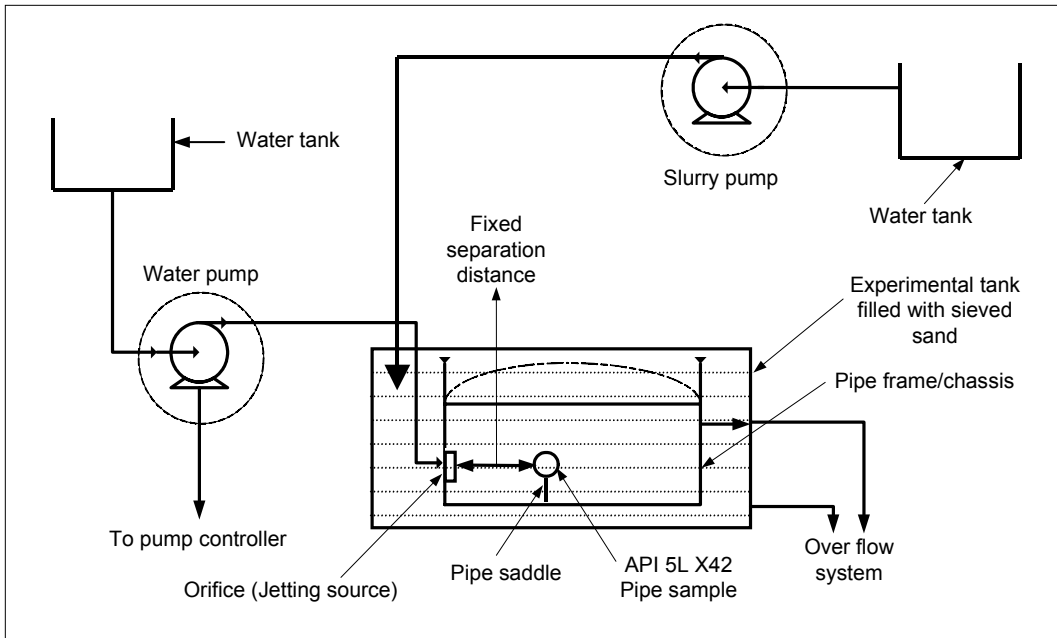
A section of natural gas pipe was attached to the saddle on the rig. The saddle was adjusted to a distance deemed suitable for the experiment. An orifice was attached to the orifice holder. Supply pressure of the water was set at 10 barg while the distance away from the jetting source was varied at 10 cm till 70 cm. Sieved sand particles of 600 – 2000 µm were the erodents was filled into the handling tank before the rig was lowered into the tank. A number of small holes drilled on the rig structure that will act as a repellent which creates small jet-push effect to disperse sand in the tank to allow the rig to be lowered down into the sand thus burying it. After the designated interval the rig was lift-out from the handling tank using a chain block system. Thinning of the sample pipe material was measured on points dictated

Figure 2 Experimental set up

based on a data-taking template. Figure 2 is a schematic diagram represents the use of experimental rig in the current study.

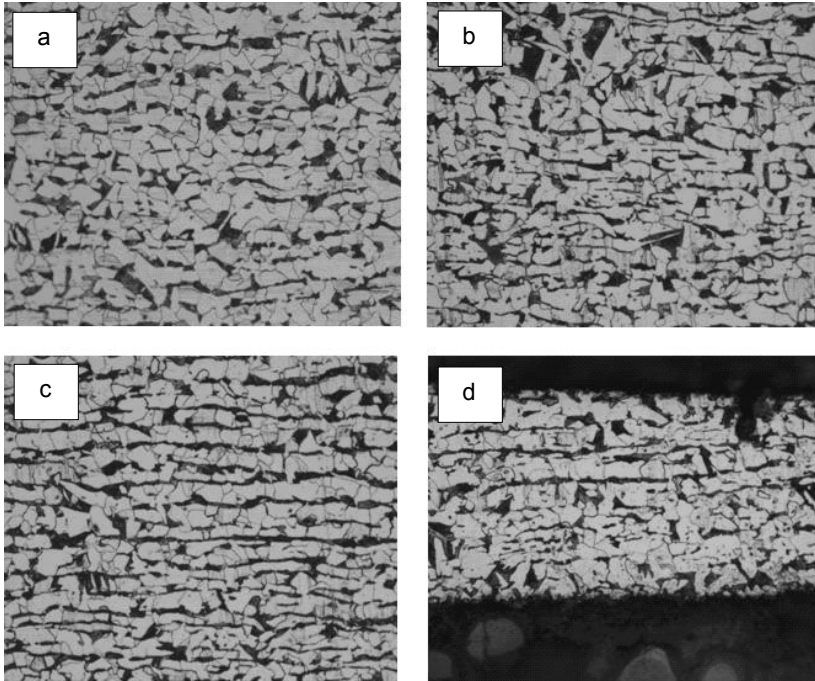
**Figure 3** Microstructures of the gas pipe showing pearlite bands phase in the ferrite matrix, at 200 \times

using the grinding and polishing wheels. In order to reveal the microstructures of the specimen were subjected to an etching process in 2% of nitric acid with 98% of methanol. The prepared specimens were then examined with 200 \times magnification using optical metallographic microscope.

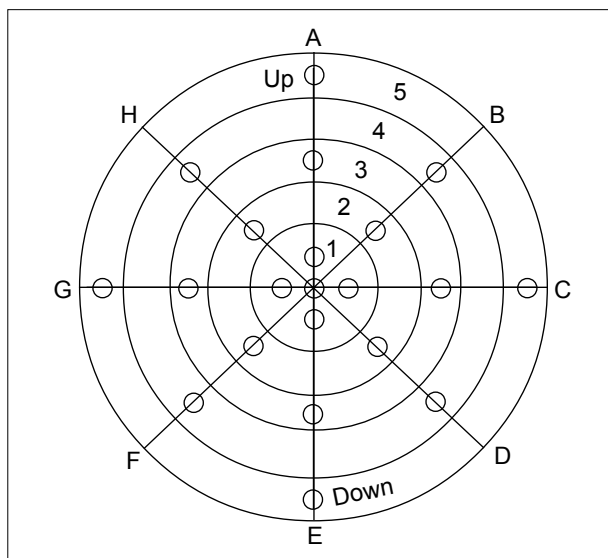
The surface of the pipe specimen was divided into 4 horizontal sections with 5 horizontal lines, namely Line A, Line B, Line C, Line D and Line E. Next, the horizontal lines were separated into 3 areas with the data taking points being the center of the area. Coating thickness data on each area were acquired using digital coating thickness gauge. In order to determine metal thickness of each specimen, a section of the specimen were coating scraped off to reveal the bare metal surface of the specimen. Three data measurement were taken from the designated point as shown in Figure 4. Once all the procedures have been accordingly followed correctly, the specimen is tied to the pipe holder rig. The position of the specimen is requiring adjustment in order to ensure the jetting of the orifice is parallel to the line and points that have been selected as the surface of the specimen.

Figure 4 Data taking template

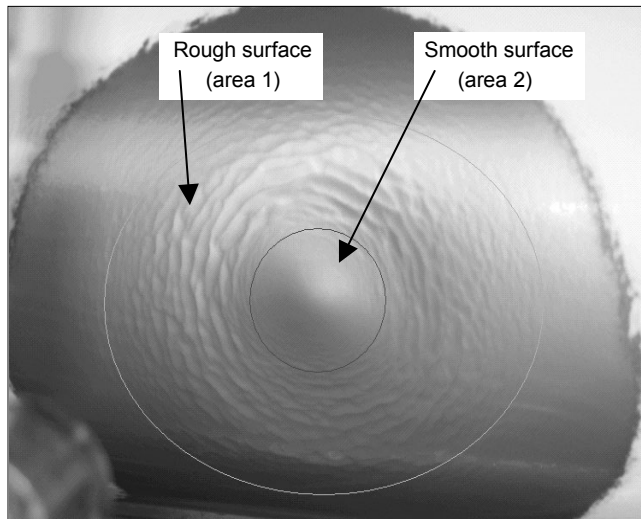
From physical examination it was clearly observed that orifice jetting produces an impact on the specimen pipe which resembles a round shape. One thing peculiar about the impacted surface is that the roughness of the impacted surface is not evenly scattered. This is indicated by the existence of two distinct areas on the specimen's surface, with one being smooth while the other being very rough. Figure 5 below depicts a specimen surface after an exposure of 170 hours to erosive jetting.

Figure 5 Specimen surface after impact

According to Figure 5, divergence away of the jet from its center point does occurred as the mark left upon the impacted specimen is larger than 5 mm diameter that bears the size of the orifice. Dispersion of water jet structure away from its center point is basically due to the high resistance of the initial impacted media which in this case is water impacting on sand particles.

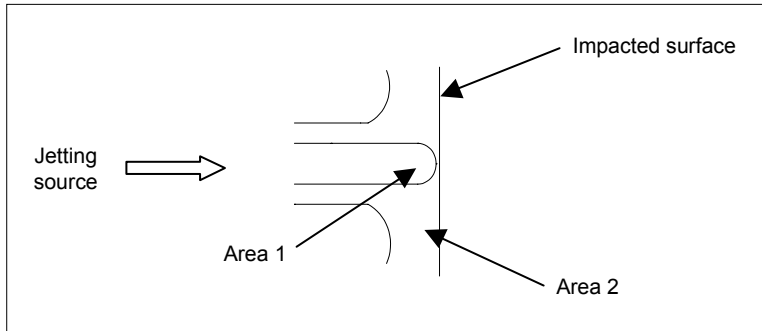
Area 1 is the one that has water as the majority erosion media. This has occurred due to the fact that the velocity of that area is higher compared to the velocity of Area 2. Difference of velocity resulted to the difference of sand carrying ability of the water jet. Sand carrying ability is the ability of the water jet to carry as much as possible of the abrasive media which in this case are the sand particles.

Figure 6 Orifice jetting profiling

In this particular case, the velocity of the various areas in the water jet resulted to the difference in the abrasiveness of the water jet. For example, velocity of the orifice outlet in Area 1 was found higher compared to the one in Area 2. Therefore its ability to carry sand particles is subsequently reduced due to the weight of the sand which reduces the sand particles' ability to move with high velocity as in Area 1. Theoretically this could be verified with the equation below;

Those two areas could be characterized as the one where only water is the majority as the erosion media while the other sand is seen as the majority of the erosion media. The one which has water as the main erosion media has a smoother surface when compared to the one which has sand as the main erosion media. In order to explain this phenomenon it is imperative that Figure 6 to be referred to.

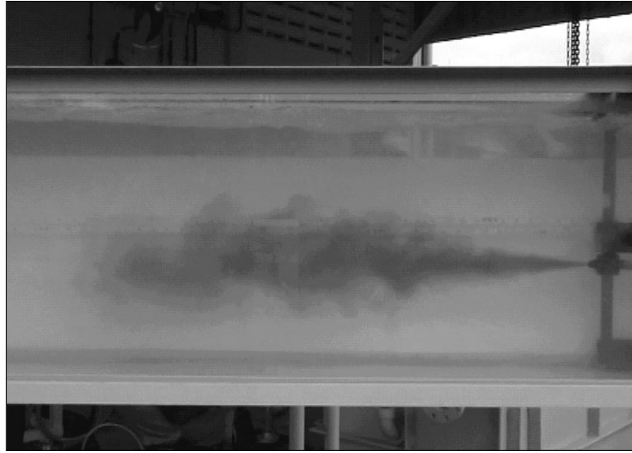
The turbulent flow is a result of the jetting pushing aside the impacted media away from obstructing it from moving forward. In order to further understand this phenomenon, Figure 7 shows the characteristics of jetting in water to water system.

Figure 7 Water to water jetting profile

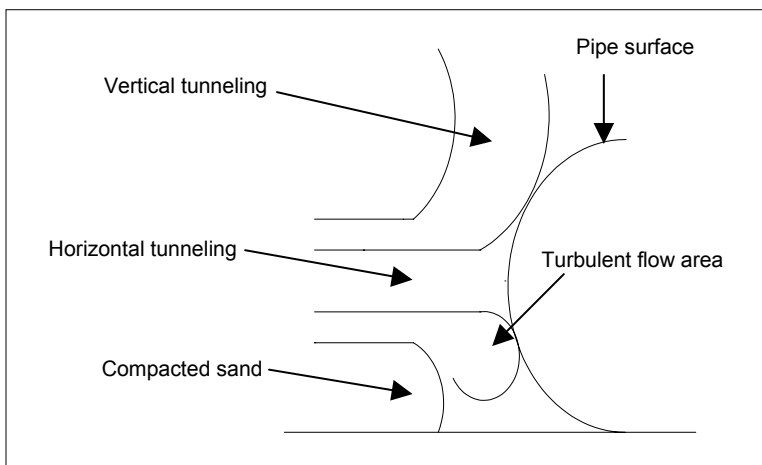
Tunneling effect could be describe as a pathway created due to the dispersion of sand to give way for water jet which has a high velocity. During the experiment two types of tunneling effect was identified. First being the horizontal tunneling and vertical tunneling being the later. Figure 8 shows how tunneling effect was formed.

This diagram shows that the existence of the vertical tunneling is due to the upwards movement of the jet after it has been impacted upon the pipe surface.

Figure 8 Tunneling profiling

Following the pipe curvature the upwards flow is a lot evident compared to the downward flow direction. This phenomenon is contributed to compact sand resistance on the upper side of the pipe that is significantly lower compared to the one beneath it. Compacted sand above the pipe can be easily dispersed due to the condition above the pipe being in the manner of an open system which has direct contact with the atmosphere. Upward movement of the jet resulted to the gradual collapsing of the sand structure above the pipe specimen. This in time will bring upon a hollow like vertical tunnel which allows the movement upwards steadily without much resistance.

In order to determine the average thinning rate of each point, the initial pipe thickness reading is subtracted by the last pipe thickness reading and divided by the total period of experiment. Table 3 is a table denoting each point's thinning rate for orifice water jetting. Points indicated in the table were based on the points marked rendered by the designed template shown in Figure 4. The table clearly showed that the highest thinning rate is in the line E region while the lowest thinning rate is evident in the line A region. This could be explained by the existence of vertical tunneling near Line A region and turbulent flow area near line E region as previously shown in Figure 8.

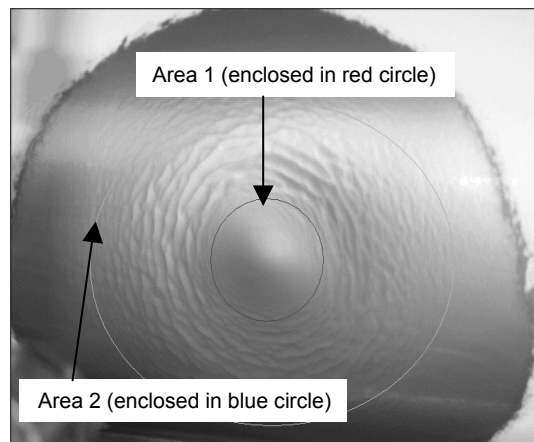
Figure 9 Tunneling effect on pipe

It could postulate that the shape of the horizontal tunneling depends on the type of jetting apparatus used. As tunneling created by the 5 mm orifice from a distance of 20 cm away from the jetting source is round in shape. Diameter of the tunneling on the specimen impacted by water jet from the orifice around 5 cm. Figure 9 shows the tunneling diameter (area 1).

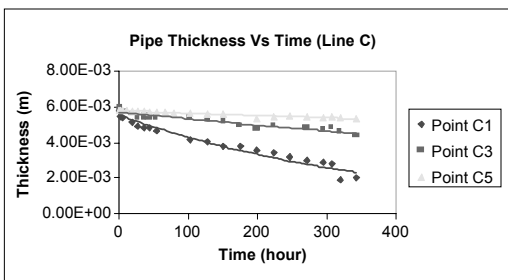
Figure 12 Analysis of Line C

From physical examination of the graph to be presented (Figure 10 to 14) it could be concluded that the rate of thinning in Zone 1 is higher compared to the rest of the lines regardless of the lines on which the points are located. This could be explained by the fact that during the jetting operation, tunneling effect was present. Thus, Zone 1 eroded at a higher rate compared to the rest of the zone. This phenomenon is largely contributed by the erosive sand slurry thus hampering its thinning rate compared to the points in Zone 1 which coincides with Area 2 of the tunneling created. Figure 10-14 illustrates the relationship between thinning rate and orifice jetting time.

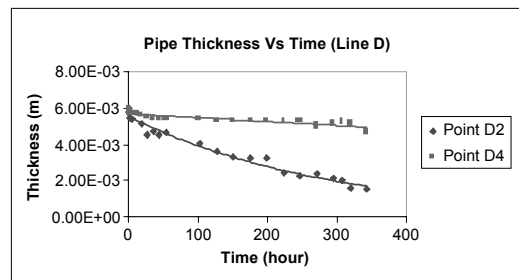
Figure 13 Analysis of Line D

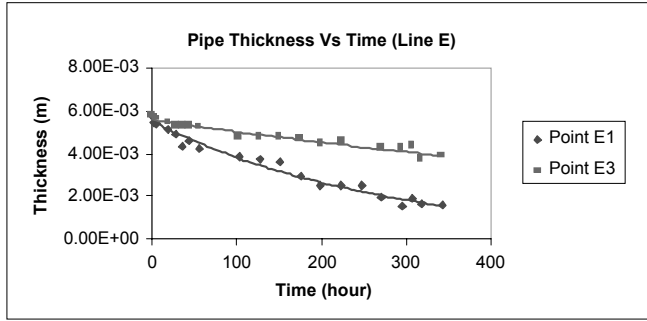
Figure 14 Analysis of Line E

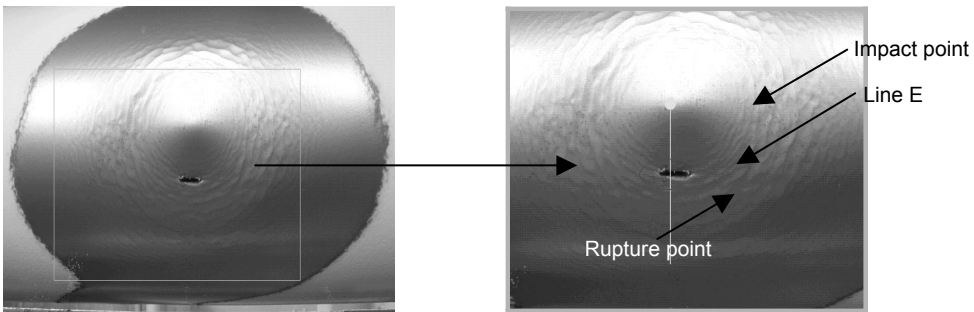
Figure 15a Picture of ruptured specimen

Figure 15b Close-up of the rupture point – blue enclosure

Besides the effect of turbulent flow in line E region, one must never forget the existence of gravitational effect. Thus, the sand with high mass would not be able to travel upwards without being pulled downwards by the gravitational force, and subsequently stays near line E region, with higher acceleration thus creating a higher concentration of abrasive material. The obvious proof that line E region has a higher thinning rate is the fact that the rupture point during the experiment lies within line E shown in Figure 15.

From the earlier observation made, it is true that the area with the thinning rate or the rupture point coincides with line E region due to the turbulent area within its vicinity. The rupture took place after almost 220 hours (Figure 16).

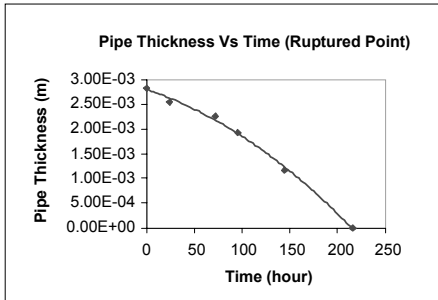
Figure 16 Thickness loss versus time for rupture point

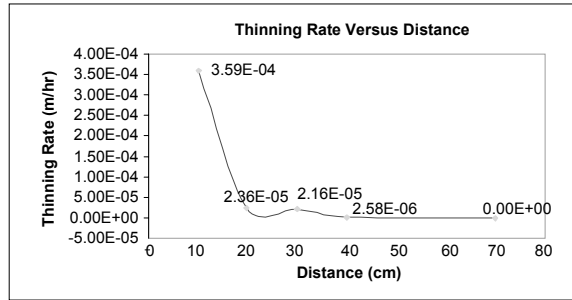
Figure 17 Thinning rate versus distance

Figure 17, indicates that the relationship of thinning rate versus the distance from the outlet of a 5 mm diameter orifice is inversely proportional from each other. The increase in distance will eventually reduces the thinning rate of the specimen. It could also be identified that the abrasive effect of the jetting stops completely at a distance of 70 cm away from the jetting source. The trend of the graph indicates that the distance of abrasive effect upon the impacted surface stops at around 45 cm away from the point of jetting. The separation distance shows that a gas piping surface must be of at least 300 mm away from piping surfaces which runs parallel to it. This in practice is clearly insufficient in curbing the problem of erosive water jetting.
