Vulnerability assessment of building material against river flood water: case study in Malaysia

Abstract. Flood risk is increasing in Malaysia specifically around river which influencing of climate change. The aim of this study is assessing the vulnerability of building materials by revealing the degree of loss for each structure. There are most five common materials has been assessing namely: brick, concrete block, steel wall panels, wooden wall and precast concrete framing. This research was conducted on 110 buildings, to record detailed attributes of each building in the city of Kuantan. Afterwards, the interviews were conducted with residents of 85 households along with a local authority staff expert. The lowest flood depth that effected on wall building was 25 cm and the highest depth of flood was recorded 150 cm. In general, the interview revealed that the flood lasted for 48 hours. The vulnerability of the structural type of building is determined from the percentages of damage to the wall material resulting from occurrence of the flood. Vulnerability curves were made for these five structural types, by plotting the relationships between flood depth and damage for each stru

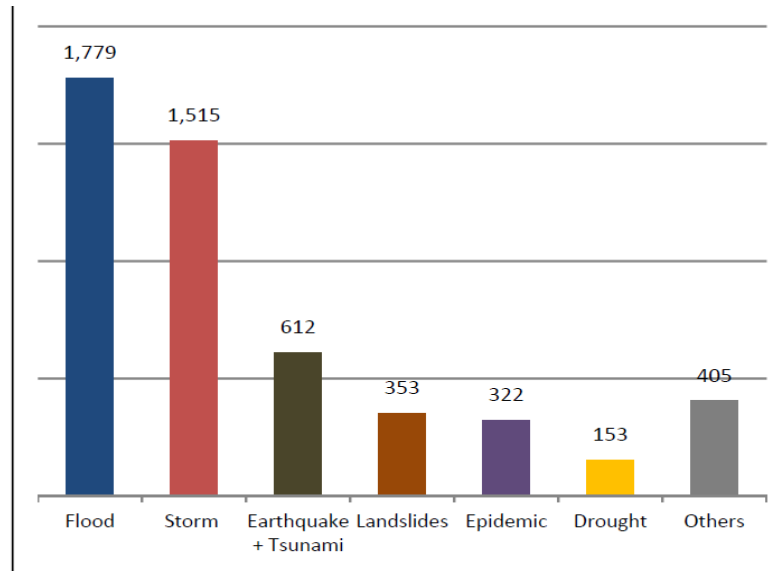
Figure 1. Occurrences of Natural Disaster Events in Asia and the Pacific by Type (1970 – 2014) [7].

Nowadays, cities around the world are frequently exposing to natural hazard such as flooding. Flood become one of the hazards that has a significant effect on human life [1]. As Figure 1 shows the number of natural disasters has been increasing in the last fifty years ago which its cause of climate change. Flood has been introduced as one of the barriers for development any country [2]. Previous research shows that more than 22% of Malaysian population is directly affected by flood [3, 4]. The number of floods since 2014 also has been increasing in many cities around Malaysia such as Kuantan, Pahang and Johor. For example, Malaysia's annual northeast monsoon has claimed two lives in Pahang and forced nearly 12,000 people to be evacuated from their homes nationwide. The number of flood occurrence also has been increased in last few years. For example, February 22 - February 28

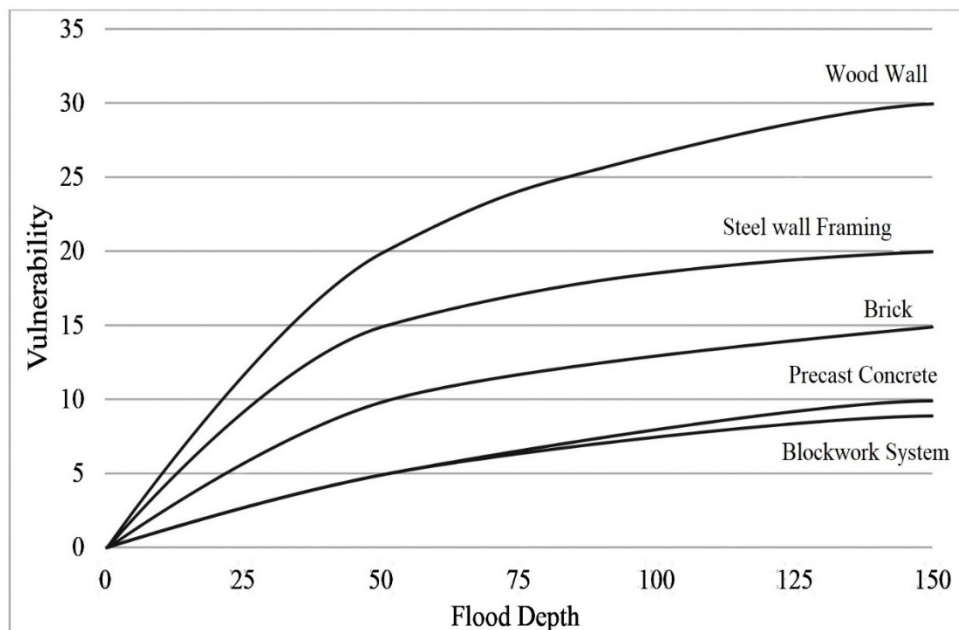
Figure 3. Vulnerability Function for Each Structural Type of House Source in one graph.

The first structure is blockwork system as shows in Figure 3 that has a better performance compare to other structures. By rising floodwater to 50 cm only 5% of wall damaged that needs to be repaired, while water rising to 150 cm the percentage of repairing wall material exceed around 9%. Although this structural type is strong against floodwater, some people also spent some money to repair the minor damage. For instance, they repair the house after floods by painting the wall or re-enforcing some holes that took place because of floodwater remaining inside the house.

This research is discussed that how high flood effect the wall materials. Figure 3 shows the comparison between five different structures and their relation of percentage and depth. Wood wall shows the most vulnerable structure against the water flood and it means there are more part of wall needs to be replaced by new material, which it can be inconvenience for house owner. The second wall structure that shows vulnerable is steel wall framing which the damage of this wall is 10% less than wood wall in 150 Cm of flood depth. However, the stability of brick against the floodwater is not as much as blockwork system but still can be acceptable if compare the damage to the wooden wall. The two most resistant wall structure are blockwork system and precast concrete wall, which both of this structure categorized as IBS system. The National Security Council Directive No. 20 (NSCD) is a department that provides the policy and guidelines on disaster management. The result of current research can be used by NSCD toward mitigating of flood damage on construction building. Future research can focus on Social effect of flood damage on resident life since there was evacuation after flood.
