Effects of Starter Defect on Energy Release Rate of Three-Point End-Notch Flexure Tested Unidirectional Carbon Fiber Reinforced Polymer Composite

Abstract: The mechanics of damage and fracture process in unidirectional carbon fiber reinforced polymer (CFRP) composites subjected to shear loading (Mode II) were examined using the experimental method of the three-point end-notch flexure (3ENF) test. The CFRP composite consists of $[0^{\circ}]_{16}$ with an insert film in the middle plane for a starter defect. A 3ENF test sample with a span of 50 mm and interface delamination crack length of 12.5 mm was tested to yield the load vs. deformation response. A sudden load drop observed at maximum force value indicates the onset of delamination crack propagation. The results are used to extract the energy release rate, G_{IIC} , of the laminates with an insert film starter defect. The effect of the starter defect on the magnitude of G_{IIC} was examined using the CFRP composite sample with a Mode II delamination pre-crack. The higher magnitude of G_{IIC} for the sample with insert film starter defect was attributed to the initial straight geometry of the notch/interface crack and the toughn

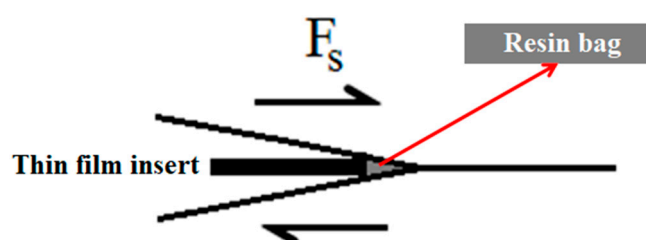
Figure 3. Resin bag supposed to feature in sample with thin film insert as starter defect.

Presence of resin bags in CFRP1, as mentioned above, might be the cause [17]. Resin bag's fiber volume fraction is low, which means it has a higher matrix content. The higher G_{IIC} of CFRP1 might be reflected from this corresponding higher matrix content at the resin rich crack tip. Additionally, crack front condition of the CFRP2 might be influential as well. As mentioned above, there is possibility that the crack front of CFRP2 might be curved, which means the crack front is longer than the initially linear crack tip. Damage zone developed at the crack tip dissipates some portion of the total external energy the sample was subjected to (by shear loading), before macroscopic propagation [16]. The longer the crack tip, as in CFRP2's supposedly curved crack front, the more strain energy dissipated prematurely and did not reflect in the bulk composite's force-displacement curve. Hence, the lower G_{IIC} of CFRP2.

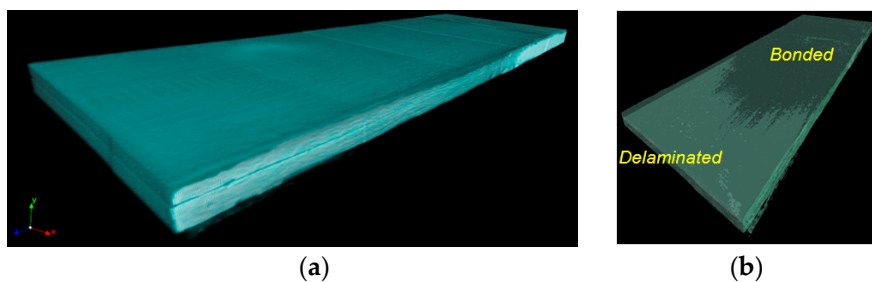
Figure 4. Isometric views of (a) the 3ENF tested unidirectional CFRP composite with thin film as starter defect (CFRP1) and (b) with its crack front profile visible.

From the available 3D image (one representation is in Figure 4), the cracked CFRP1 features the curved crack front. This micro CT image of curved crack front profile, as the result of 3ENF test on unidirectional CFRP composite, is currently the first one ever reported. A previous report [16] had indirect analysis that crack front of 3ENF tested CFRP was curved, but no image was shown as evidence, and attempts to verify this by sectioning and acoustic emission were unsuccessful.

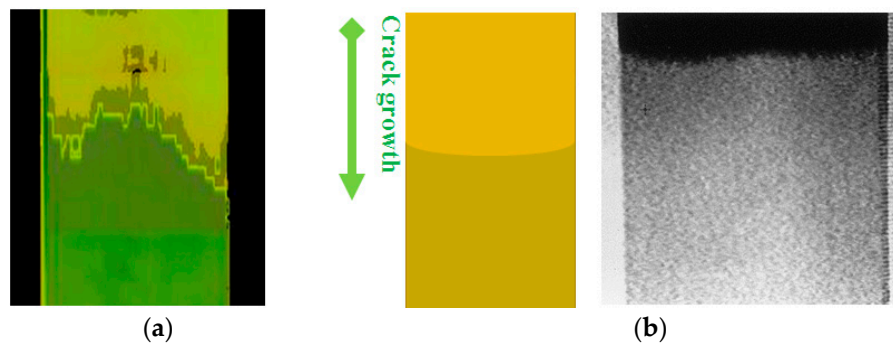
Figure 7. Internal crack profiles of (a) Mode II fracture in this study and (b) Mode I fracture [19].

Comparing the crack front profile between that obtained from mode II fracture test found in this study and mode I fracture test performed previously [19], the orientation of the curve was the opposite (Figure 7). The propagation pattern that eventually becomes the final crack front profile might be governed by the location of the site of initial crack. Considering the crack front profiles of CFRP1 and CFRP2 reported here, it seems crack initiation started from the edges. The microcracks might initiate from sites with less matrix content (higher fiber volume fraction) at the edges, created when the specimen was sectioned. This observation that the crack initiated at the edges puts a doubt to analysis in Section 3.1, where the cracks initiated due to fiber breakage like what happened to flexure tested CFRP composites [13].

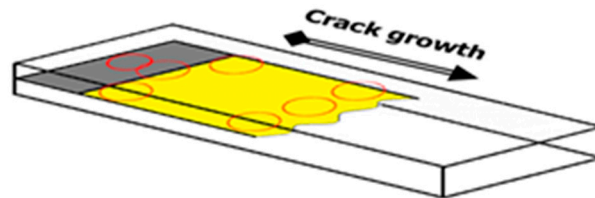
Figure 8. Schematic drawing of the location of the SEM observation on CFRP2 sample.

Fractography analysis on 3ENF tested CFRP composites was done using scanning electron microscope (SEM). It was intended to complement the analysis on damage mechanisms on the unidirectional CFRP composites. Another intention was to verify the findings from micro CT scans, since the rendered images resolution of the scanned object was not so high. The 3ENF tested samples were opened to reveal the paths of crack propagation. The analysis was done only on the CFRP2 sample, since it featured both the traces of crack front from 3ENF tested CFRP1 and the final crack front of CFRP2 itself. Considering the small area coverage of SEM, the images should be captured from multiple sites of interest within the sample. A schematic drawing showing the locations of the SEM observation taken on the sample is depicted in Figure 8. To help clarify the location, top view of the sample showing the location of SEM observation was also presented (Figure 8). What to observe in Figure 9a is the trace of a crack front left behind by 3ENF tested CFRP1. Four locations were observed for this purpose. Point 1 was at the pre-cracked area (initial) where it included the insert film’s image.

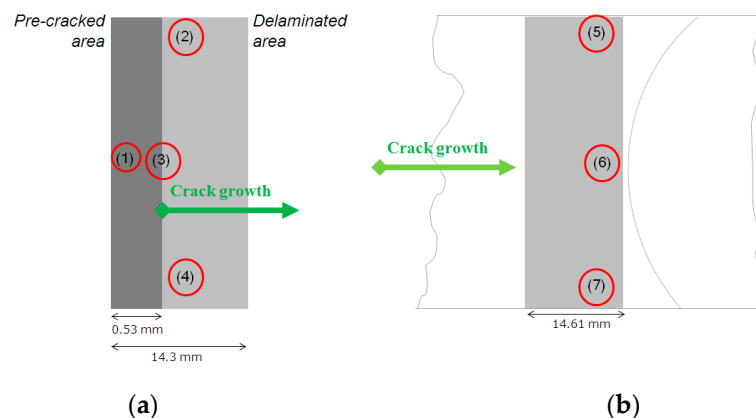
Figure 9. Schematics of top view of the CFRP2 sample showing the locations of SEM observation: (a) initial condition and (b) after 3ENF test.

Points 2 and 4 show the delaminated area at the edges, while point 3 is at the center. Figure 9b shows the shortest final crack front of the 3ENF tested CFRP2, where points 5 and 7 were at the edges while point 6 was at the center. The longest path of the crack front at edges was not observed due to difficulty in sectioning the sample without forced opening (intended to preserve the crack front).
