AN EXPERIMENTAL AND FIELD STUDY OF CAVITATION DETECTION IN
PUMP

A thesis submitted in fulfilment of the
requirements for the award of the degree of
Master of Engineering (Mechanical)

Faculty of Mechanical Engineering
Universiti Teknologi Malaysia

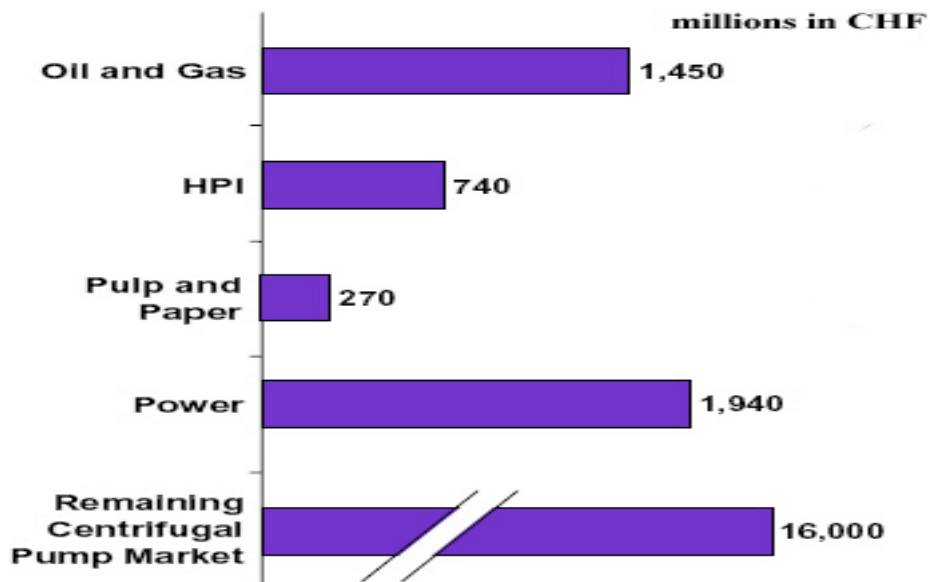
Figure 1.1: Estimated new pumps market (extracted from Sulzer Pumps)

From the estimation of new pump market done by Sulzer Pumps (2006) as shown in Figure 1.1, centrifugal pump consists more than 70% of the estimated new pump market with a financial cost of 16 billions CHF. It is therefore not surprising that continuous extensive research & development for pump manufacturers and operators had been undertaken.
