AUTOMATED PAVEMENT IMAGING PROGRAM (APIP) FOR PAVEMENT CRACKS CLASSIFICATION AND QUANTIFICATION – A PHOTOGRAMMETRIC APPROACH

M. Mustaffar^{a*}, T. C. Ling^b, O. C. Puan^b

^aSurveying Unit, Faculty of Civil Engineering, Universiti Teknologi Malaysia - mushairry@yahoo.com ^bDept. of Geotechnics and Transportation, Universiti Teknologi Malaysia

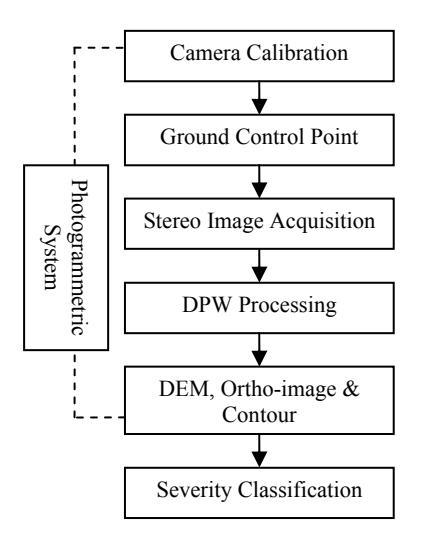
Figure 1. Schematic diagram of the photogrammetric system

An overview of the research procedure developed for pavement distress evaluation is presented. A combination of close-range photogrammetric and image processing metrology were developed in various stages and is illustrated in Figure 1 and 6, respectively.

In the first stage, a stereovision measurement technique is developed to evaluate and monitor the pavement conditions. To achieve this, several processes were conducted. These processes were categorized as, camera calibration, ground control, image acquisition and digital photogrammetry workstation (VirtuoZo) processing. The following sections describe these processes.

Ground control is currently provided by means of a frame that was calibrated in the laboratory. This arrangement was chosen because it is convenient to be used in the field.

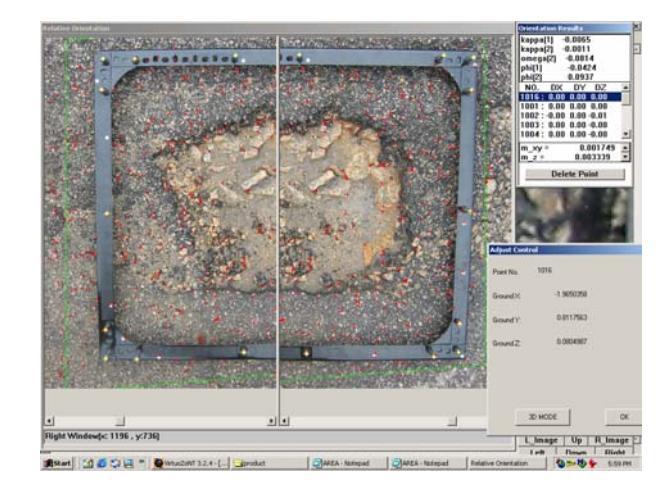
Figure 3. Relative orientation of stereo image

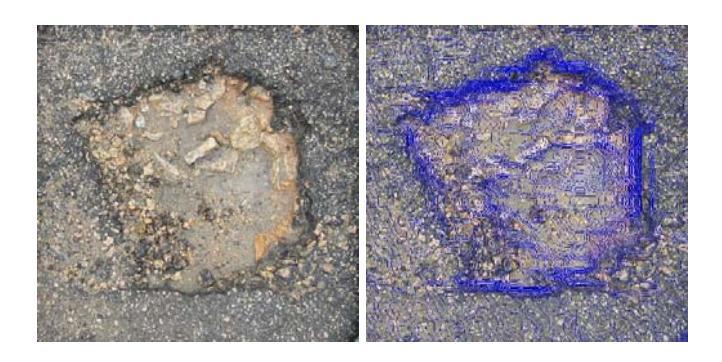
Figure 4. Ortho-image and contour overlap of pothole

After performing the steps in VirtuoZo digital photogrammetry workstation, ortho-image and contour overlay as well as 3D DEM data was generated. Figures 3 and 4 show the ortho-image and contour overlay of pothole (disintegration) distress respectively.

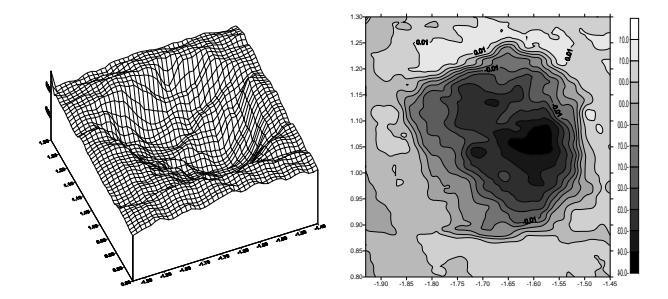
Figure 5. 3D model and contour plots generated by SURFER

3D DEM coordinates output from VirtuoZo became the input data for SURFER software and MATLAB to produce contour plotting and cross section plotting respectively. SURFER consisted of three programs: QGRID, TOPO and SURF. QGRID takes irregular data from ASCII file and created a regularly spaced 'grid'. The reformatted file was then entered into a graphics programs, TOPO or SURF. TOPO created topographic maps and SURF created three dimensional terrain surfaces. The 3D surface as shown in Figure 5 shows that the Y-axis coordinates were positive in the direction of traffic movement; the X-axis coordinates represented the measurements crossing the road; and the Z-axis coordinates area were positively upward.

Negative surface area of 3D model shown in figure was assumed as the bowl shaped cavity in the pavement surface (area of pothole). Volume and area of pothole was then calculated at about 0.00354 m^3 and 0.1182 m^2 respectively, with the help of the program SURFER. Consequently, depth of the distress of about 29.95 mm could be easily determined by dividing the volume with the area. The severity of pothole was classified according to the DEM data based on guidelines set by the Public Works Department (JKR) of Malaysia. Based on Table 1, the pothole was classified as a moderate level.

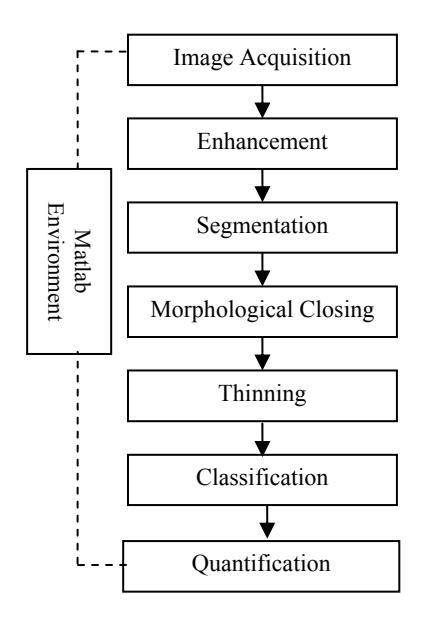
Figure 6. Schematic diagram of the Matlab environment

The second stage is to develop an Automated Pavement Imaging Program (APIP). The APIP for pavement crack analysis involved six major steps: image enhancement, image thresholding, morphology closing, thinning, distress classification and distress quantification.

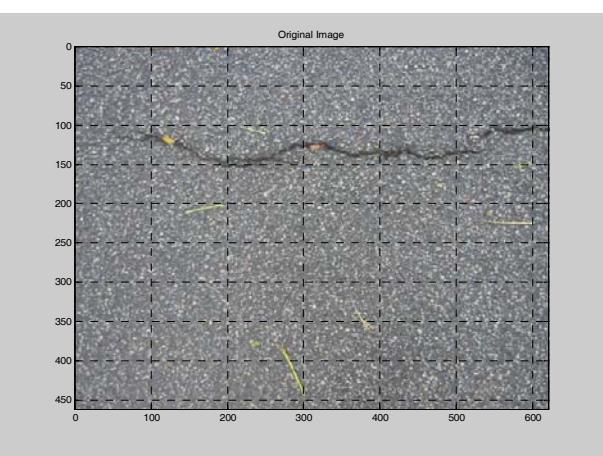
Figure 7. Original image of pavement cracks

Once the optimal threshold value was determined, the pixels with gray level below the threshold were referred to as distress pixels and pixels whose gray level value exceeded the threshold were referred to as background. The selection of an appropriate value played a very important role in the entire process since it was the value that ultimately defined the mapping of the distress features in the binary image. It is found that the simple image enhancement algorithm worked well in predicting the presence or absence of distress features on the image as shown in Figure 7. Figure 8 show the binary image obtained from proposed segmentation algorithm

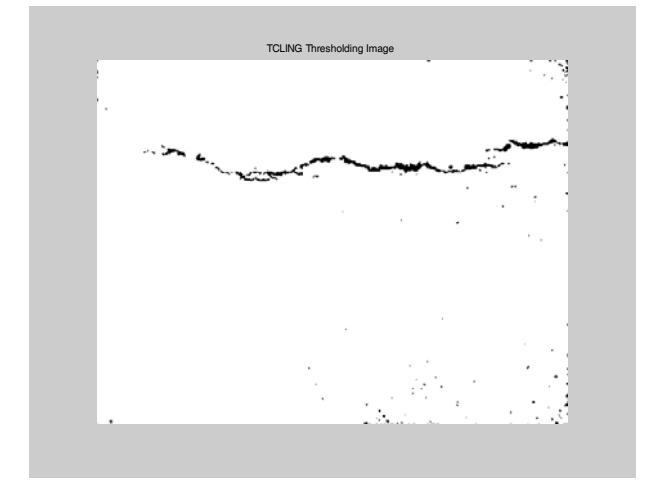
Figure 8. Binary image (proposed algorithm) of pavement cracks

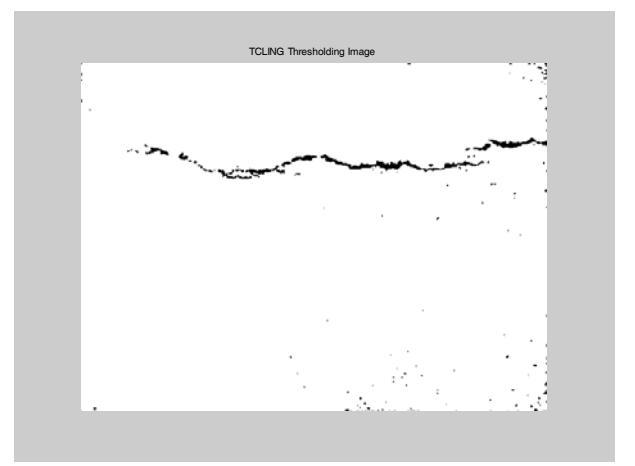
Figure 9. Image segmented of Figure 3 before closing and noise removal

Figure 9, which is a segmented image of Figure 7, shows how some noise cluster occupies open space corresponding to the background. Noise removal at the threshold of 10 pixels was applied, followed by performing morphological closing with structural element of size 5, than producing another binary image. The resulting aspect is shown in the sample of Figure 10, where it can be noticed that some of the noises have been removed and some holes being filled with object pixels.

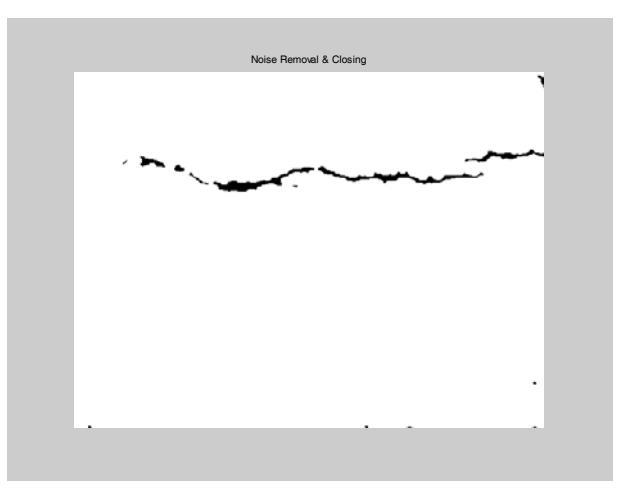
Figure 10. Image segmented of Figure 7 after closing and noise removal

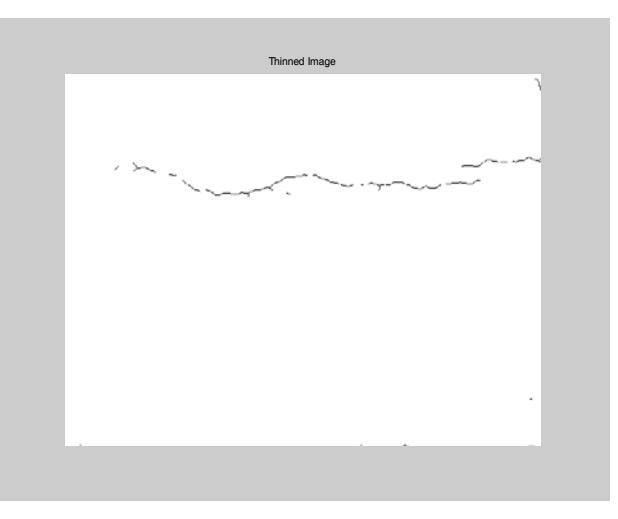
Figure 11. Image of Figure 6 after thinning

The binary image with clusters was not useful enough and had to be further processed by thinning. After thinning, a generic source image had the appearance as shown in Figure 11. Crack length was determined using the thinning algorithm based on the central lines with one pixel wide. Then, the average width of crack was obtained by dividing the area and the length. These parameters were found to be very beneficial for cracking quantification.
