## Geospatial approach for Landslides Vulnerability Assessment of Physical Infrastructures in Sireh Park, Johor Bahru

### Abstract

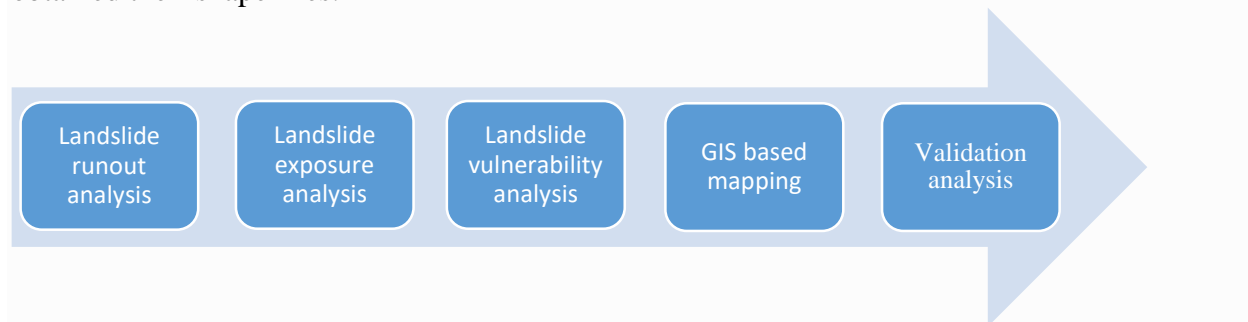
**Figure 2.** Methodological flow of the study

vulnerability analysis, GIS based mapping, and validation analysis as shown in figure 2 below. The landslides inventory was overlaid with google earth image in order to locate the landslides area. This is done by converting obtained landslides inventory shapefile into KML file, the file was then imported to Google Earth Pro. Thereafter, an individual landslide polygon was demarcated from Google Earth imagery through the process of digitization.

The landslides inventory was used to generate landslides hazard map in GIS environment, which was later combined with the slope gradient map to generate the landslides run out distance at the boundary of the Sireh Park. In producing the landslides run out map, slope failure runout analysis is carried out along the boundary of Sireh Park, the value of slope gradient has been integrated with the specific hazard classification in GIS software. The landslides runout distance map was used to identify the interested elements at risks (buildings and roads) around the study area. A mobile tool was used to collect the data about the identified elements at risk and their associated vulnerability indicators and sub-indicators during field surveys. The tool was developed by Universiti Teknologi Malaysia on an ESRI mobile platform. It can collect data on elements at risk that include slope, building, road, and socio-economic. Also, Google Earth Imagery of the study area was georeferenced and used in GIS software to digitized the elements at risk in order to obtained their shape files.

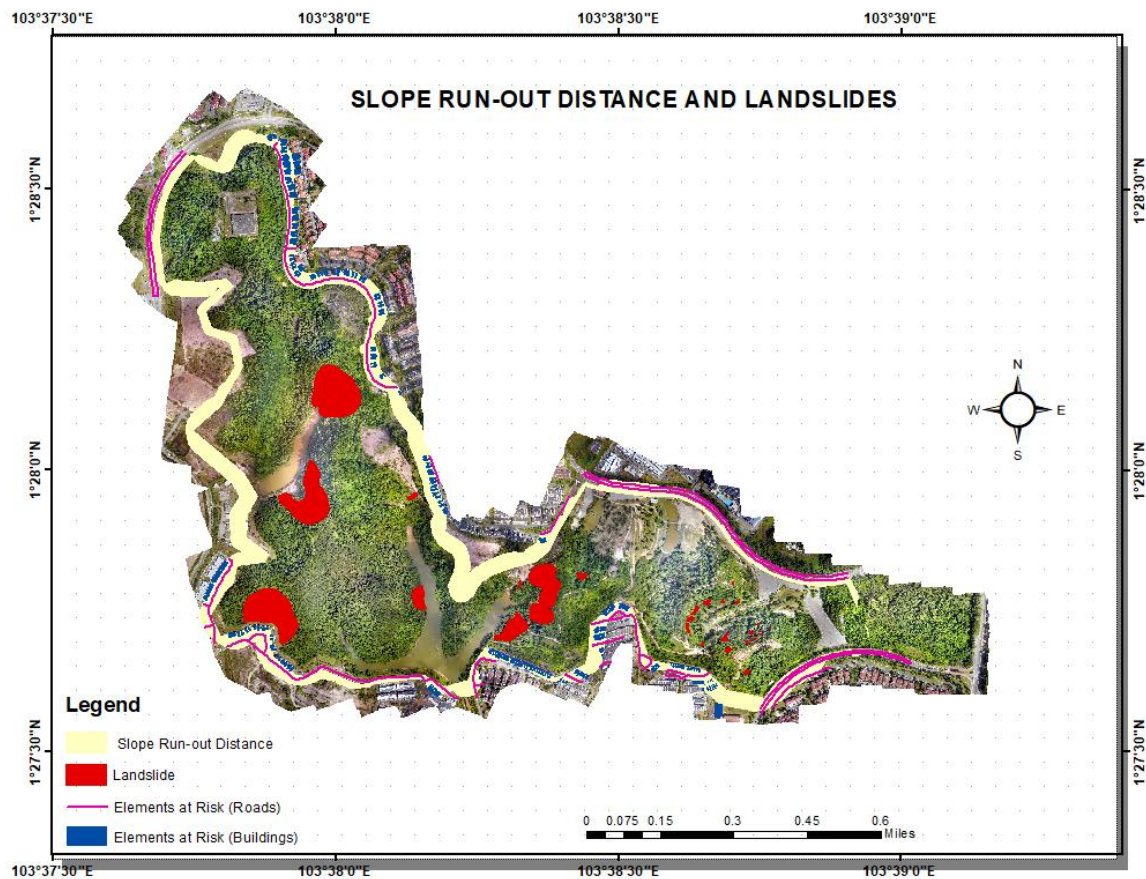
**Figure 3.** Map showing run-out distance and exposed elements at risk in Sireh Park

In figure 3 below, the yellow boundary encircling Sireh Park visually represents the extent of the landslides' runout distance, containing both linear road features and polygonal building structures located within, touching, or situated between this delineated area and the Sireh Park. They are the exposed elements at risk of physical infrastructures in the study area. The executed run out distance shows about 252 elements at risk exposed to landslides in Sireh Park, if landslides are to happen. Out of this number, 226 are buildings, which represent 89.7% while 26 are roads, which represents 10.3%. In addition, out of those buildings, 188 that represents 83.2% have 2-5 levels including the Chinese School while the remaining 38 that represents 16.8% have single floor. Meanwhile, out of the 26 roads, 23 that represents 88.5% are urban local streets while the remaining 3 that represents 11.5% are urban arterial roads.

Also, majority of those exposed elements at risks are located in the southern part of Sireh Park with about 138 houses out of 226, and 15 roads out of 26. Altogether, 173 out of 252. This accounted for 68.7% of the total number of the exposed elements at risk in the study area. This indicates that elements at risk in southern part of Sireh Park are more potential to landslides than those in the northern part.

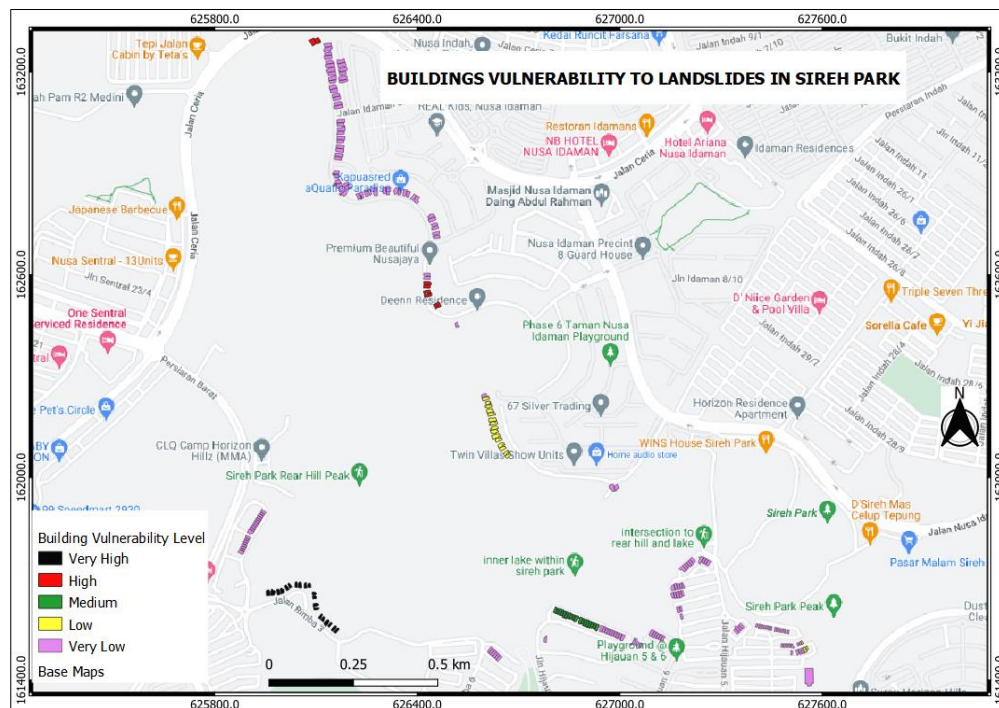
Figure 4. Map of landslide vulnerability of buildings

From the figure 4 below, buildings are classified into five (5) classes of vulnerability using natural breaks classification method in GIS software. The classification is from very low- showing those buildings with lowest vulnerability to very high- showing those buildings with highest vulnerability to landslides. Buildings represented with red colour have highest vulnerability with value ranging from 0.0773 to 0.0986, while those with dark blue colour have the least vulnerability values, ranging from 0.0324 to 0.0339. From the map, 137 buildings have low landslides vulnerability, which is about 60.6%; 26 buildings have high landslides vulnerability, vulnerability, which is 11.5%; 25 buildings have very low landslides vulnerability; 20 have very high landslides vulnerability which is 11.1%; and 18 have medium vulnerability which is 8.0%.

The reason for very high vulnerability for those buildings may be due to no protection at the slope around them, they are located at the toe of the slope, landslide accumulation height around them is greater than 2 meters, landslide volume around them is greater than 250000m<sup>3</sup>, and they have average population density. Some of these reasons are in line with the findings of the studies conducted by Francone (2022) and Singh et al. (2019).

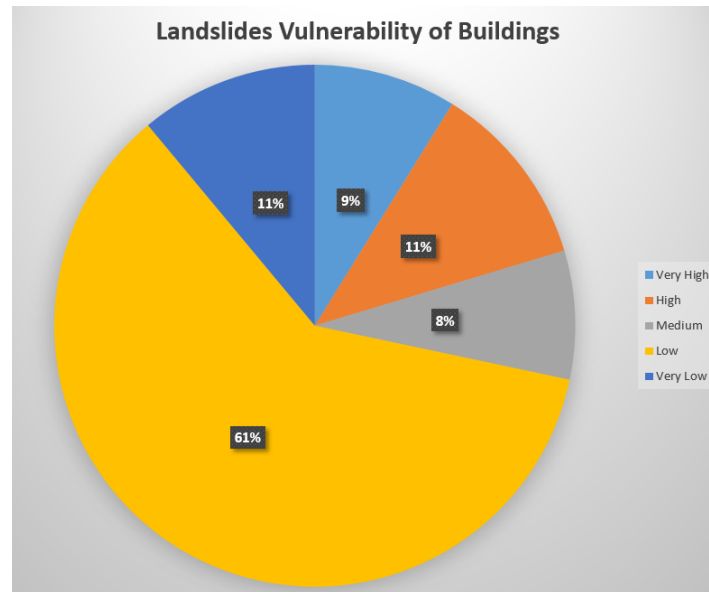
**Figure 5.** Graphical representation of buildings vulnerability to landslides in Sireh Park

According to the data presented in figure 5 below, a significant majority of the structures situated within Sireh Park exhibit minimal vulnerability to the hazards posed by landslides. Several factors account for the relatively low level of vulnerability among these buildings, including the presence of deep foundation piles, medium-rise floor plans, engineered slope protection systems, and a lack of landslides with accumulation heights exceeding 1.5 meters in close proximity to the structures. Additionally, the buildings' renovation status and moderate population densities contribute to their resilience. Notably, landslide volumes exceeding 500m<sup>3</sup> and accumulation heights greater than 0.2m are observed in the surrounding areas of these structures, further underscoring the importance of implementing effective protective measures.

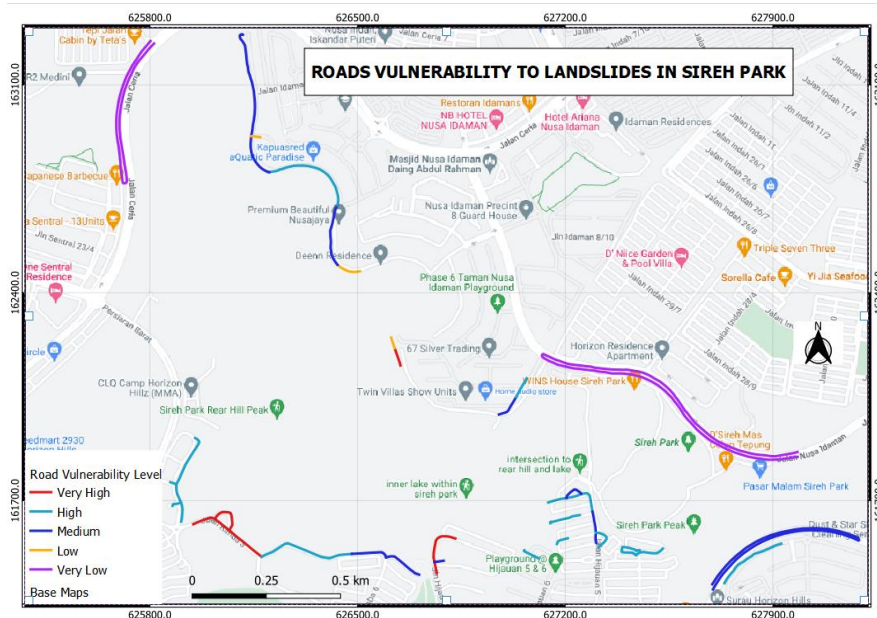
Figure 6. Levels of landslides vulnerability for roads in Sireh Park

The classification of roads based on their vulnerability to landslides in Sireh Park is shown in figure 6. From the figure, approximately 31 sections of roads are vulnerable to landslides in Sireh Park. Of these sections, 13 have a high level of vulnerability (0.0301-0.0341) and account for 41.9% of the vulnerable sections. Additionally, nine sections have a medium level of vulnerability (0.0281-0.0301) and account for 29% of the vulnerable sections. There are also four sections with a very high level of vulnerability (0.0341-0.0419) that account for 12.9% of the vulnerable sections, while three sections have a low level of vulnerability (0.0265-0.0281), accounting for 9.7% of the vulnerable sections. Finally, two sections have a very low level of vulnerability (0.0255-0.0265), accounting for approximately 6.5% of the vulnerable sections in the study area. Most of the roads with high and medium vulnerability are located in the southern part

of Sireh Park. This suggests that the majority of roads in the southern part of Sireh Park are more vulnerable to landslides compared to those in the northern part.

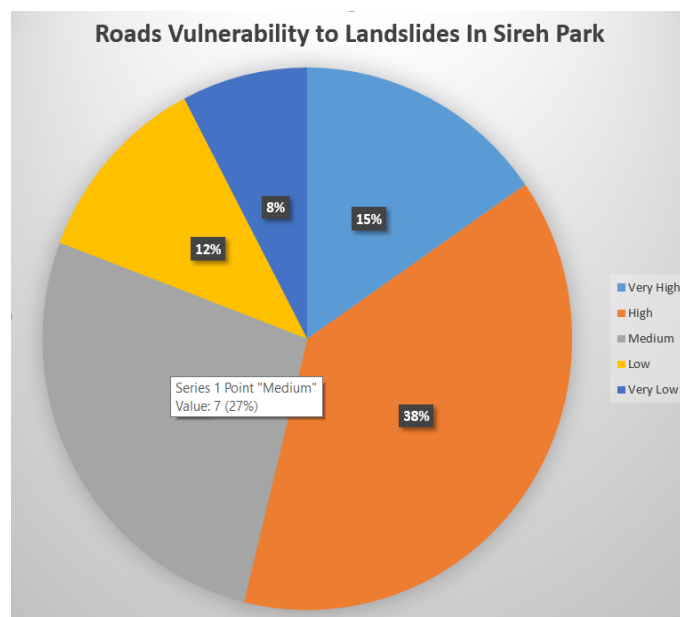
Figure 7. Pie chart showing levels of roads vulnerability to landslides in Sireh Park

In figure 7 below, majority of the roads in Sireh Park are having high vulnerability to landslides. The reasons for this high vulnerability is attributed to the roads having the following indicators: the road is located within the height of the slope, the road has no protection, landslide accumulation height is less than 0.2 meters, landslide thickness is less than 1.5 meters, and landslide volume is less than 500m<sup>3</sup>

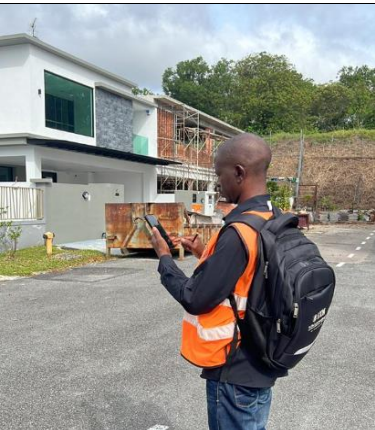
<p>Buildings and road located within the height of the slope. 1.467175°, 103.636083°</p>

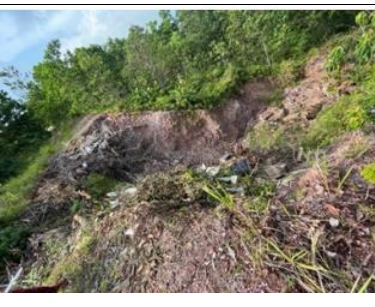
<p>A slope failure outside the border of Sireh Park but close to residential area 1.466111°, 103.635556°</p>

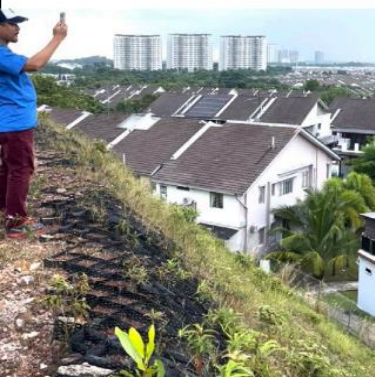
<p>Slope with rubber sheeting above the height of buildings 1.466111°, 103.635556°</p>

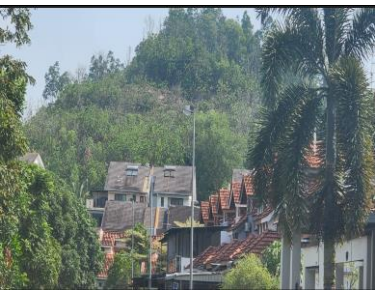
<p>Building located within the height of the slope 1.470233°, 103.635239°</p>

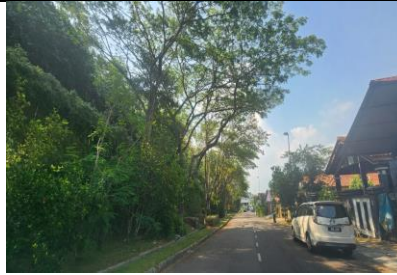
Road located at the foot of  
the slope  
1.475969°, 103.631797°
