Paper No.16: The Malaysian Experience

THE CONSERVATION OF KOTA DUYUNG: A REVIEW¹

Department of Architecture

Faculty of Built Environment, Universiti Teknologi Malaysia

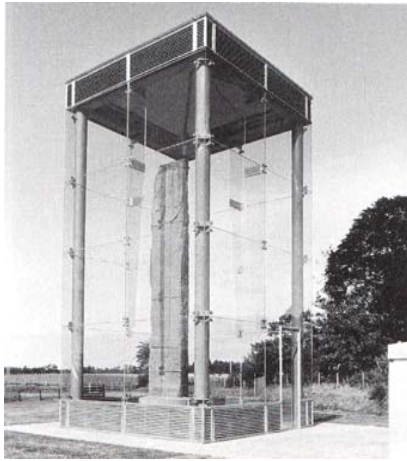
Fig. 1

In a sincere attempt to protect a historic object or artifact it is somehow unavoidable that the new structure becomes the subject in focused, in some cases even to the extent that overriding the prominence of the historic object. (Fig. 1)

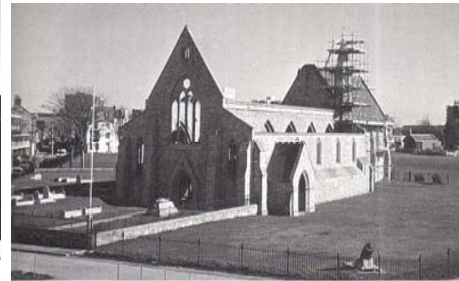
Fig. 2

This is probably the result of an over-enthusiasm on the part of the parties involved in the conservation effort resulting in an over-consolidated ruin. Rather than looks like a natural ruin it has made the fabric or structure to become a beautified ruin or sometime even gives an impression of an incomplete building. The danger here is that its historic ambience and setting might be lost entirely. (Fig. 2)

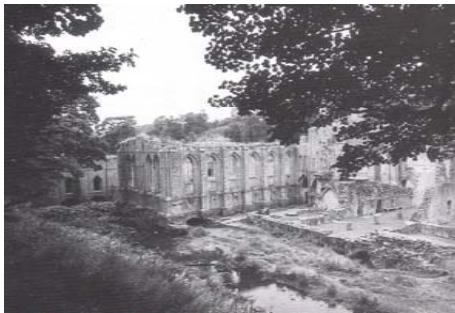
Fig. 3

A ruinous building can sometime become intimately integrated into nature thus forming a landscape of 'natural ruin'. It means that the ruin is so ingrained with nature to the extent that its significance as a ruin has been overtaken by the natural setting that is often picturesque or romantic. (Fig. 3)

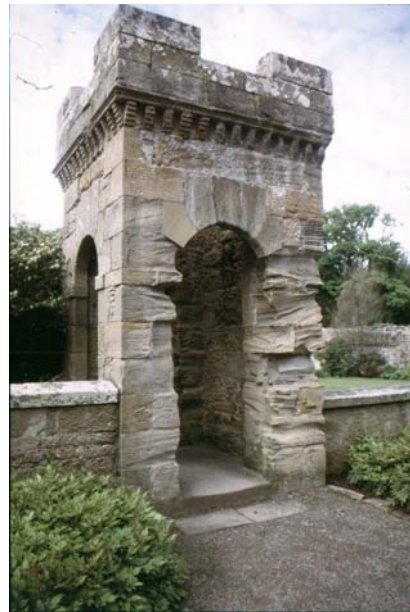
Fig. 4

Passing and living through the test of time, weather and other environmental conditions, a building is expected to have taken and give way to the forces of nature as it should. A damage caused by battering weather could be seen as a testimony of history that gives patina to the fabric. The same damage can also be understood as an unwanted element appearing on the structure causing structural instability as well as interrupting the intended architectural composition. So, a philosophical question as well as an ethical one

raised here is that how much loss is tolerable and acceptable? (Fig. 4)

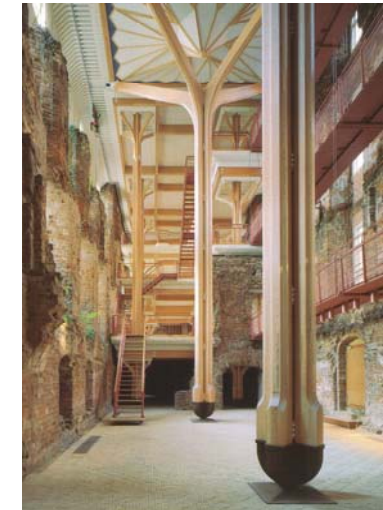
Fig. 5

Overly sympathetic intervention in an historic structure can sometime be seen as being too conscious about the need to differentiate between the existing fabric and the new structure. Of course it is highly recommended that any attempt as conserving historic fabric has to differentiate the old and new, between the existing and additional elements, in the most appropriate ways. An exaggeration of this attempt would only heighten the tension between the old and new rather than harmoniously marrying the two together. (Fig. 5)

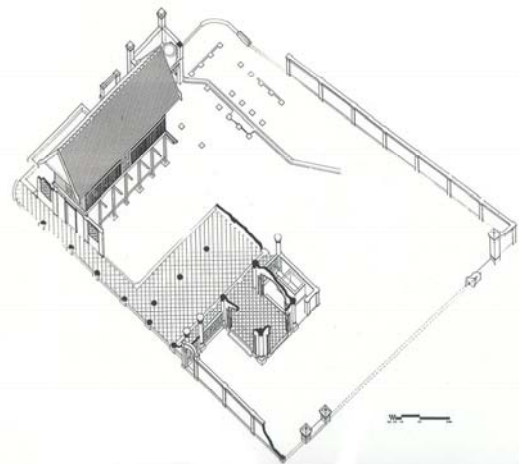
Fig. 6

The approach is to preserve the existing structures (the Rumah Bujang and part of the walls) intact as a historic fabric, no more and no less than what it is found. (Fig. 6)

This is considered as an ideal solution which allows the least intervention to the structure. However, in the case of Kota Duyung, the existing ruinous fabrics are perhaps too insignificant in scale to be preserved as they are. Coupled also with the fact that no important event or incident took place here thus making the building weak in its

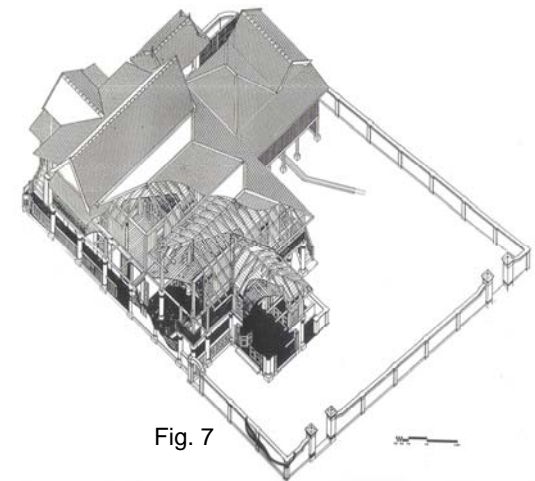
Fig. 7

The idea is to preserve the existing structures (the Rumah Bujang and part of the walls) and to reconstruct new structures as authentic as possible to the glorious period of 1920, including landscape within the house compound. (Fig. 7)

This alternative offers a more realistic solution than Alternative A allowing the flexibility in the choice of periods to be preserved or restored whilst appropriate improvement in the architectural composition can be made accordingly to respond to new functions. However a good program must first structured if this alternative is to succeed, otherwise the building might just be neglected within a few years.

After a long deliberation of all possible alternatives it was decided that Alternative B is the most appropriate and viable. This alternative was further deliberated and a clearer and more precise objective was formulated:

Kota duyung shall be reconstructed as authentically as possible to its glorious period of 1920, keeping the notion that Rumah Bujang shall be preserved as much as possible whereas all the existing remains shall be restored and the new structure shall be reconstructed as faithfully as possible according to the findings of the historical and architectural research.

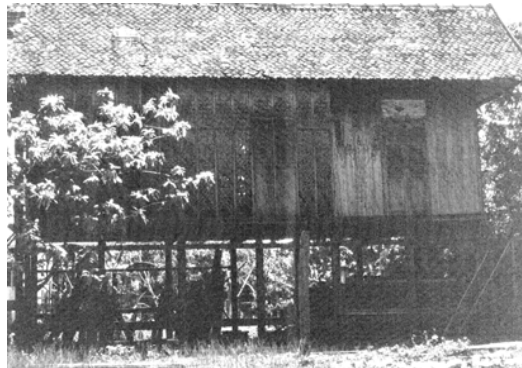
Fig. 8

This alternative offers the advantage of preserving the old but responding to the new because the protected Rumah Bujang (Fig. 8) and other ruinous parts of the place become truly an historical fabric whereas the reconstructed building on a new site. It would allow for greater flexibility in functional response and an appropriately broader architectural improvement could be made to cater for new needs since the building should also function as a museum.

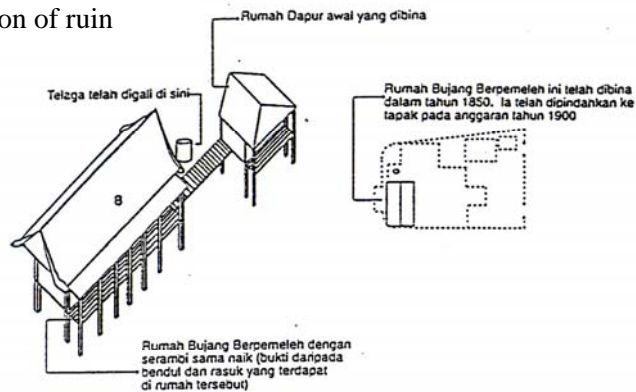
Gambarajah 1a: Peringkat 1: Pembinaan Rumah Bujang Berpemeleh (B)

Fig. 9 – The chronology of Kota Duyung physical development

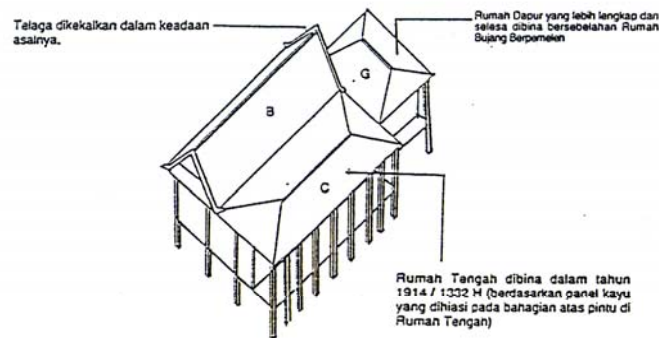
Gambarajah 1b: Peringkat 2: Pembinaan Semula Rumah Dapur (G) dan Pembinaan Rumah Tengah (C)

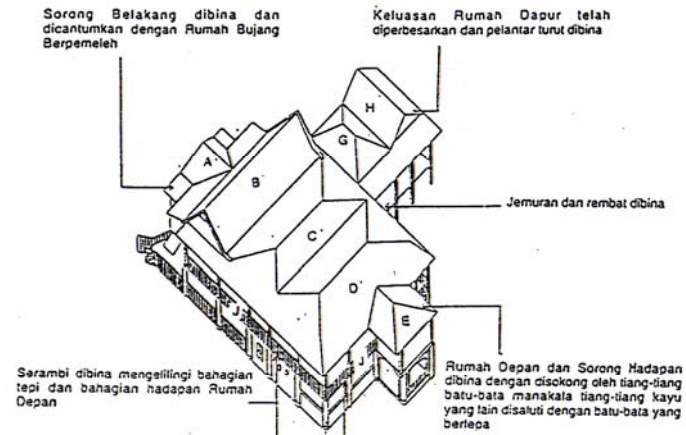
Gambarajah 1c: Peringkat 3: Pembinaan Rumah Depan (D), Serambi (J), Sorong Hadapan (E), Sorong Belakang (A), dan pembesaran Rumah Dapur (H)

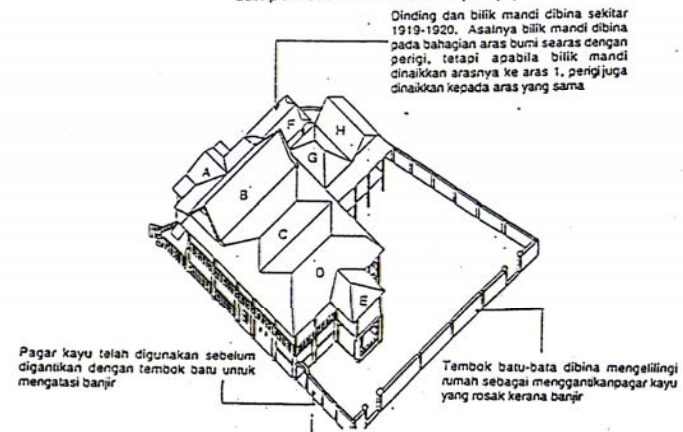
Gambarajah 1d: Peringkat 4: Pembinaan Bilik Mandi (F) dan Tembok Batu-bata

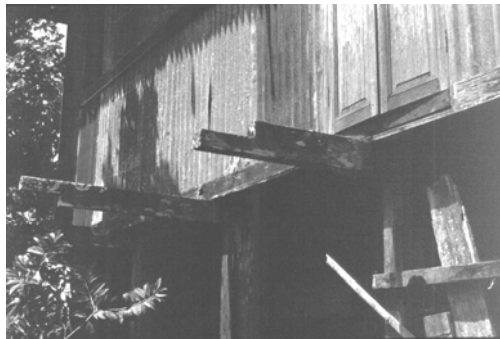
Fig. 10 – Floor beam projected out from Rumah Bujang indicates its connection with other parts of the house.

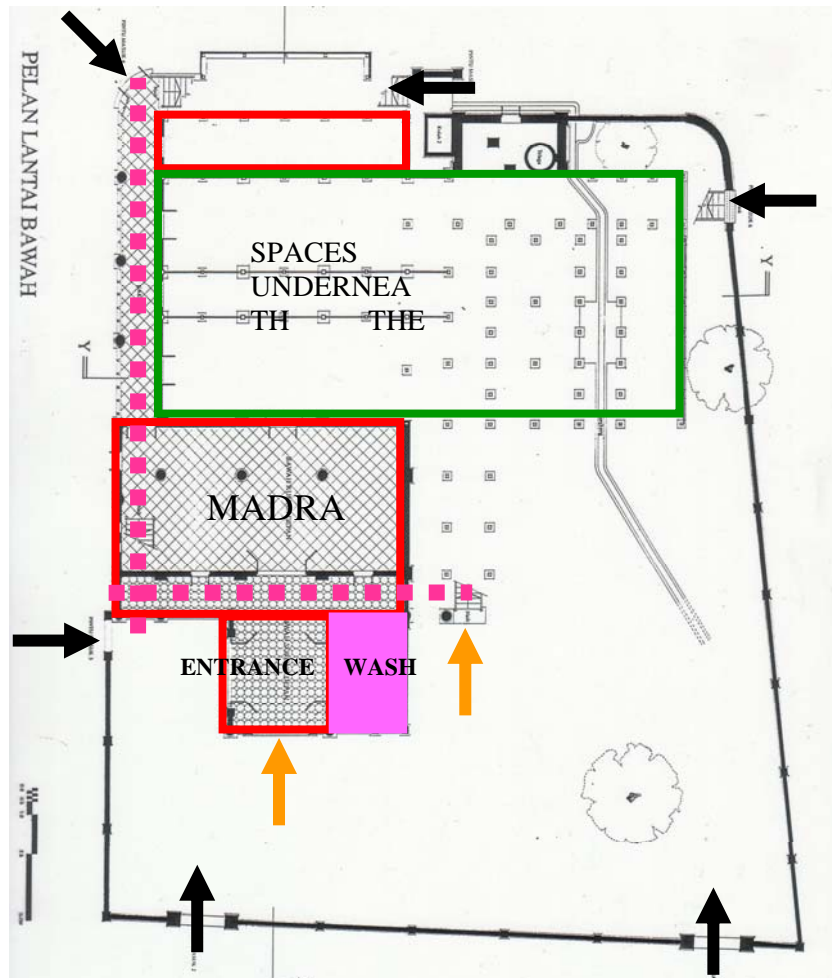
Fig. 12 – House plan at ground level. The house has 5 entrances with different hierarchy of usage on each of them.

Since not many people who have witnessed the glorious period of 1920 it's immediately posed to us the task of establishing the architecture of Kota Duyung of that period. We have taken an investigative approach in the effort to re-establish the characteristics of Kota Duyung. Evidences needed for the task can be divided into 4 types (Fig. 11): physical (e.g., elements on site, building parts found elsewhere), pictorial (e.g., family and classmate photos), oral (interviews with related elders and neighbors), and theoretical (a deduction from local Terengganu architecture would be sought in the absence of any of the first three evidences). Figures 12 and 13 explain division of spaces on

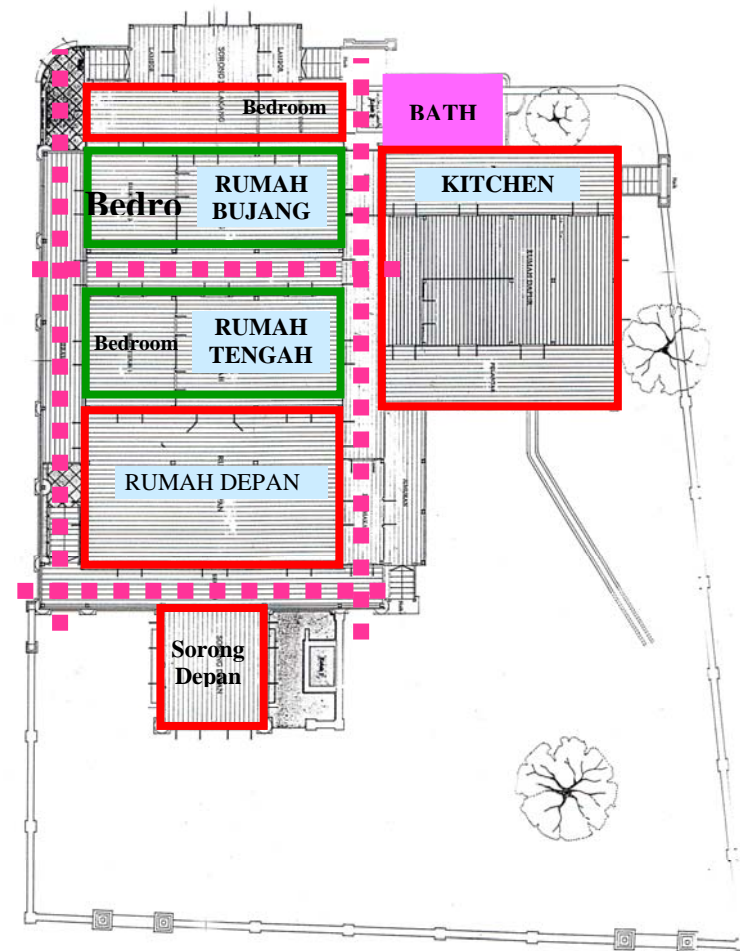
Fig. 13 - House plan at upper level. Rooms or spaces are separated and surrounded with circulation spaces.

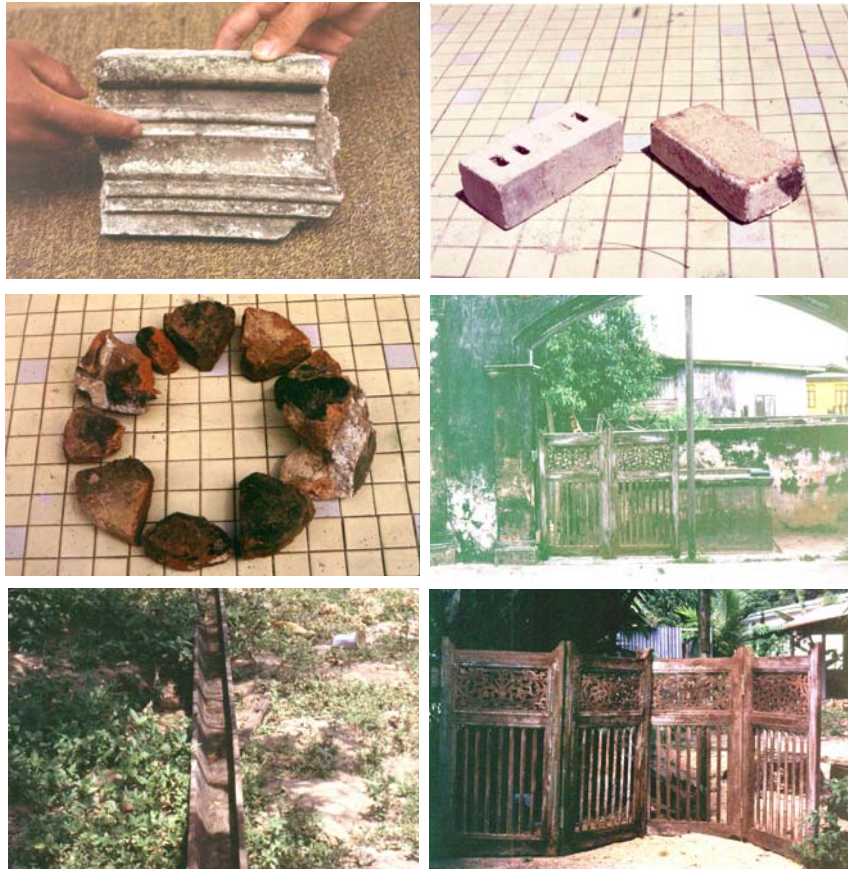
Fig. 14 - Fragment of cornices (top left), original brick used in Kota Duyung compared to the modern red brick (top right), cut bricks arranged to form round shape for the pillar (centre left), examining the fitness of foldable wooden gate (pintu pagar) to its original location (centre right), dug-out wooden gutter (bottom left), the complete set of the foldable wooden gate (bottom right).

floor plans of Kota Duyung. Some images of its architectural and constructional details are presented Figures 14 and 15.

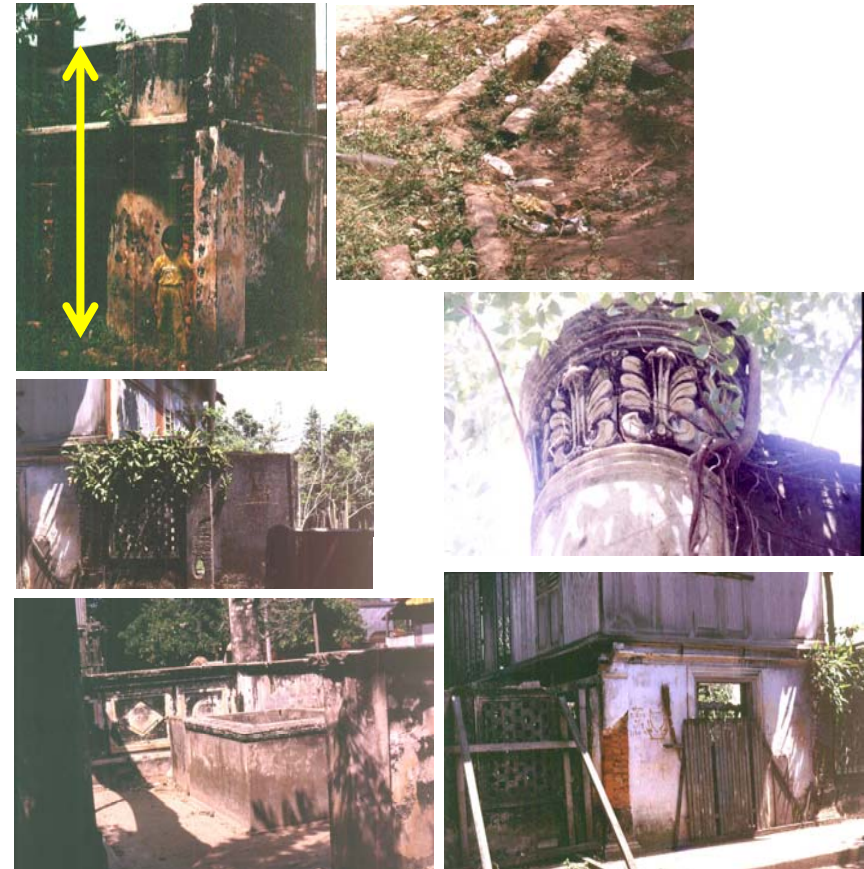
Fig. 15 - Condition of Kota Duyung before it was restored: the elevated indoor well (top left), physical traces of surface drainage (top right), part of the wall and Rumah Bujang overgrown with ivy (centre left), the round pillar with its characteristic capital (centre right), pool to store water placed at house front for ablution and washing feet (bottom left), half-hearted attempt to braced part of collapsing wall (bottom right).

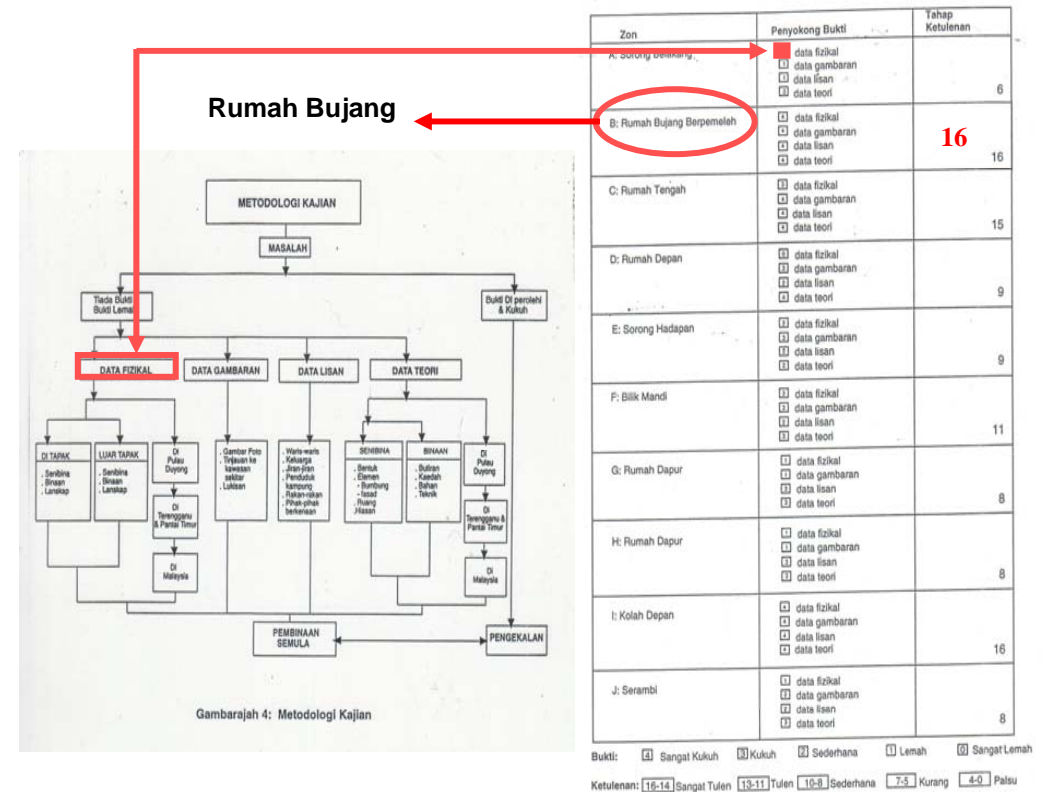
Fig. 16 – Method of evaluating authenticity (right) related to flow

Immediately after the completion of the research, the finding about Kota Duyung architectural history obtained recognition from the Terengganu Society of Historian. The 1920 images and characteristics of Kota Duyung architecture was based on the architecture investigated and concluded in the report. The authenticity of the architecture was measured using a specially designed method of evaluation. (Fig. 16)
