CORROSION PERFORMANCE OF Zn-Al-Mg COATED STEEL WIRE ROD FOR OFFSHORE APPLICATION

A project report submitted in partial fulfilment of the requirements for the award of the degree of Master of Engineering (Material Engineering)

> Faculty of Mechanical Engineering Universiti Teknologi Malaysia

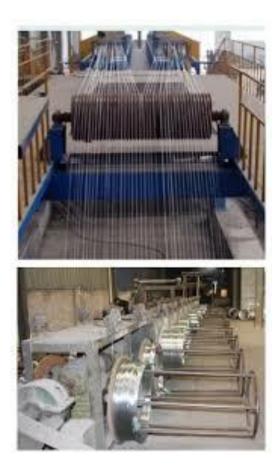
Figure 1.3: Steel wire rod ready to be hot-dipped in galvanizing bath

One of the most used coating on steel is Zinc known as galvanized steel. This is done by applying Zn on substrate which normally use hot-dip galvanizing process. This method has been applied years ago for the purpose of inhibiting corrosion against the substrate metal. Galvanized coat will act as a galvanic protector to the substrate as zinc element is more anodic to most of metal and alloy especially steel. The coating will promote protective layer on the substrate and corrosion process will take place on zinc first before it affecting the substrate thus it will slow down the corrosion process on the metal. Figure 1.3 shows a typical hot-dipping galvanizing process.
